HOMESAFE INSPECTIONS  
info@homesafeinspections.com.au  
<http://www.homesafeinspections.com.au>

## PCI OR DEFECTS REPORT

1234 MAIN STREET,  
SYDNEY NSW 2227

BUYER NAME  
08/06/2023

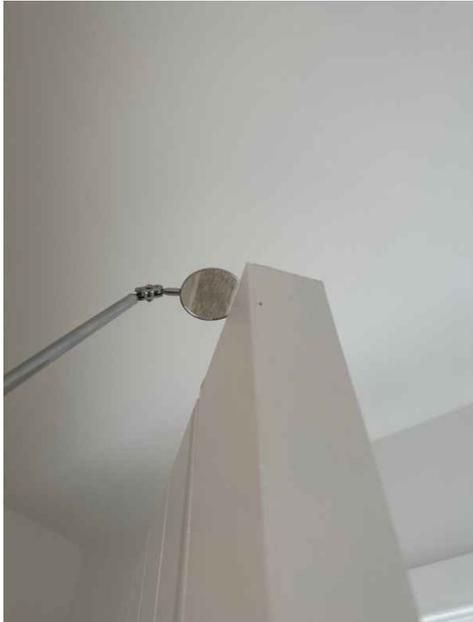
Front door

Bottoms and tops of doors have not been painted/sealed. This is defective please see the below reference to The Guide to Standards and Tolerances

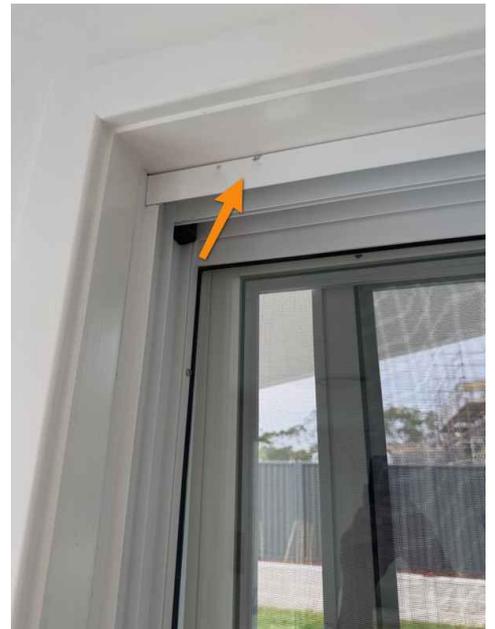
Sliding door system to the backyard has been damaged.

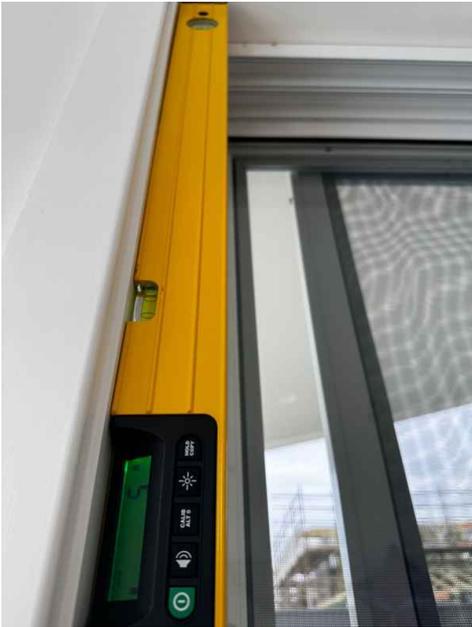
Door set leading to the backyard has been installed out of square

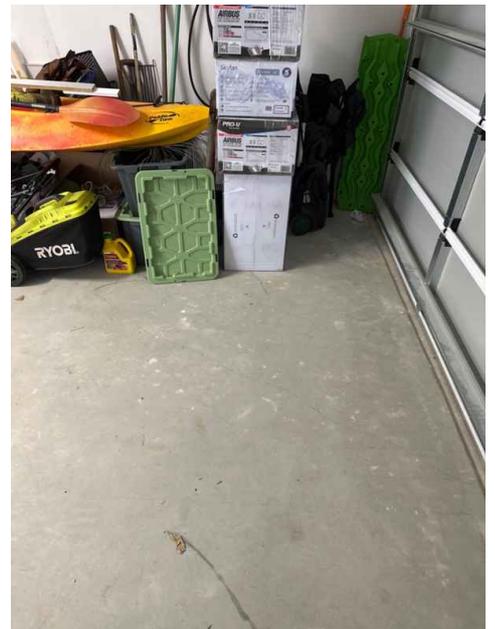
Garage floor still has building debris attached and has not been adequately cleaned

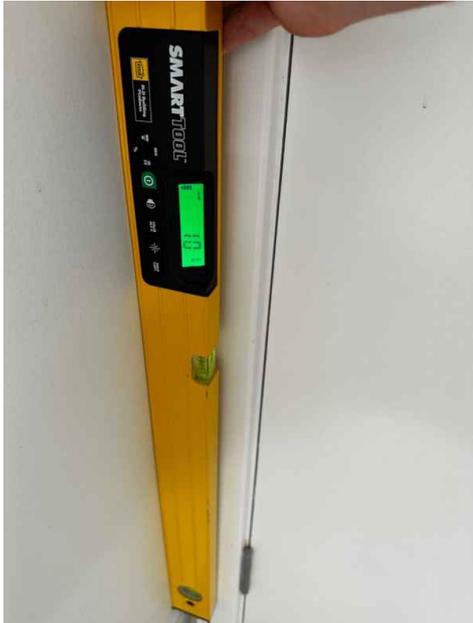
Wall next to external laundry door is out of plumb by 10mm over 1200mm

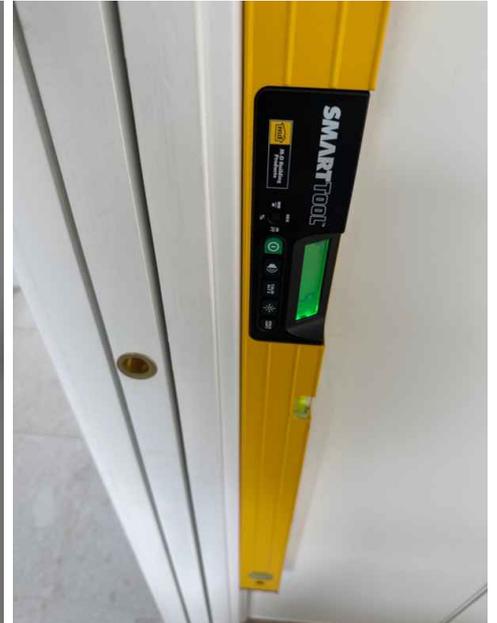
Laundry cavity slider has been installed out of plumb

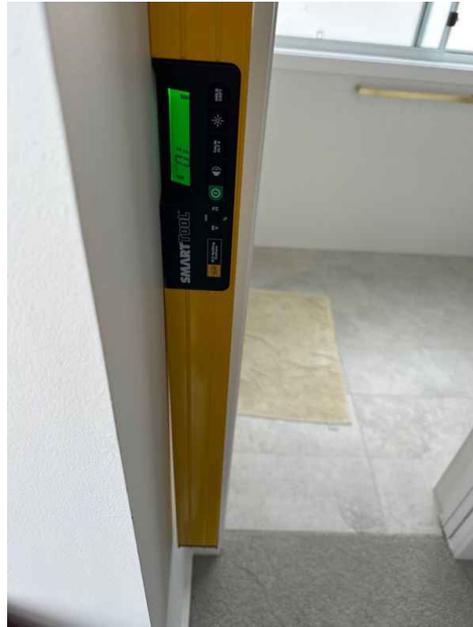
Walk-in robe wall out 10mm over 1200mm

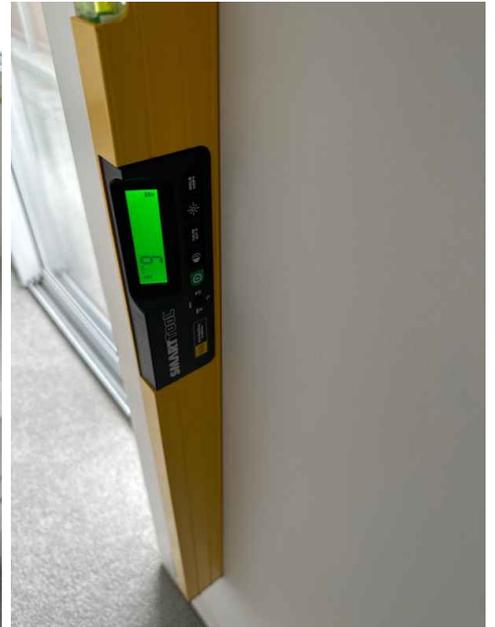
Wall next to backing door is out 6mm over 1200mm

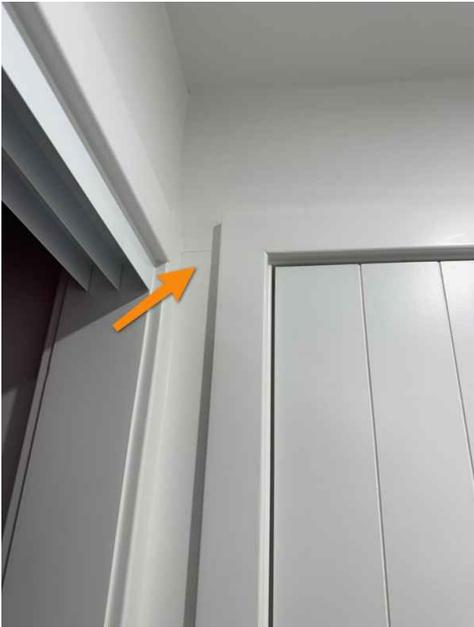
Downstairs bedroom entry

*Unless documented otherwise, a plasterboard finish is defective if Level 4 finish (as defined below) is not provided.*

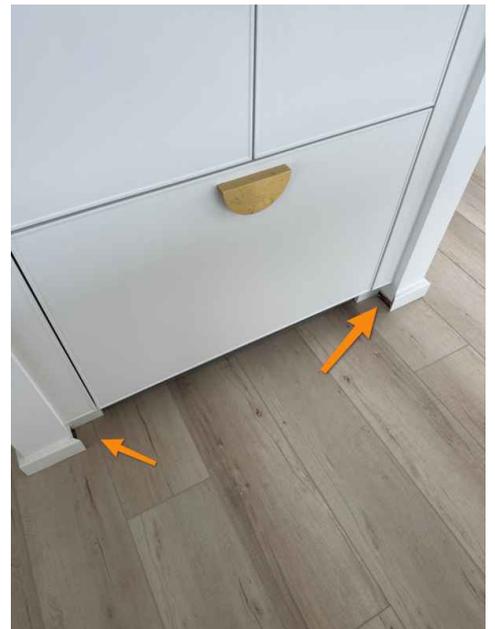
Kitchen

Skirting is loose/missing install/fix as needed

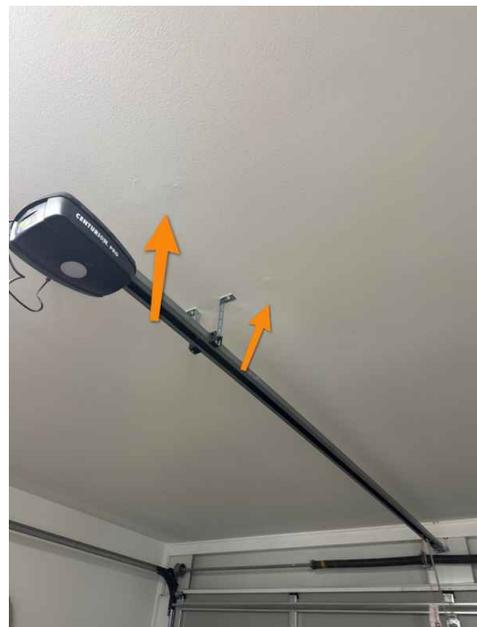
Poor patching noted to the garage ceiling

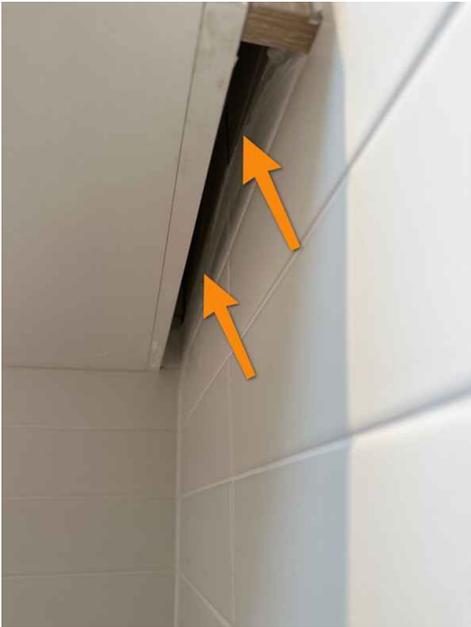
No grout installed next to vanity

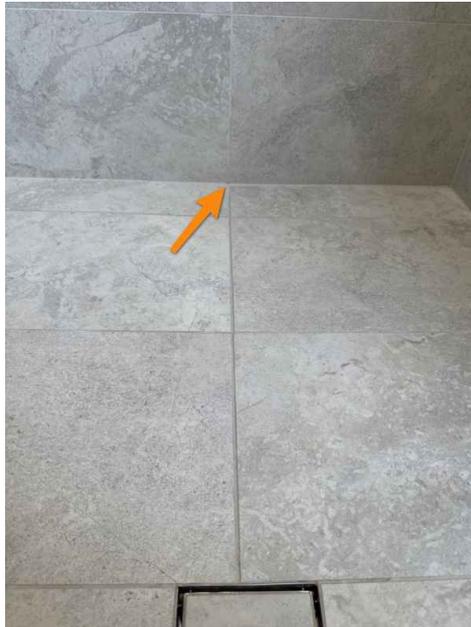
Gap in grout or sealant noted to the ensuite shower

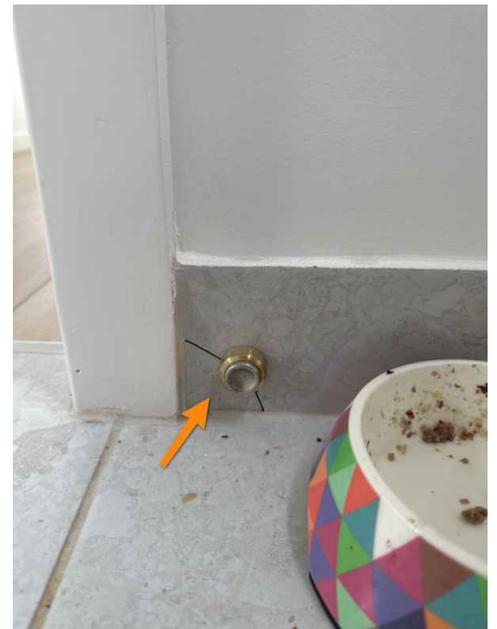
Cracked tile in the laundry

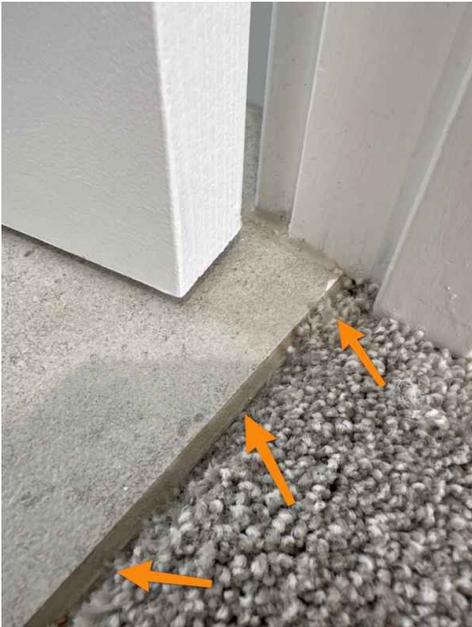
Waterstop finishes 6mm below the finished tiled height in the upstairs bathroom

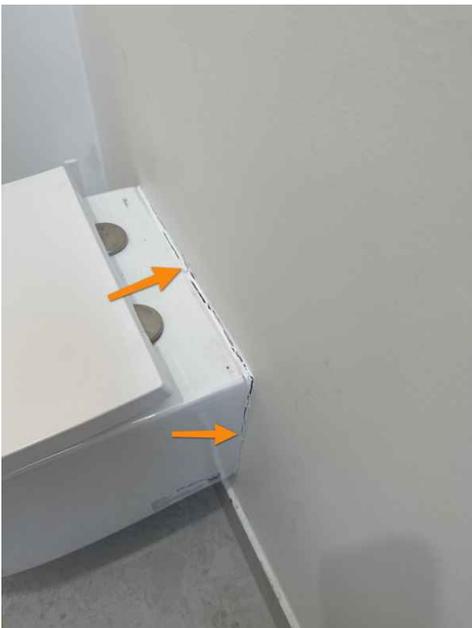
Poor sealant installation around the powder room toilet

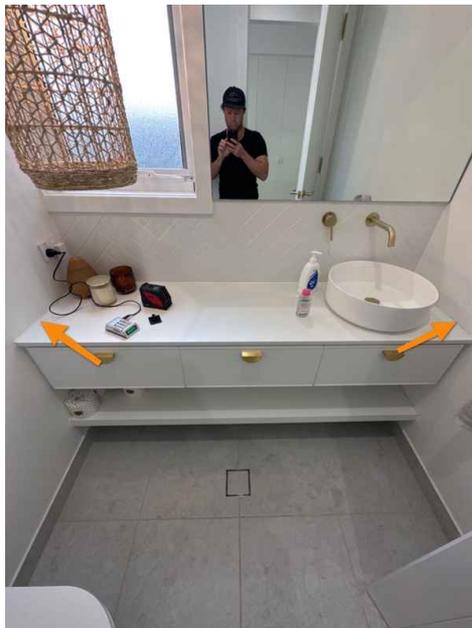
Either side of the powder room benchtop

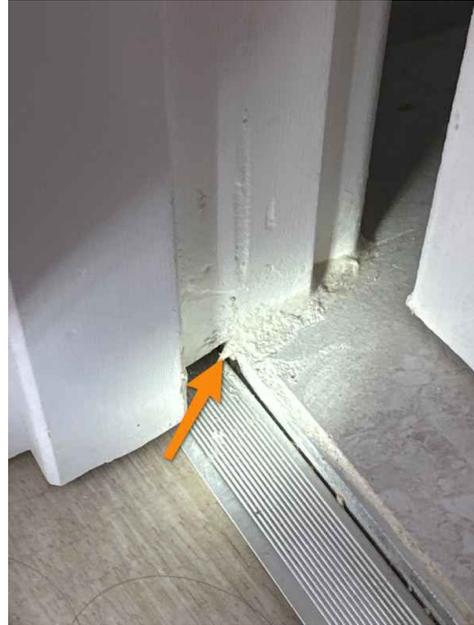
The laundry waterstop angle does not extend the full required length. This is non compliant

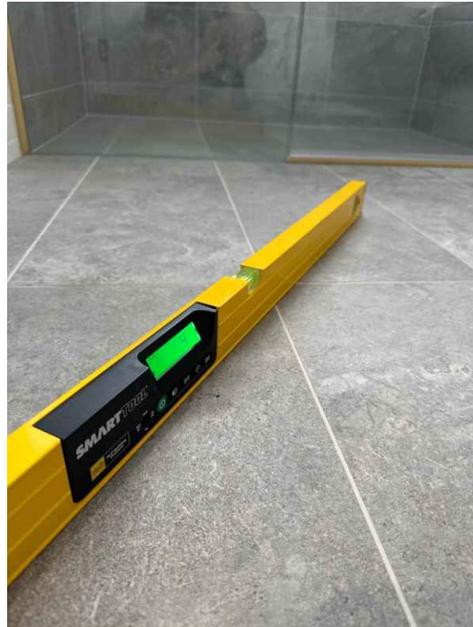
Downstairs ensuite only achieved 4mm fall. This should be minimum 12mm

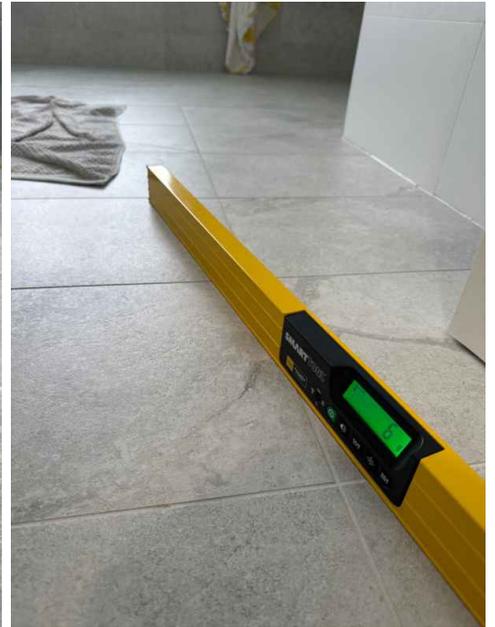
Upstairs bathroom has only achieved 6mm fall over 1200mm. This should be 12mm

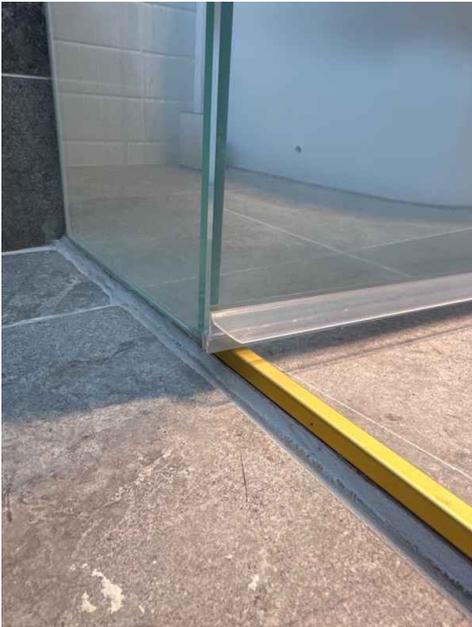
Waterstop angle should extend to the top finished tiled height outside of the shower. The waterstop angle installed only sits 3mm above the finished tiled height in the shower

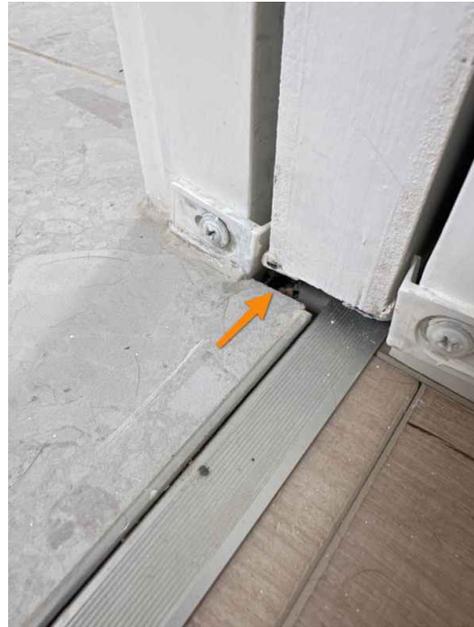
Waterstop should return around the tile under the cavity slider in the laundry

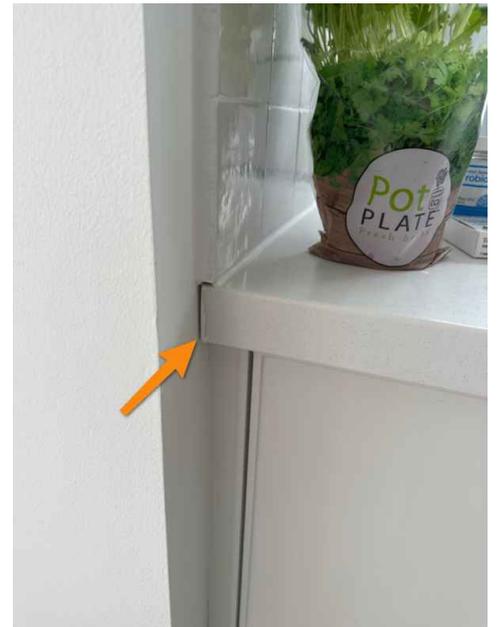
Kitchen benchtop

*Flexible or waterproof sealants to junctions are defective if they are not installed when required by the BCA and AS 3958.1, or in accordance with the manufacturer's installation requirements.*

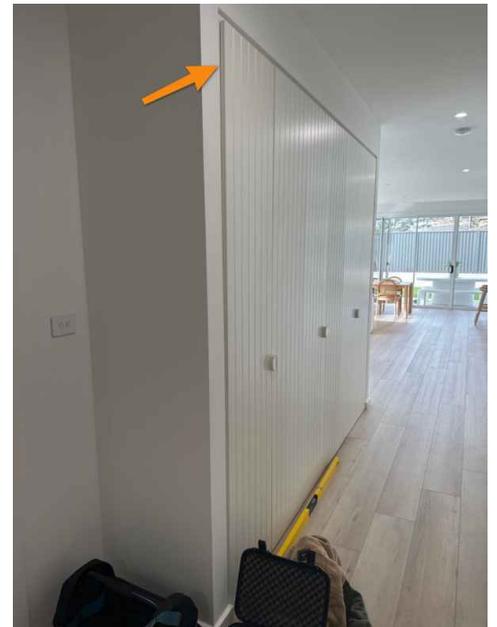
Vanity cabinet door defective as it does not close as intended.

Cabinet door installed 7mm out plumb and does not line up with the wall

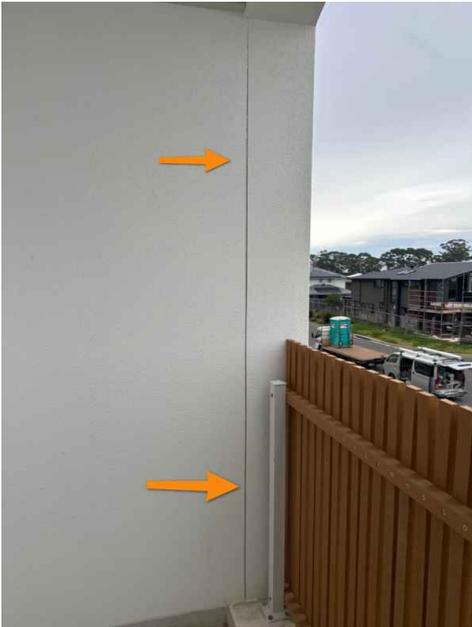
Join between 2 panels requires sealing

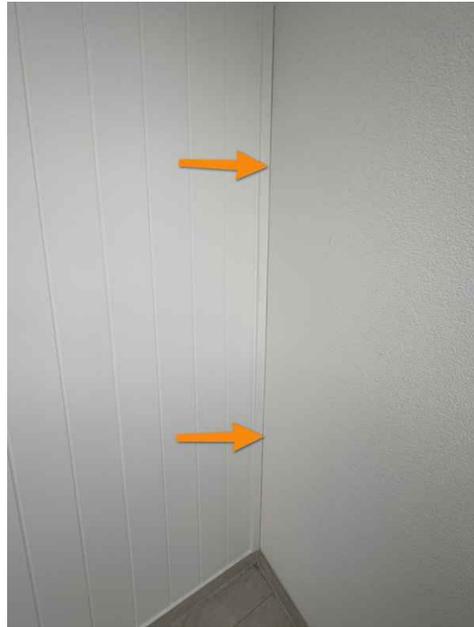
Sealant required between timber trim and rendered panel on balcony

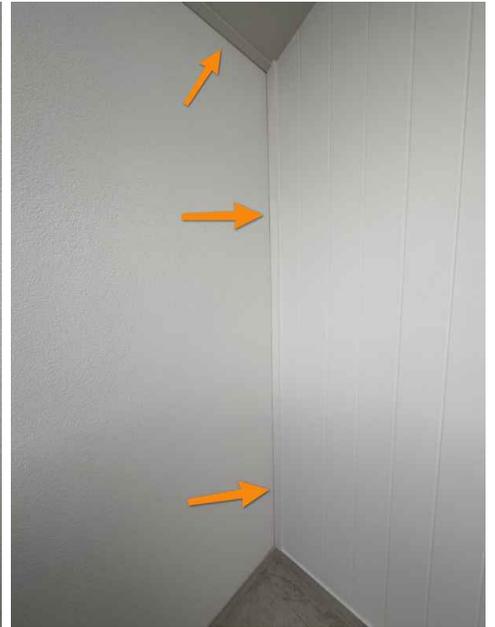
Sealant required between materials on balcony

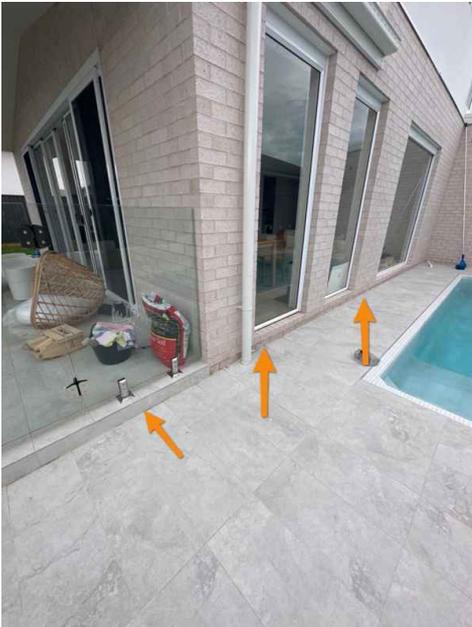
Flexible sealant should be installed to all floor and wall junction areas. This is required to all external areas

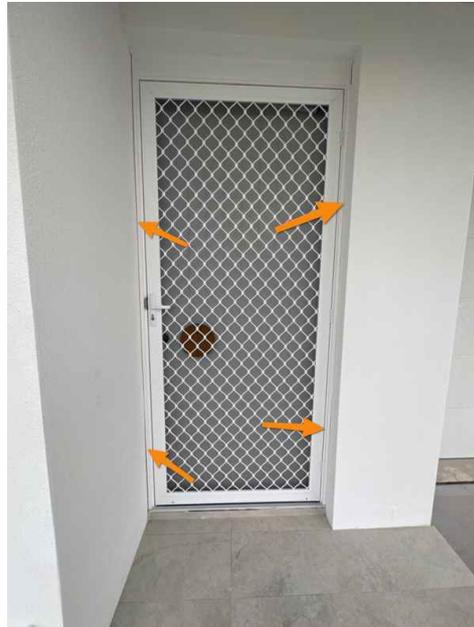
Sealant required at junctions

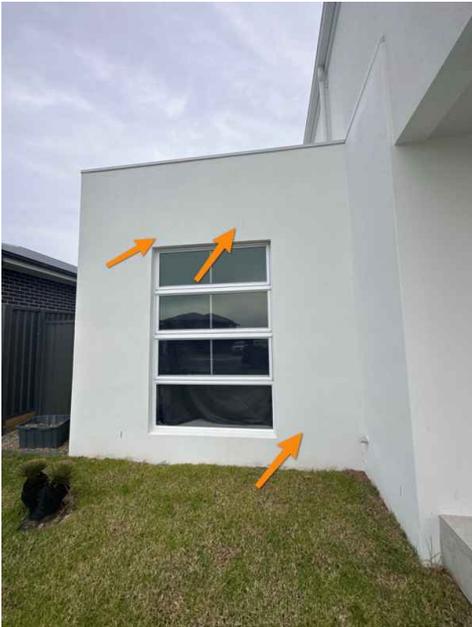
Weeps rendered over and missing

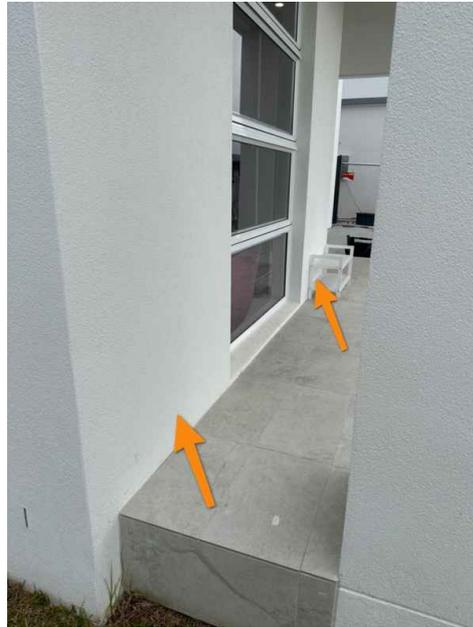
Weeps painted over and blocked. These weep holes have been installed at the incorrect height

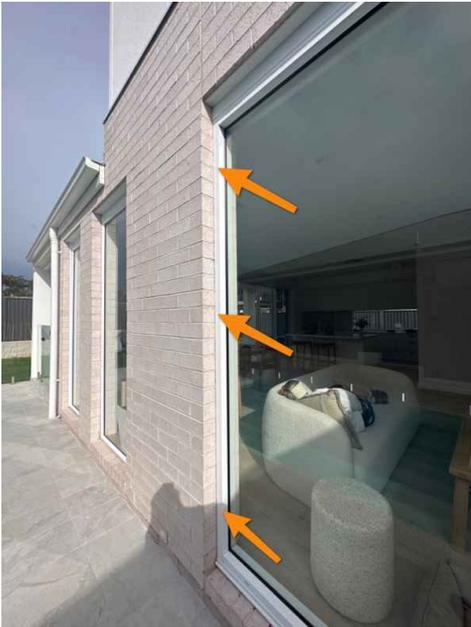
The articulation joint does not extend as the window has been installed tight to the brickwork. The window should have a 10mm gap that is sealed to allow for movement

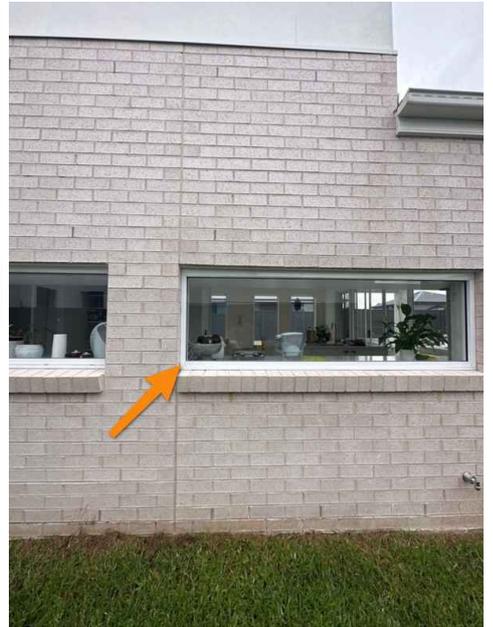
Blocked by window

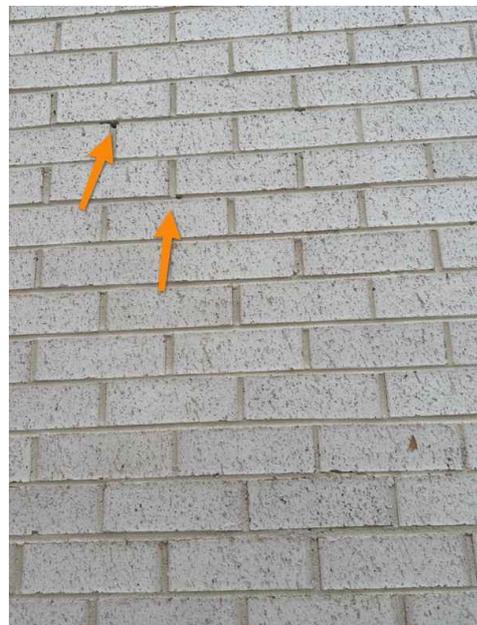
Some areas where mortar was defect has attempted to be fixed. This has been done with mortar that does not match the original. This is defective and outline in the guide of standards and tolerances

Gaps in the mortar noted. This is common throughout the property and the photos are only an example.

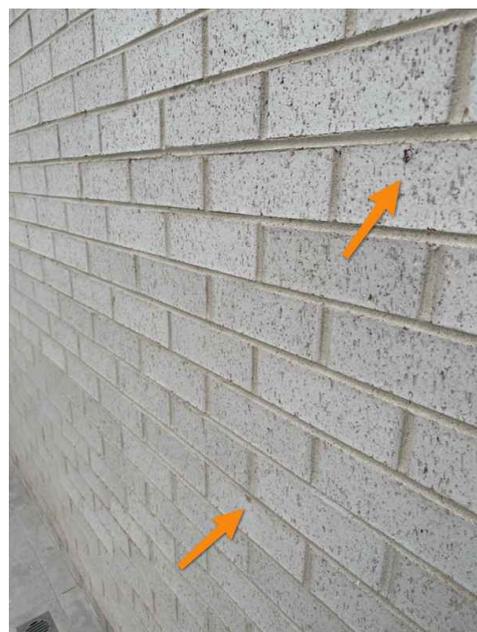
### **DAMAGE BRICKS**

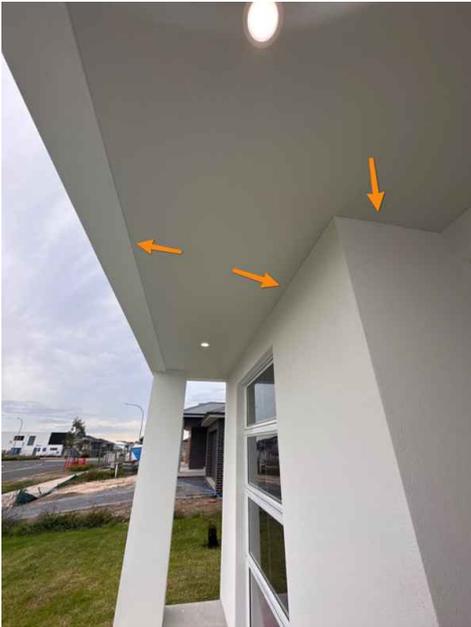
Gaps noted between the ceiling lining and render cladding. Either a trim or sealant should be installed for an adequate finish

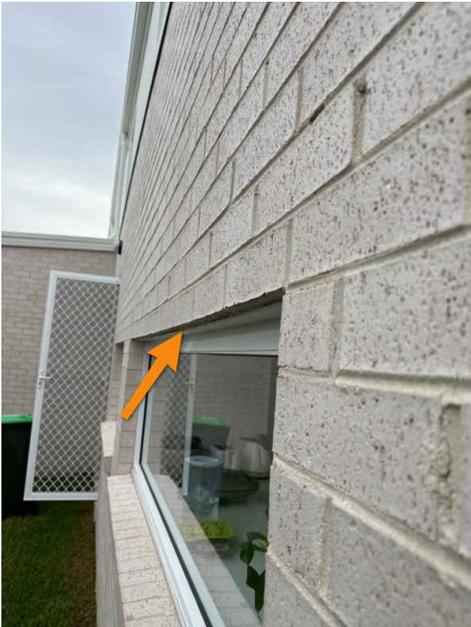
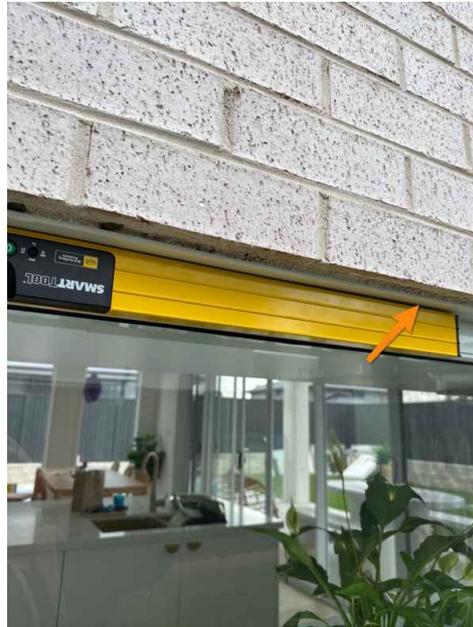
Kitchen window

The lintel outside the kitchen has sagged. This means the steel lintel installed is not adequate to support the weight of the brick veneer wall. It is recommended the lintel be checked against the engineer plans to determine if the correct one was installed.

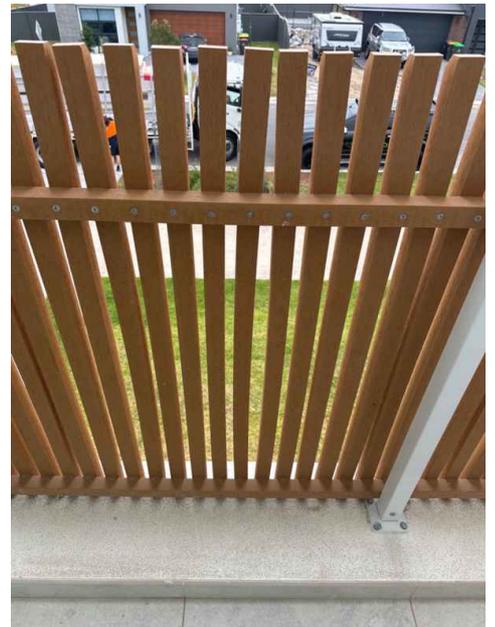
Balustrade installed poorly with uneven gaps common

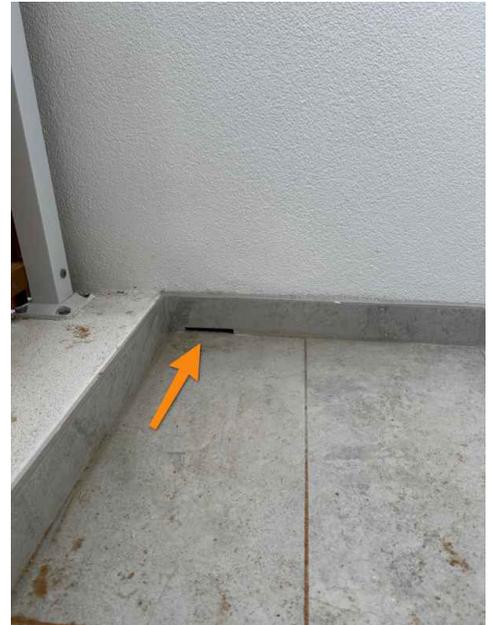
Inadequate overflow installed

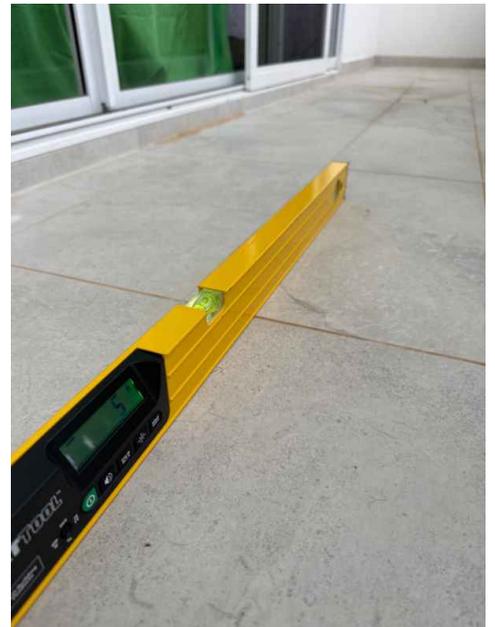
AS 4654.2 Waterproofing Membranes for External Above-Ground Use stipulates a fall requirement of no flatter than 1:100.

Only 5mm over 1200mm fall achieved. This should be 1200mm

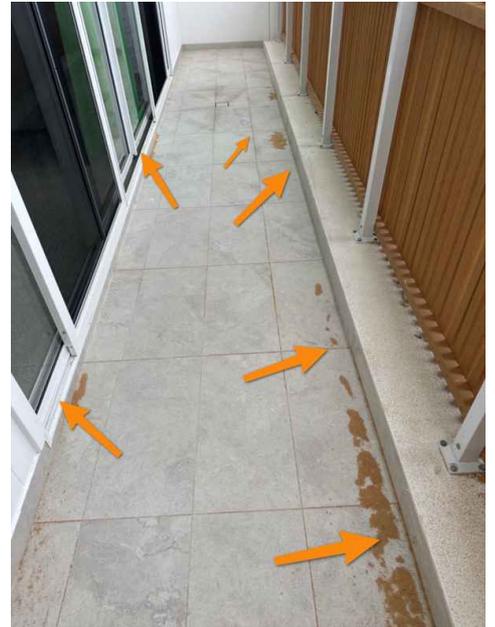
Building sites are defective if they are not clear of building debris.

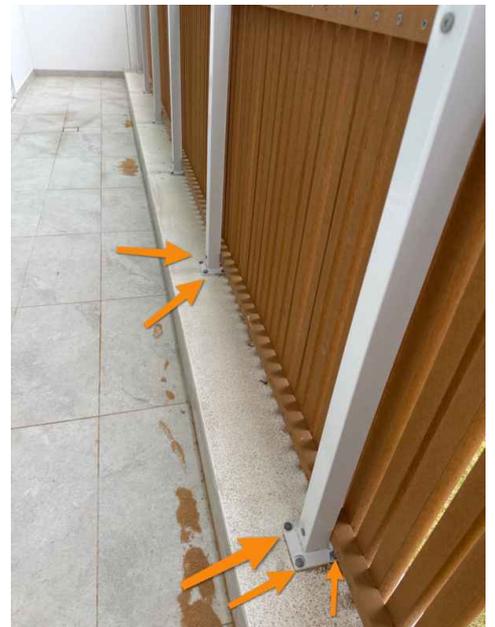
Likely penetration of the waterproofing due to the balustrade fixing penetrating the substrate with no evidence of additional waterproofing.

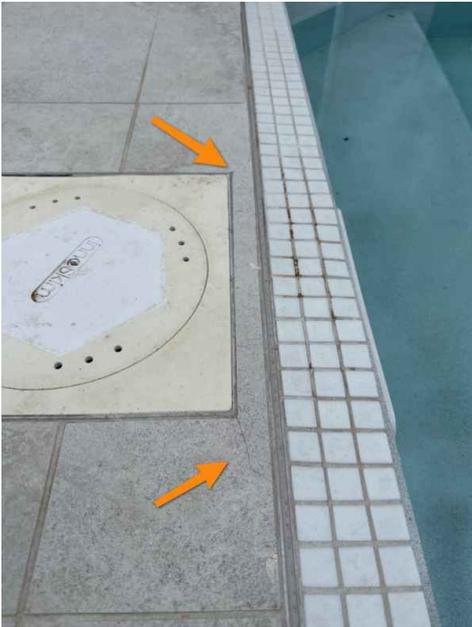
Cracked tile around pool

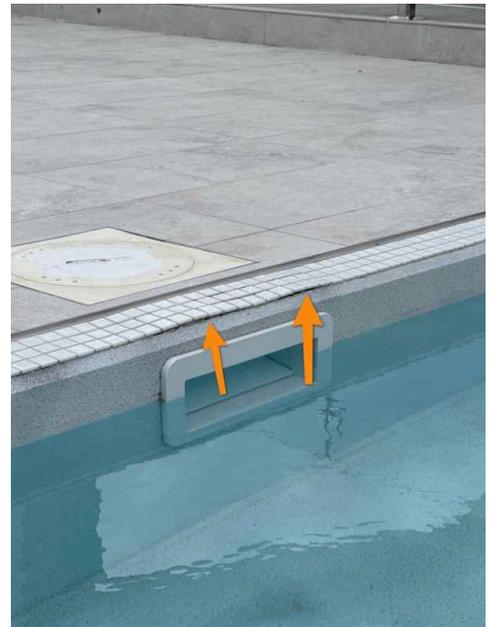
Tile lift has occurred due to grout deterioration

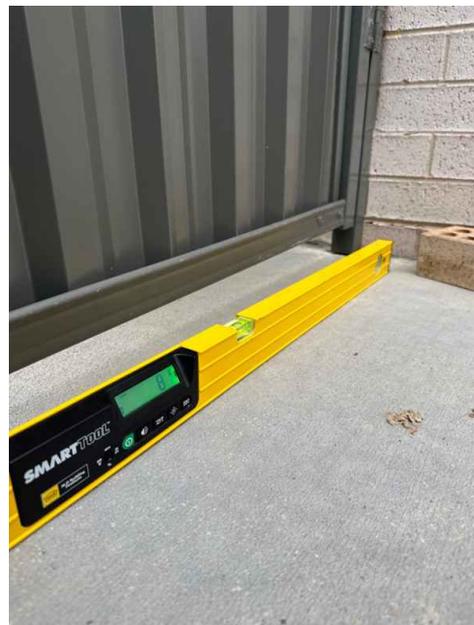
Only 8mm fall over 1200mm. This should be 20mm

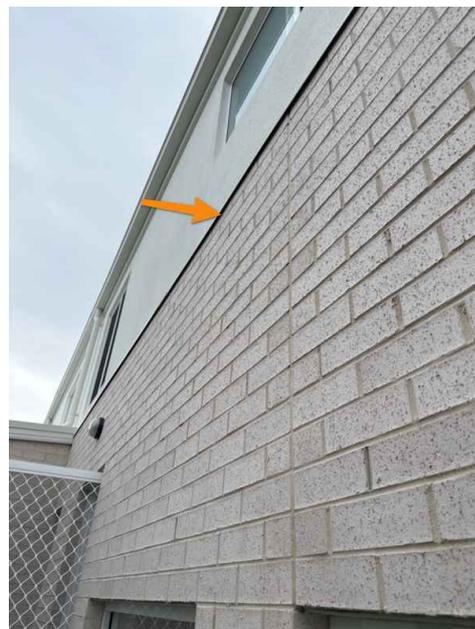
Excessive gap between flashing and brickwork

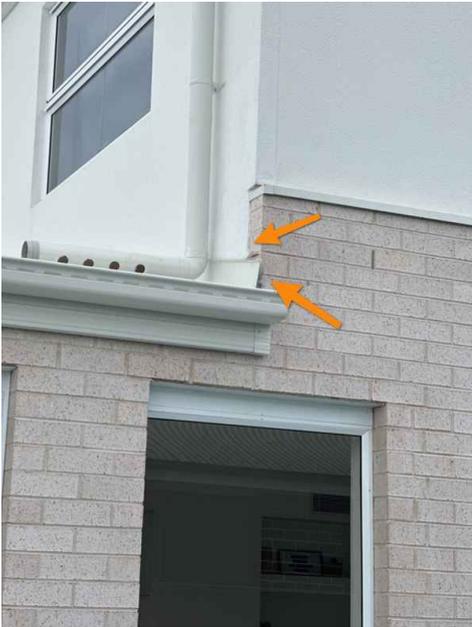
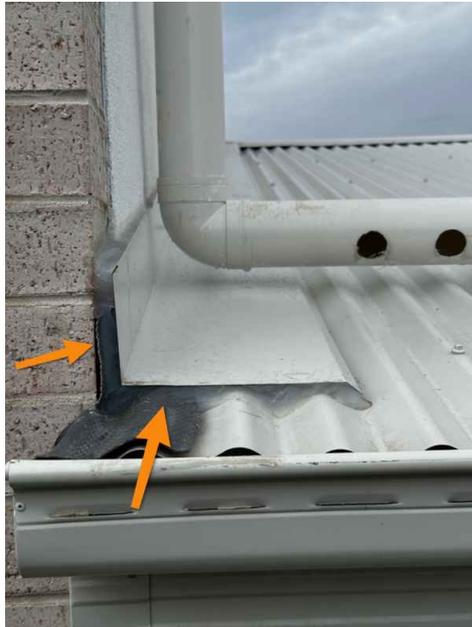
Poor workmanship and a pressure flashing should be installed over the top of this flashing. This is non compliant works
