HOMESAFE INSPECTIONS
info@homesafeinspections.com.au
<http://www.homesafeinspections.com.au>

COMBINED BUILDING AND PEST INSPECTION

1234 MAIN STREET
SYDNEY NSW 2227

16/06/2023

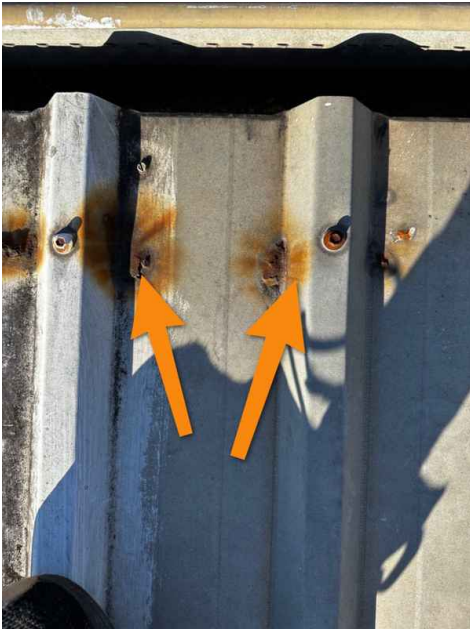
ROOF RUST

Metal roof is rusting and requires or replacement as the may lead to water ingress into the roof cavity.

Contact a qualified roofing professional.

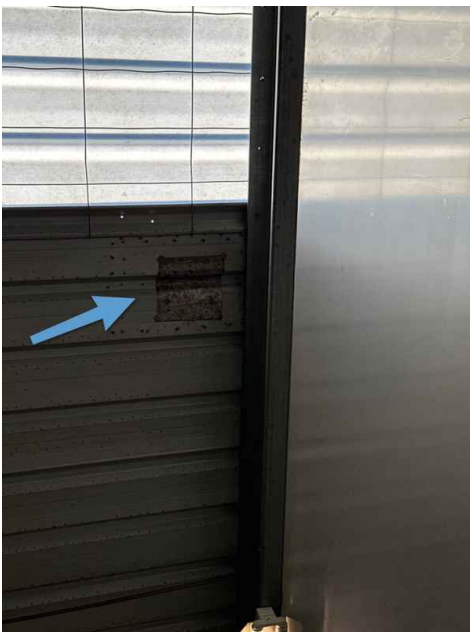
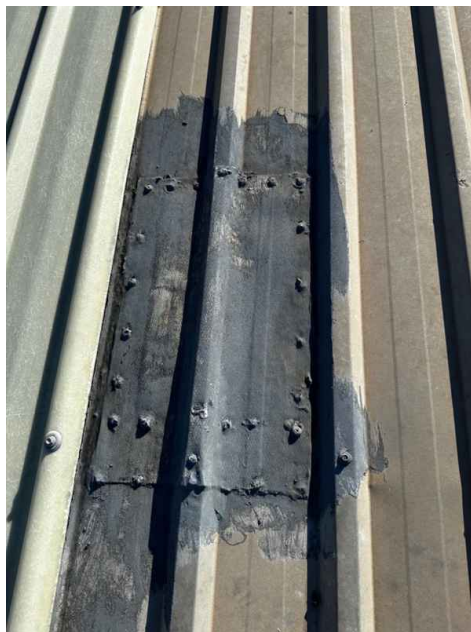
3.1.2 Coverings

SCREW RUST

Some of the screws on the roof have begun to rust. Some of these may need to be replaced in the future

Contact a qualified professional.

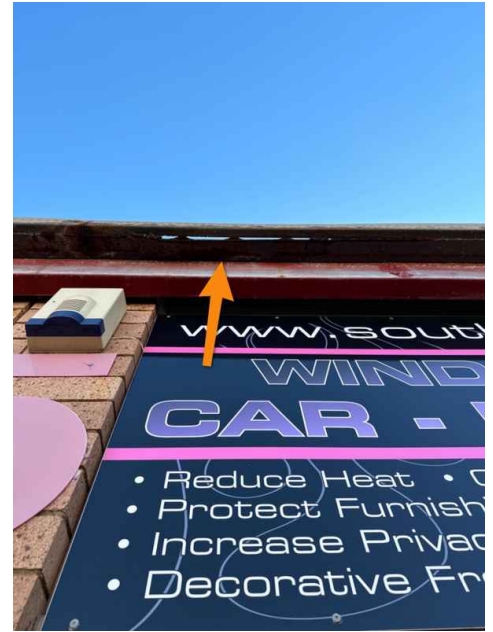
RUST PENETRATION

Gutter rust/penetrations - The gutter has excessive rust where leaking will occur.

Contact a qualified roofing professional.

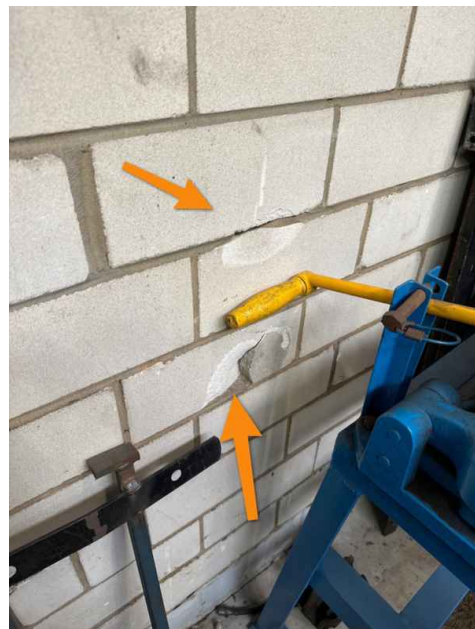
IMPACT DAMAGE

Impact damage noted. Patch and paint will generally suffice, however, see a qualified plasterer for further advice

Contact a qualified professional.

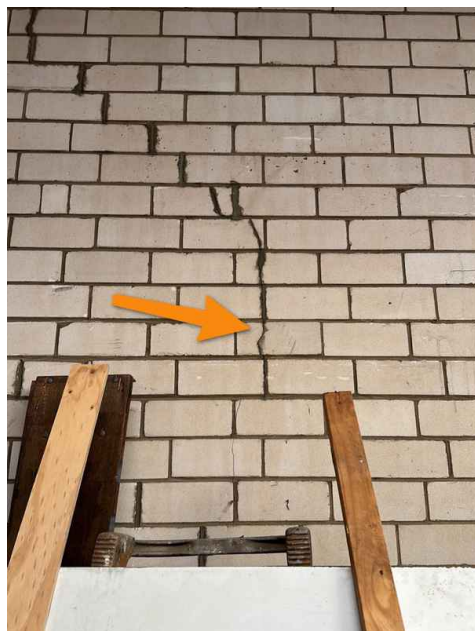
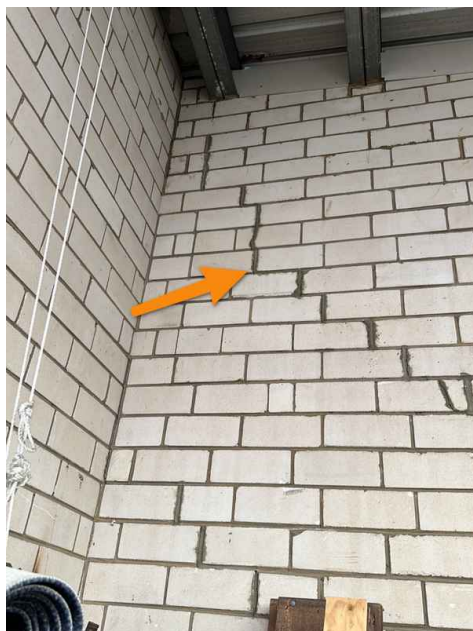
4.3.2 Internal Wall

SETTLEMENT CRACKS

Settlement Cracks Noted. These are typical and generally, patch and paint will suffice, however Monitoring these cracks advised for 12 months and if become wider or longer, you will need to contact a structural engineer to assess.

Contact a qualified professional.

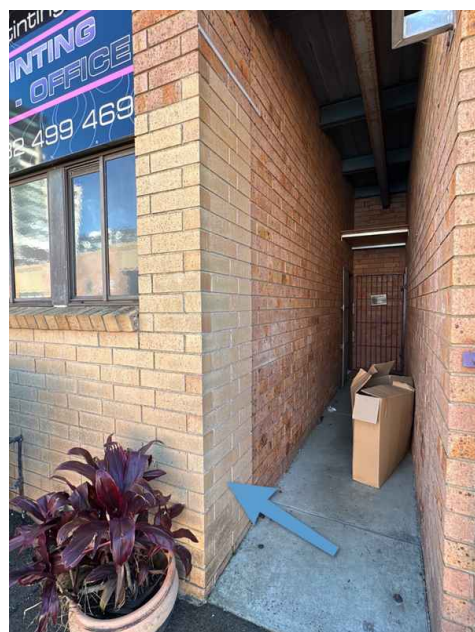
IMPACT DAMAGE

Impact damage noted to the exterior from a vehicle impact this has been repaired to a high quality and shouldn't be of any concern in the future

Contact a qualified carpenter.

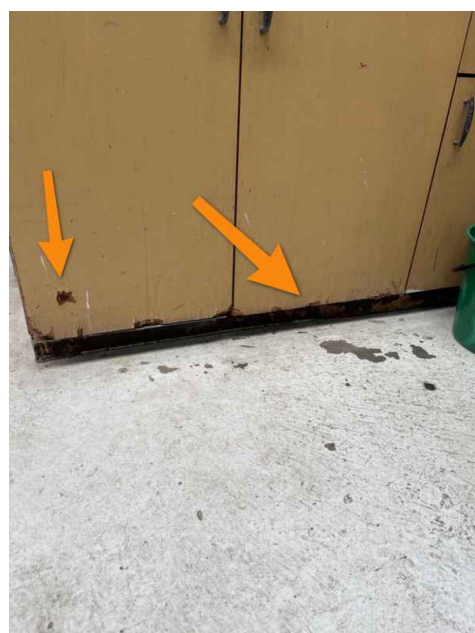
DAMAGE TO CABINETS

Damage was noted to the cabinets, contact a joinery company for repairs

Contact a qualified cabinet contractor.

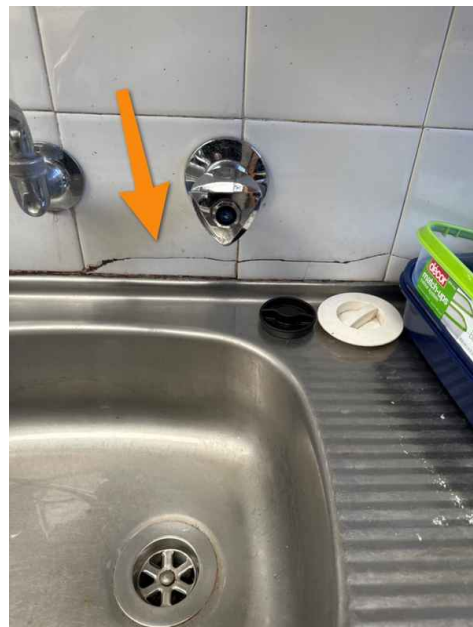
7.3.2 Sink, Cabinetry & Benchtops

SPLASHBACK TILES CRACK

Splashback tile cracking visible.

Contact a qualified tile contractor

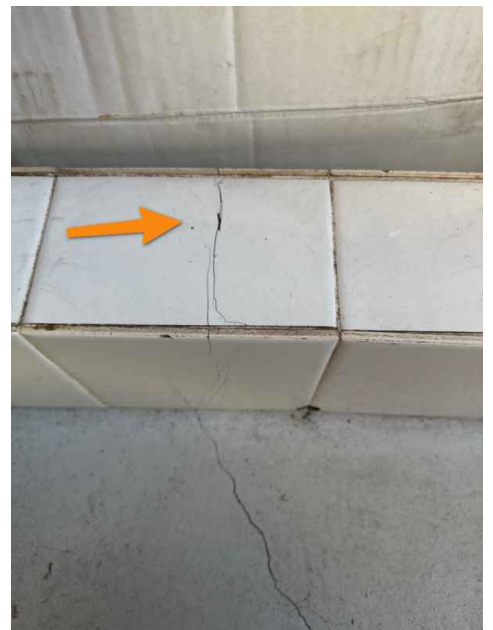
9.9.1 Shower & Bath

CRACKED TILES

Cracked tile/s noted. This can cause extensive floor and floor frame damage if water is leaking through the cavity. A qualified tiler should be engaged for advice and recommendations.

Contact a qualified tile contractor

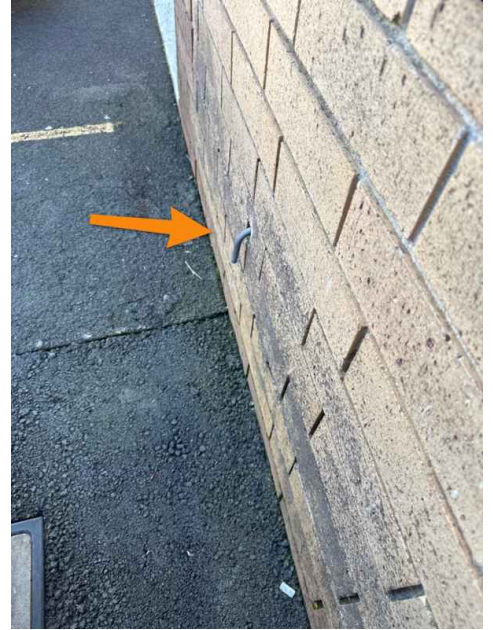
10.1.1 Hot Water Unit

The hot water overflow requires diverting to a drain or further from the wall or footings of the dwelling. Excess water ponding alongside walls and into perimeter footings has the potential to cause rising damp, differential settlement, and wall cracks over time.

Contact a qualified plumbing contractor.

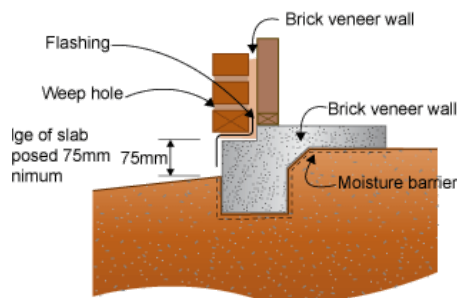
Is the slab edge exposed - No

No, the slab edge should be exposed to a minimum of 75mm around the entire dwelling. It is impossible to ascertain termite entry if the concrete slab is not exposed. Termite damage may exist.
