HOMESAFE INSPECTIONS
info@homesafeinspections.com.au
<http://www.homesafeinspections.com.au>

COMBINED BUILDING AND PEST INSPECTION

1234 MAIN STREET
SYDNEY NSW 2227

03/07/2023

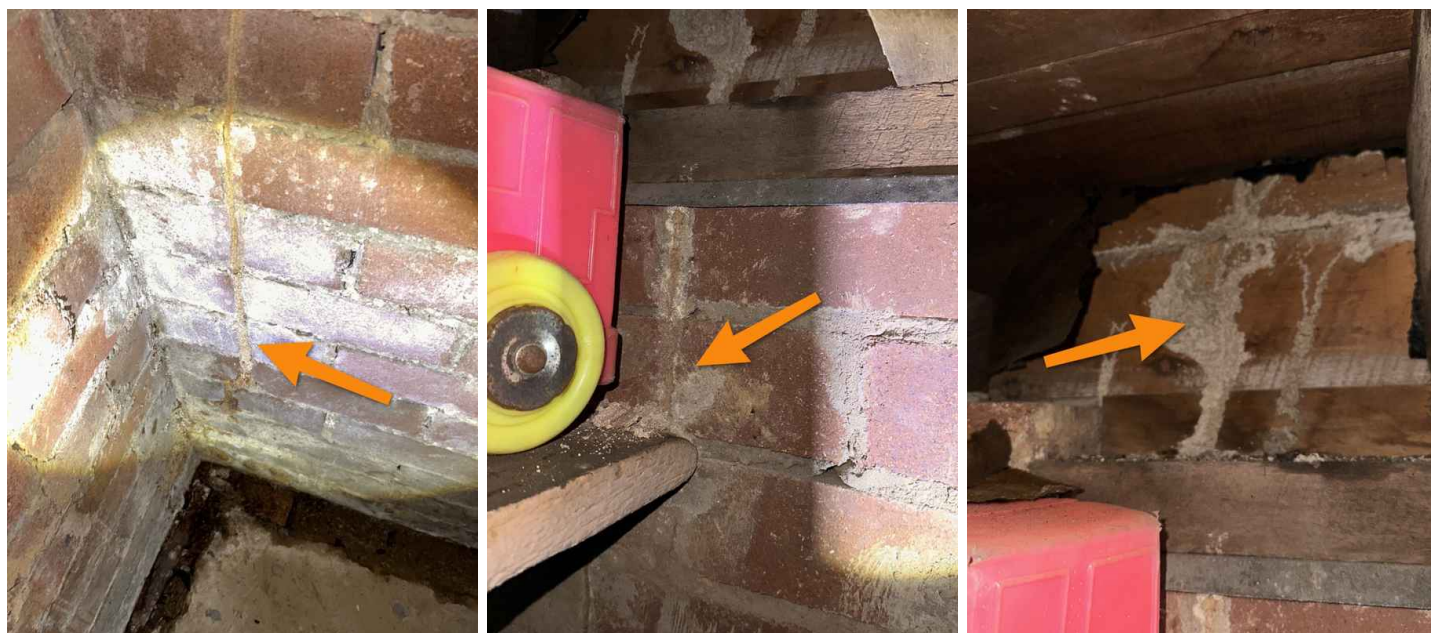
4.3.1 Internal Wall

Old termite damage and mudding noted. It is recommended that a timber pest management system be implemented to prevent further attacks.

Contact a qualified professional.

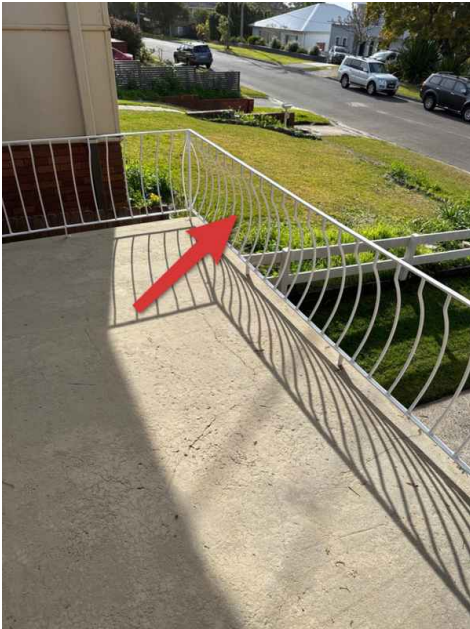
5.8.1 Balcony

Major Defect/Safety Hazard

Contact a qualified professional.

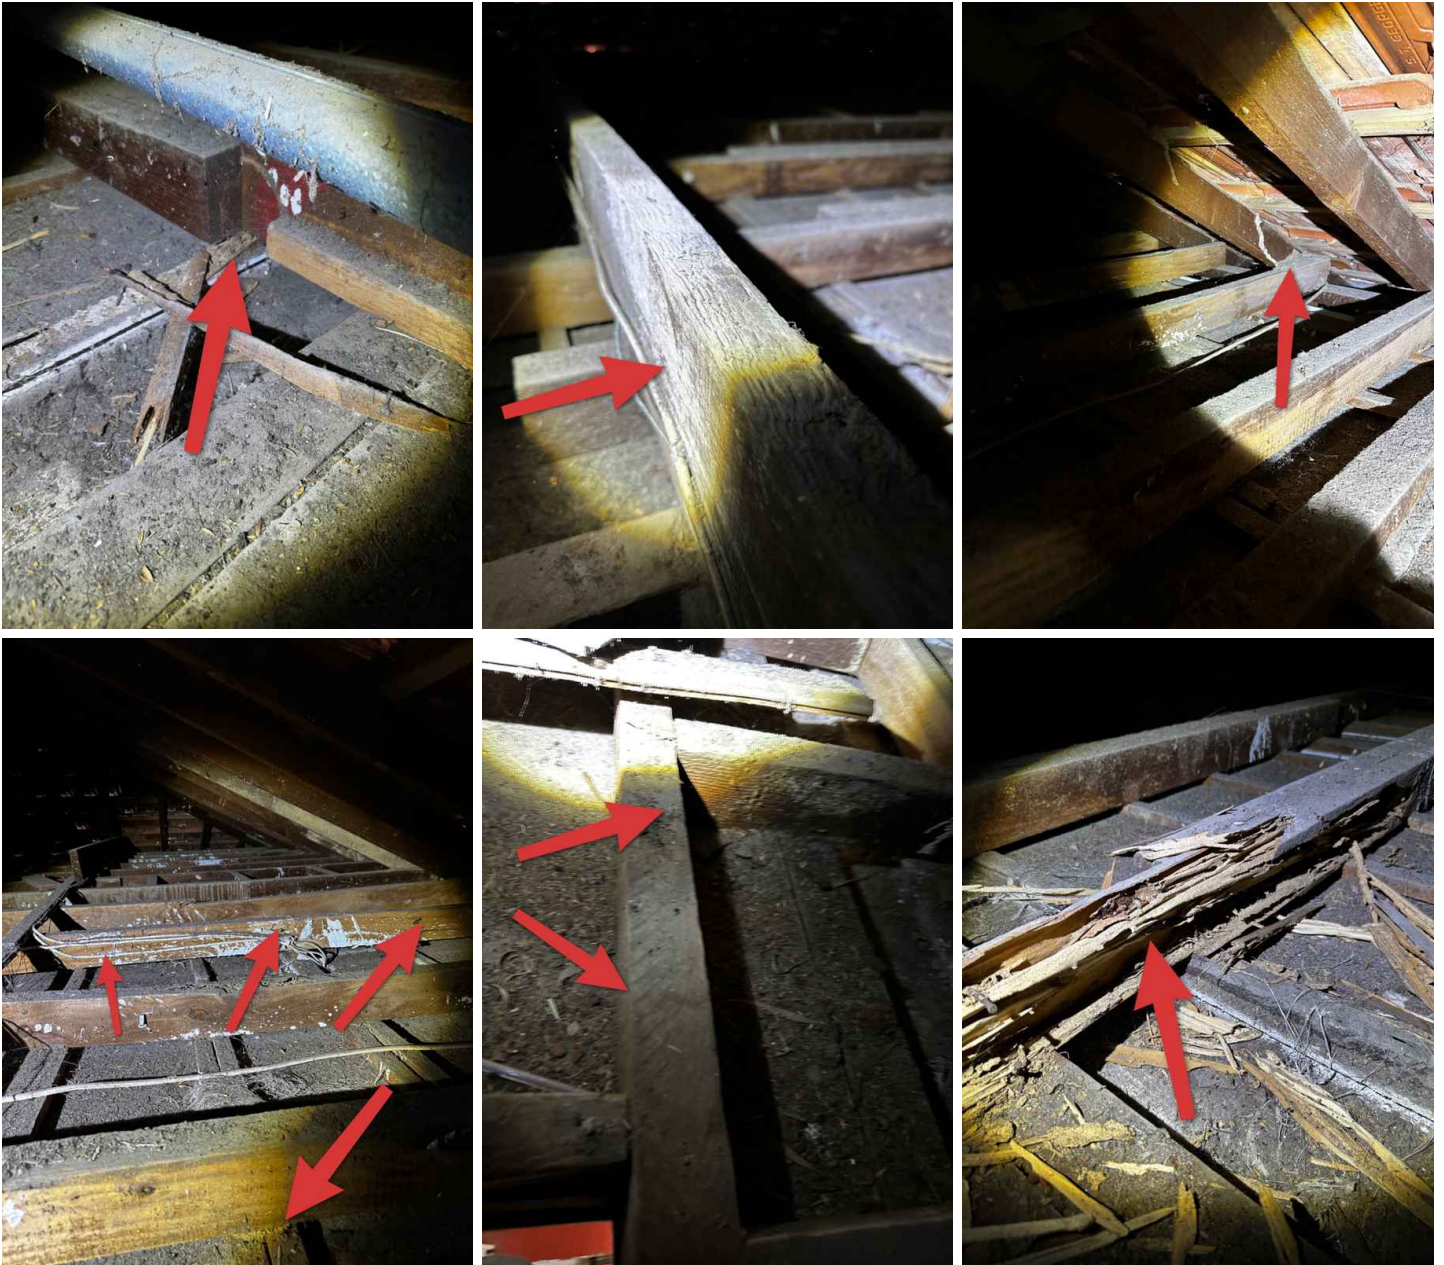
The roof cavity has substantial termite damage in vicinity of manhole, Timbers have been compromised and not safe to walk on

Timber Pest Attack Noted.

Major Defect/Safety Hazard

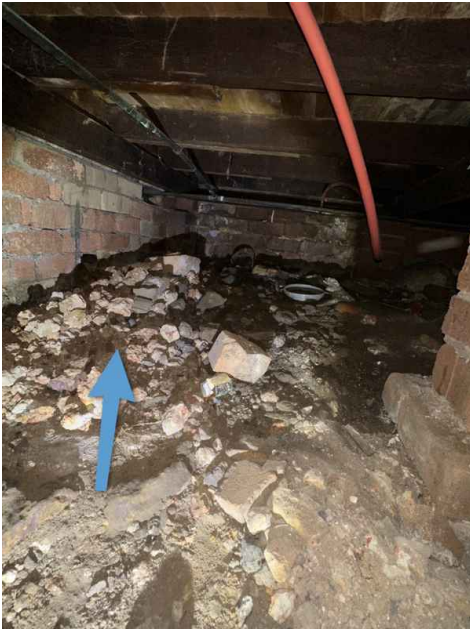
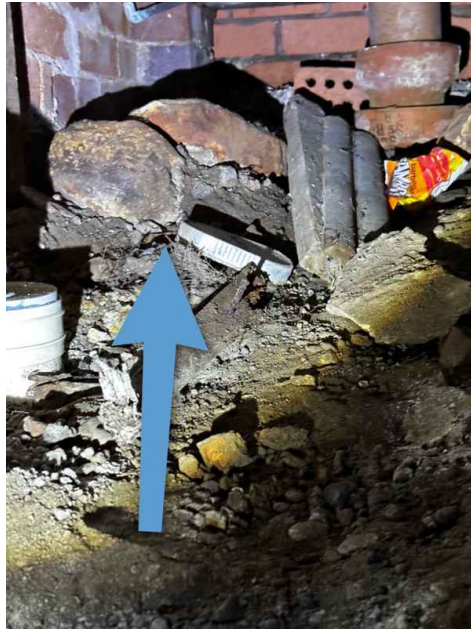
6.3.1 Subfloor

DEBRIS

There was debris and other material in the subfloor, we recommend cleaning these to aid with ventilation and reduce the likely hood of rodents and pests.

Maintenance/Monitor Item

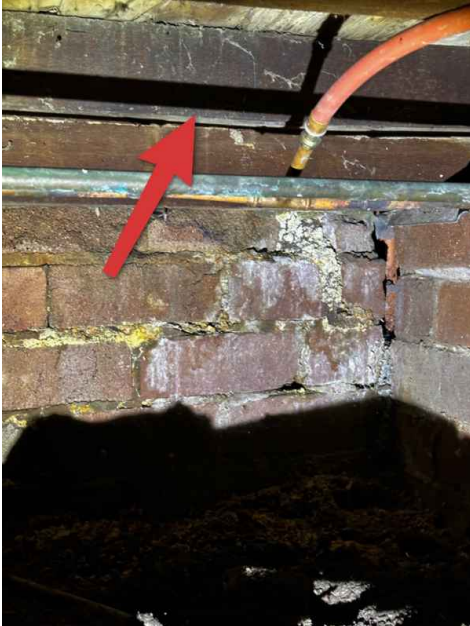
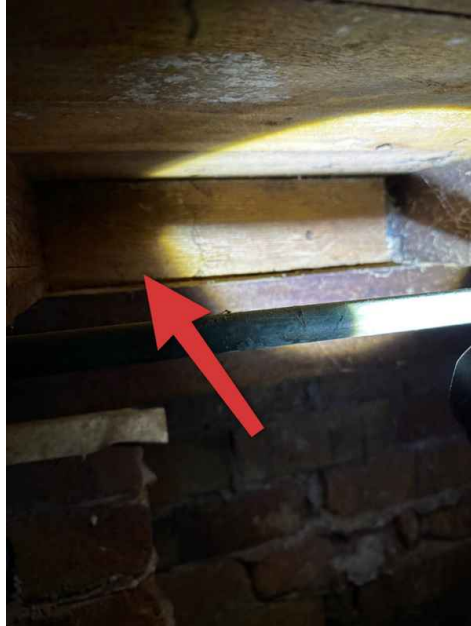
6.3.2 Subfloor

TIMBER PEST ATTACK

Timber pest attack noted.

Major Defect/Safety Hazard

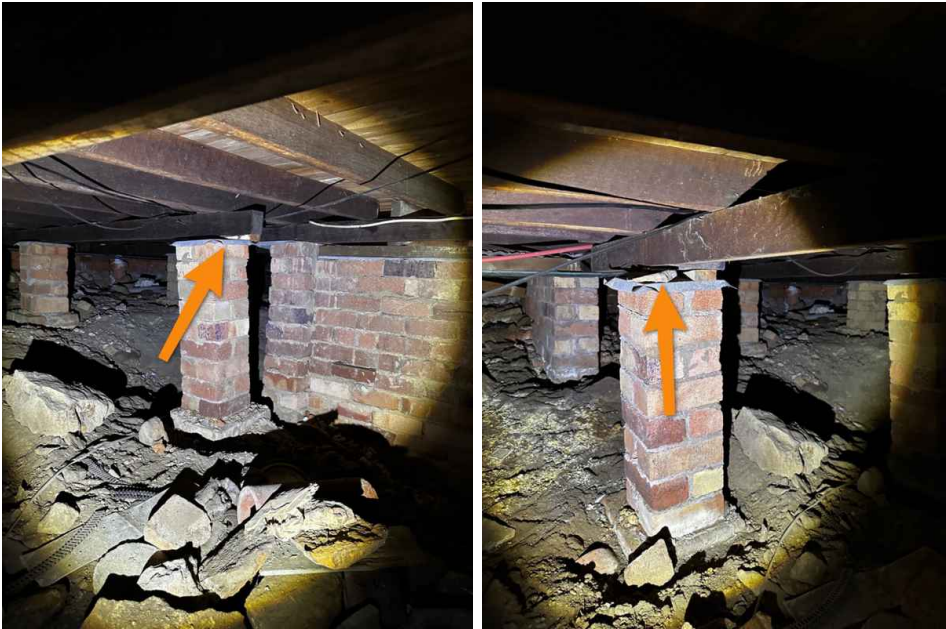
6.4.1 Piers & Foundation Walls

INADEQUATE PACKING

Inadequate packing noted to pier. Re packing recommended to support bearer.

Minor Defect/Recommendations

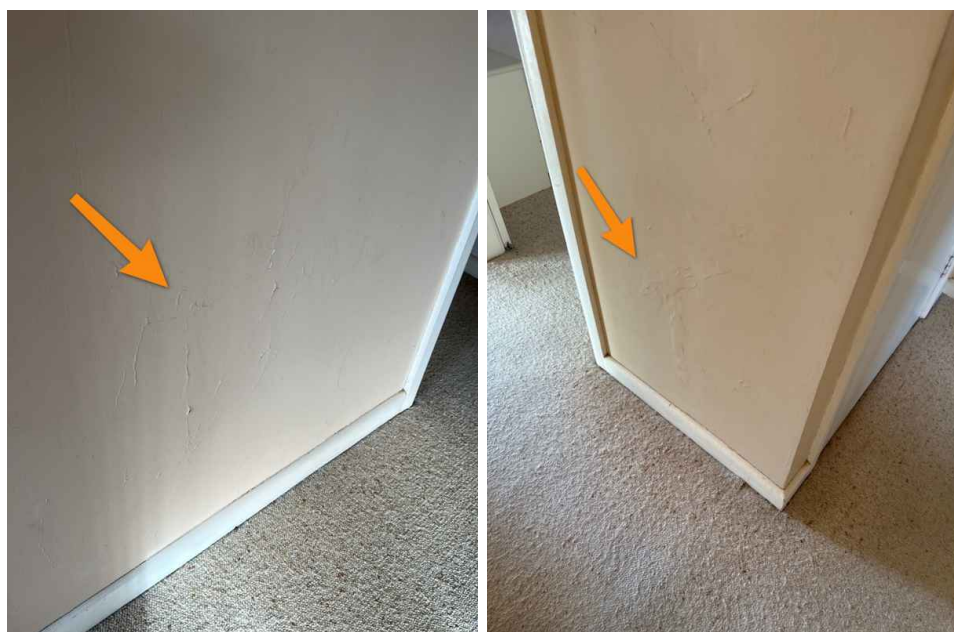
PAINT DETERIORATION

Wall paint deterioration in one or more areas. Recommend a qualified painter evaluate and apply a new coat.

Contact a qualified painting contractor.

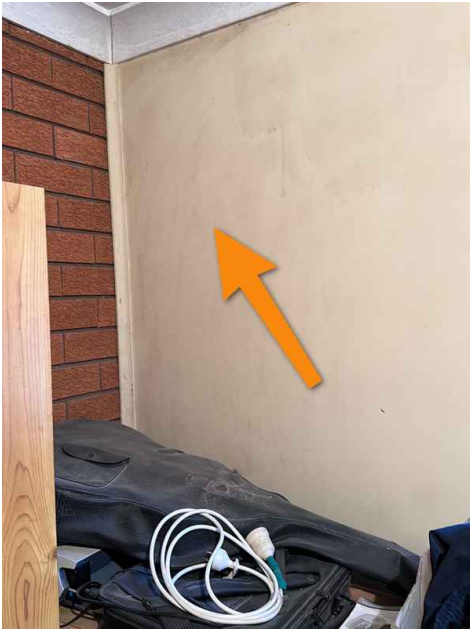
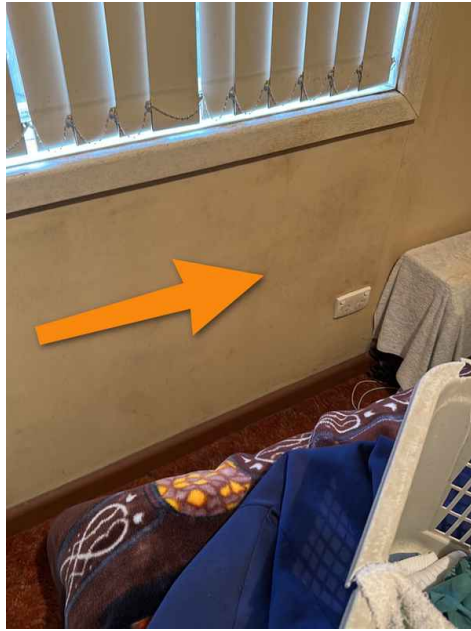
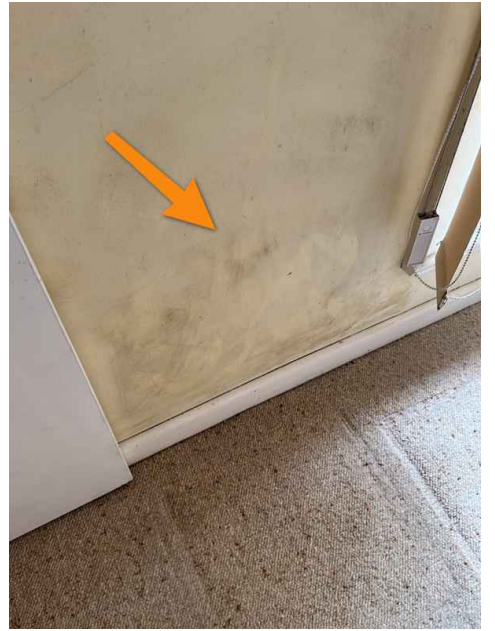
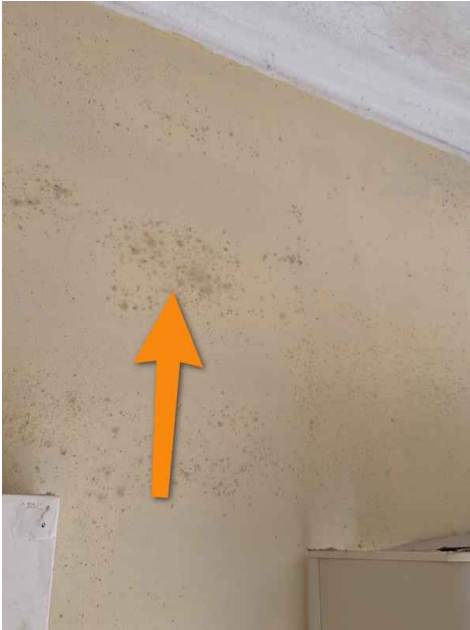
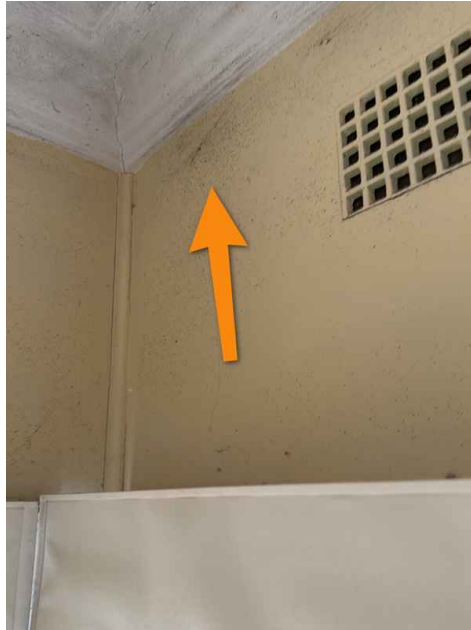
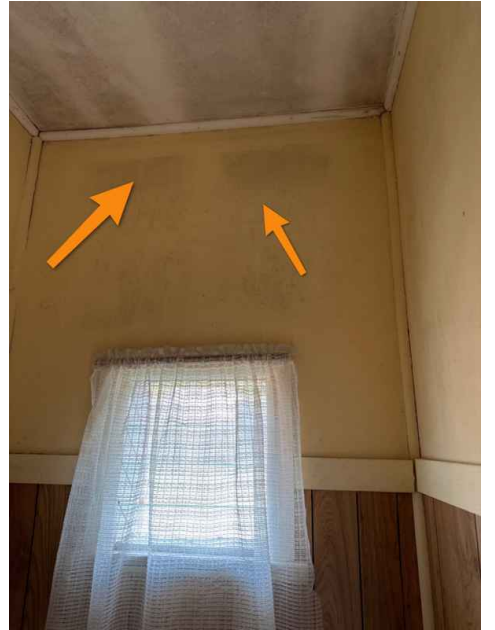
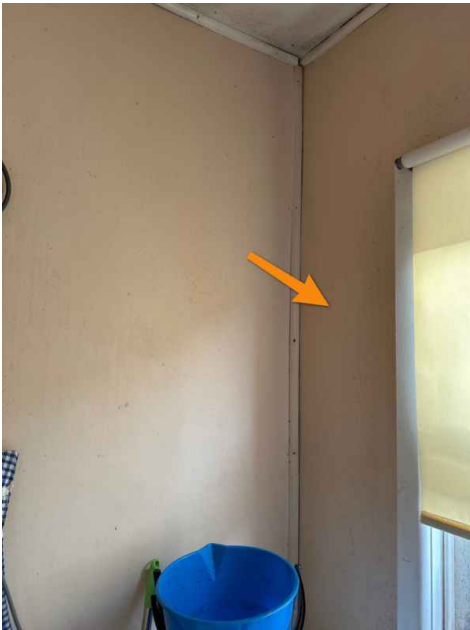
7.3.2 Walls

Possible mould noted throughout the property, most rooms have what is possibly mould

Contact a qualified mold inspection professional.

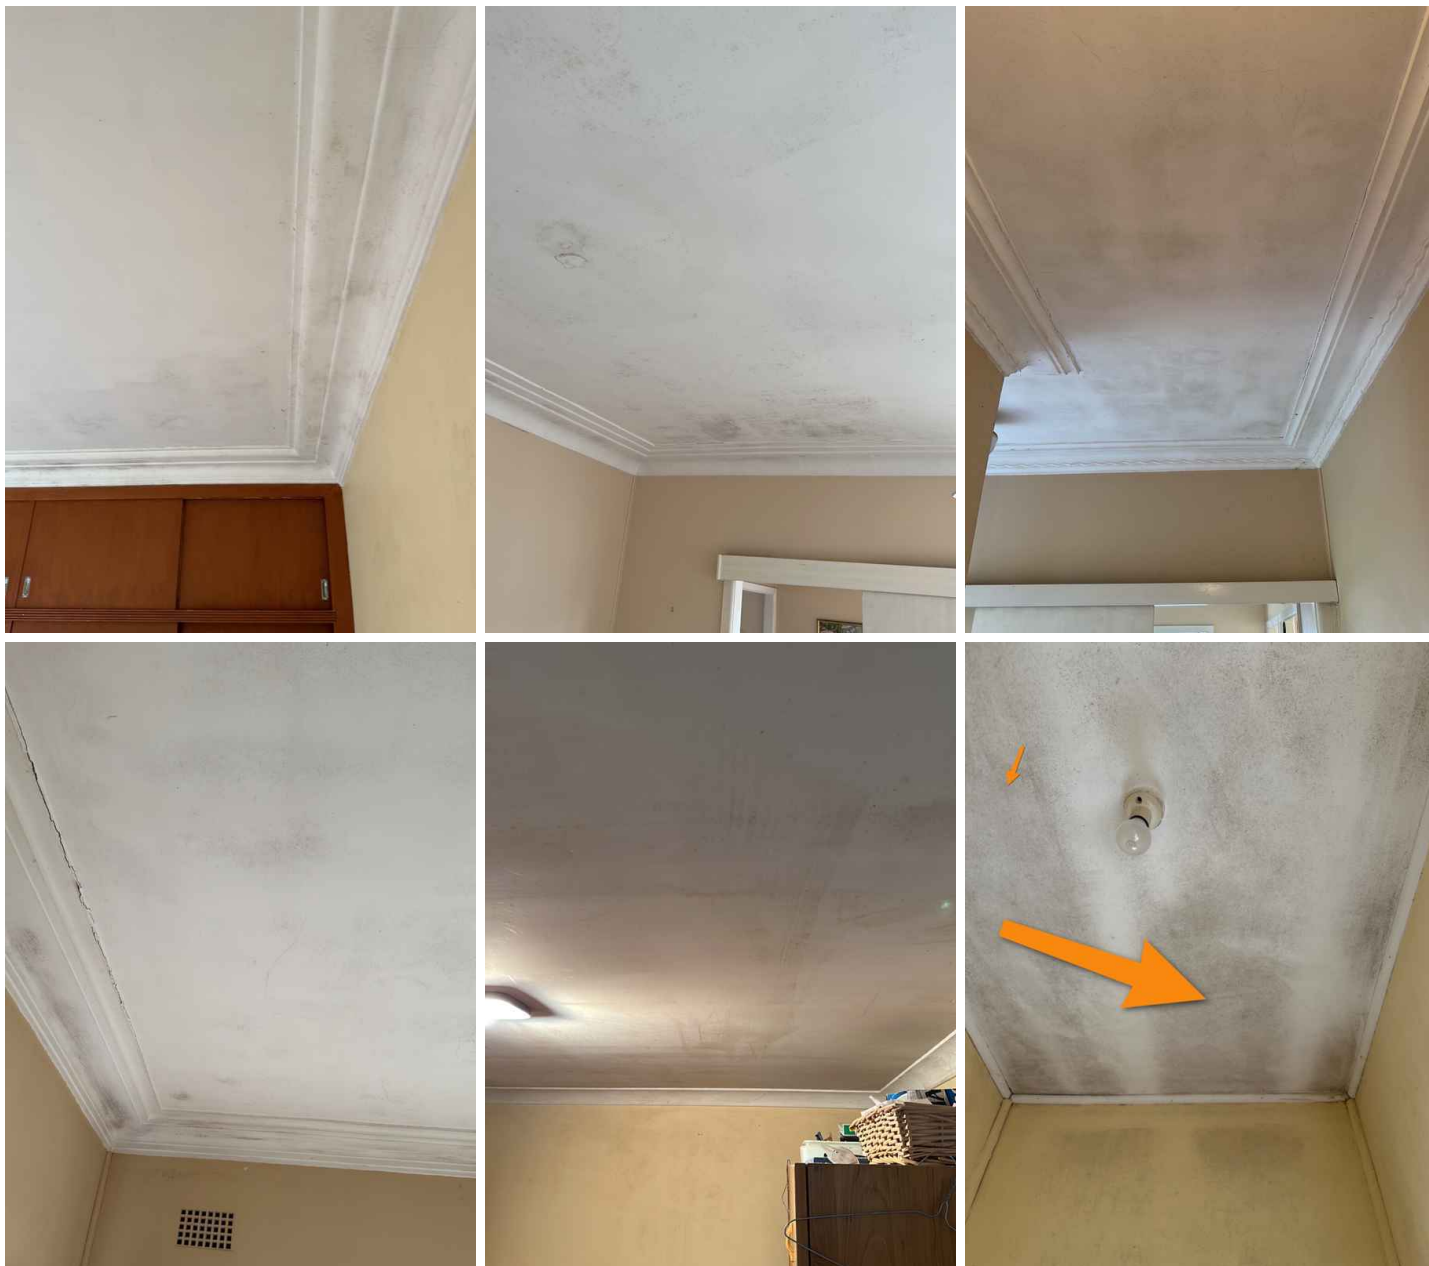
POSSIBLE MOLD

There are possible signs of fungi growth on ceiling. It is unknown if this is a safety hazard. Recommend a qualified mold inspector evaluate.

Contact a qualified mold inspection professional.

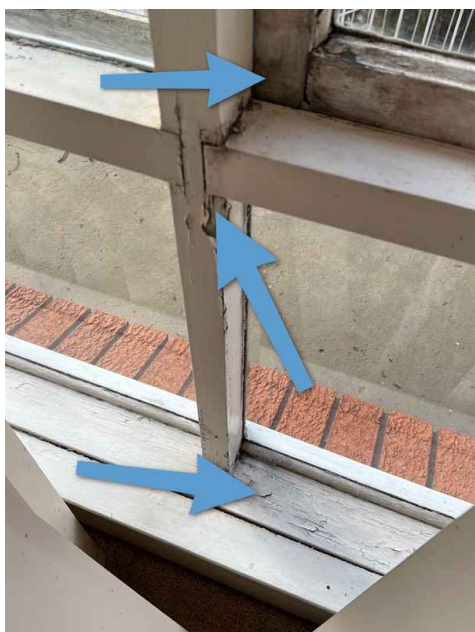
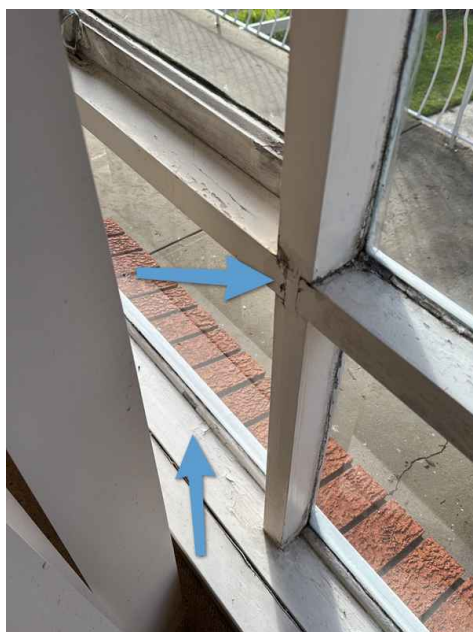
8.2.1 Windows

AGE/DETERIORATION

General age & deterioration - The window frame/components showed evidence of ageing and wear.
Recommendations: General maintenance works required.

Contact a qualified window repair/installation contractor.

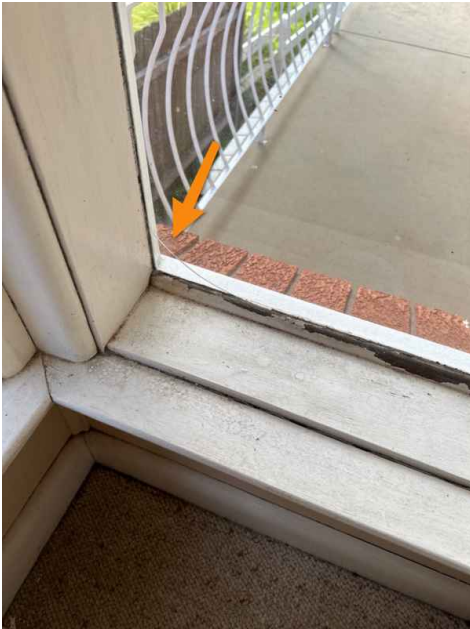
9.2.1 Windows

CRACKED PANE

Cracked pane - Recommendations: A qualified glazier contractor should be engaged for repairs.

Contact a qualified window repair/installation contractor.

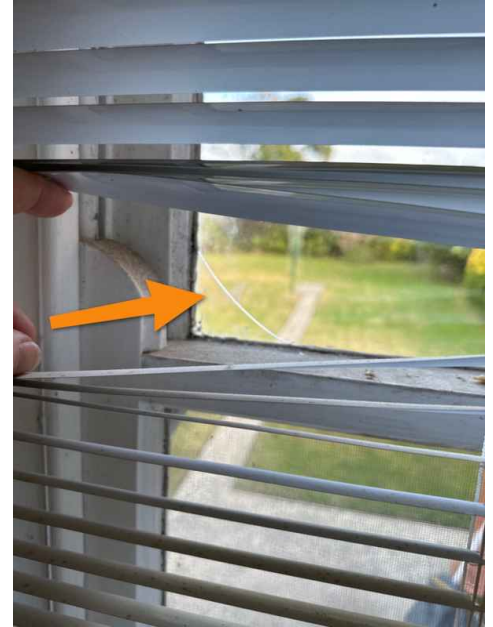
CRACKED PANE

Cracked pane - Recommendations: A qualified glazier contractor should be engaged for repairs.

Contact a qualified window repair/installation contractor.

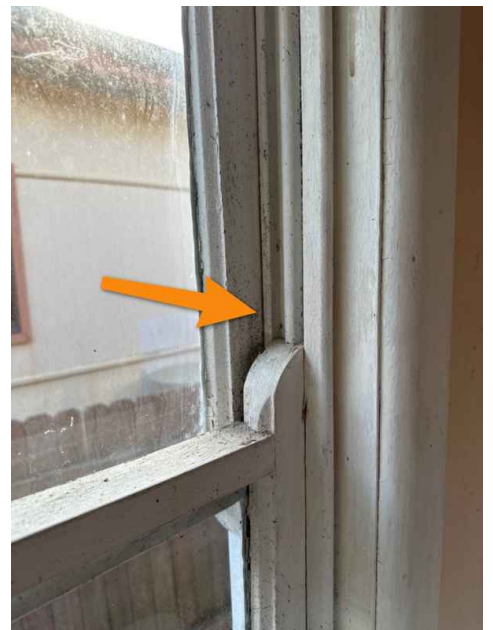
11.2.1 Windows

LOOSE SPRINGS

The springs to the window which enable the window to remain in the open position have sagged. Replacement recommended.

Contact a qualified window repair/installation contractor.

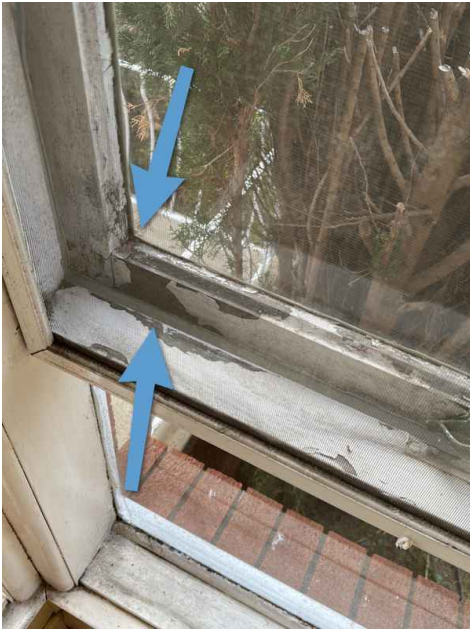
12.2.1 Windows

PAINT DETERIORATION

Paint deterioration noted to the window frames.

Recommended DIY Project

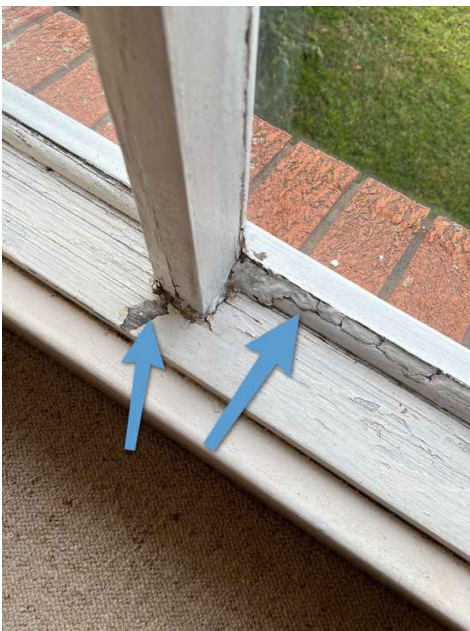
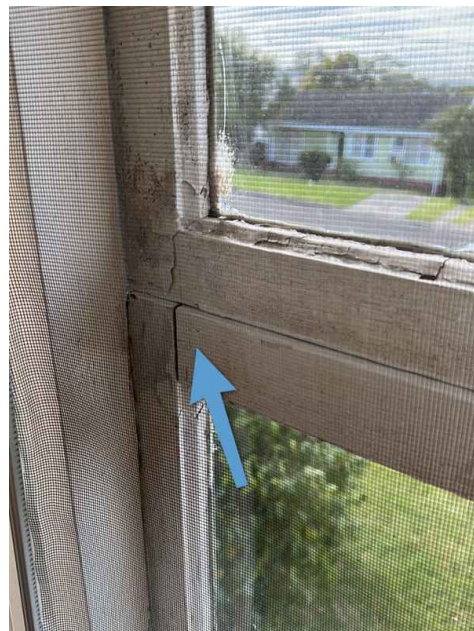
12.2.2 Windows

AGE/DETERIORATION

General age & deterioration - The window frame/components showed evidence of ageing and wear.
Recommendations: General maintenance works required.

Contact a qualified window repair/installation contractor.

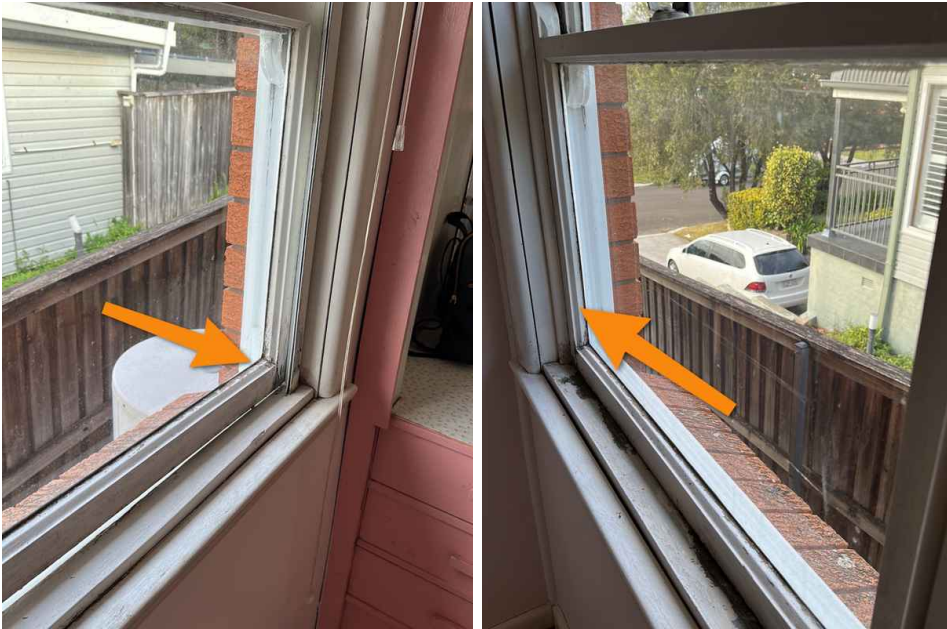
13.2.1 Windows

Faulty/unable to open - Recommendations: A qualified carpenter should be engaged for advice and recommendations.

Contact a qualified window repair/installation contractor.

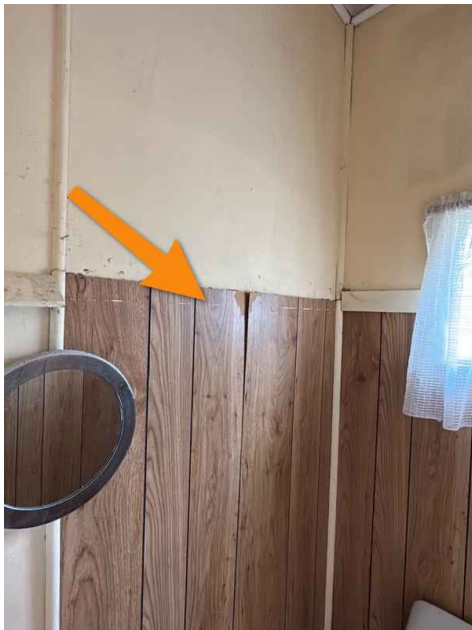
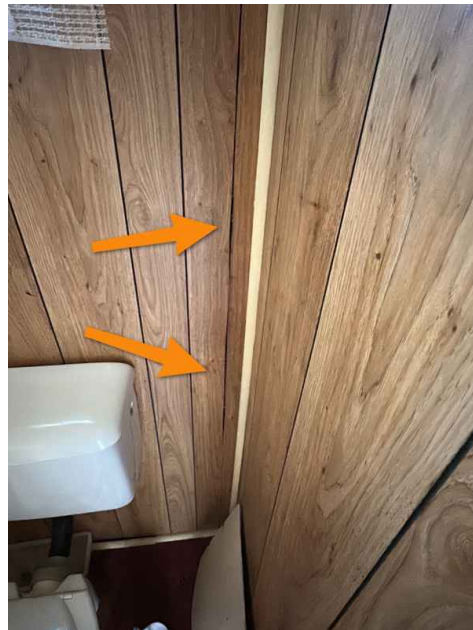
16.3.1 Walls

General aging and/or denting and/or wear and/or previous wall patching and the like is evident on wall linings - Recommendations: A qualified painter should be engaged to assess and repair as required.

Contact a qualified professional.

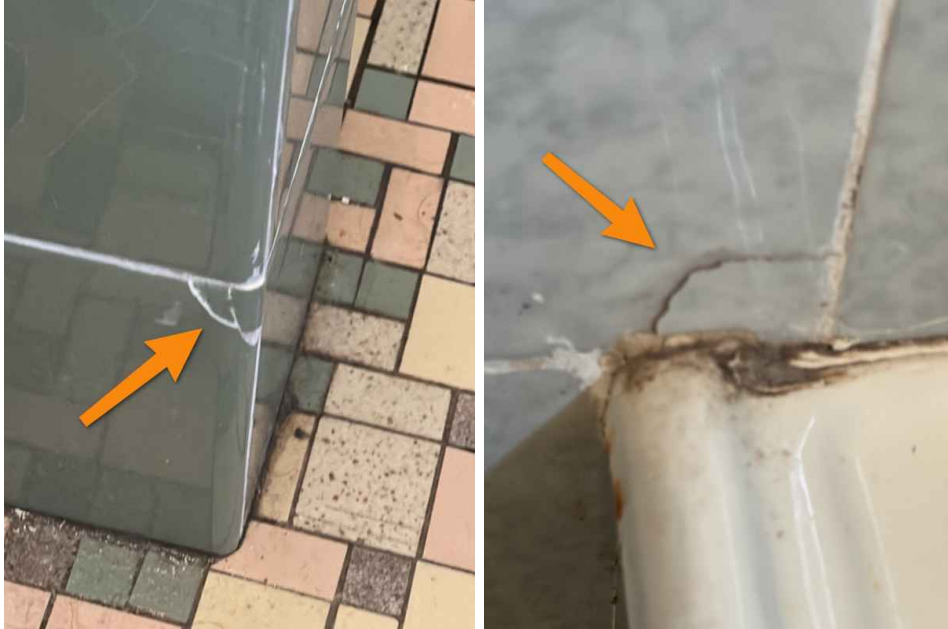
CRACKED TILES

Cracked tile/s noted. A qualified tiler should be engaged for advice and recommendations.
Missing tile/s noted. Contact a licensed tiler and a waterproofer for repairs. Further damage may occur to the affected and adjoining walls and floor if this isn't rectified.

Contact a qualified tile contractor

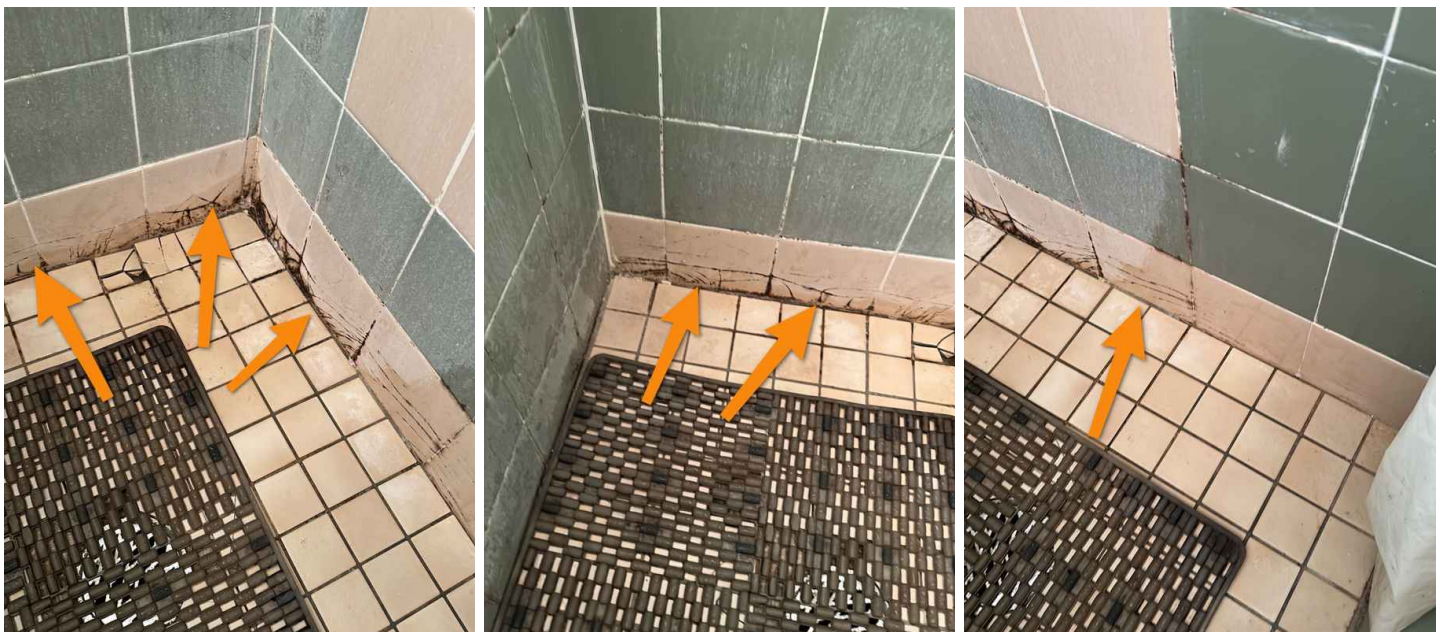
CRACKED TILES

Cracked tile/s noted. This can cause extensive floor and floor frame damage if water is leaking through the cavity. A qualified tiler should be engaged for advice and recommendations.

Contact a qualified tile contractor

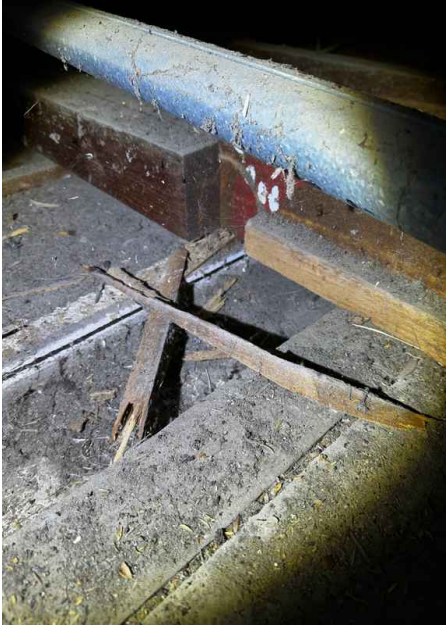
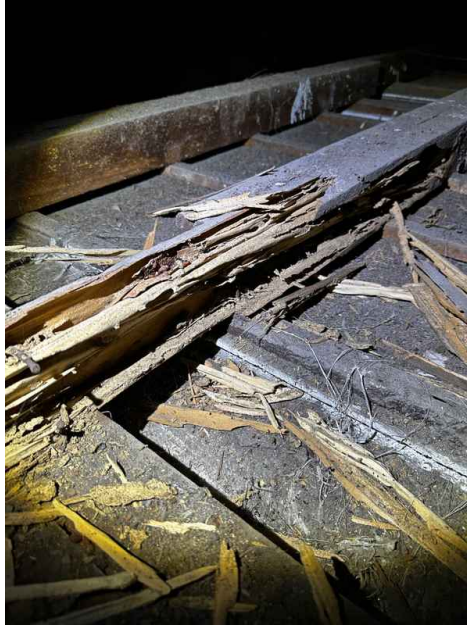
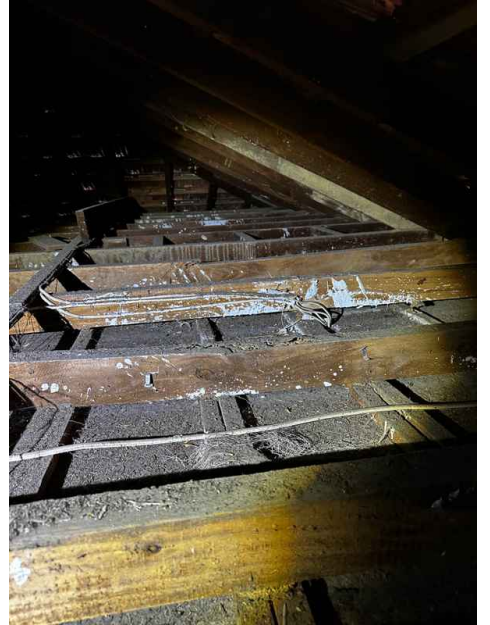
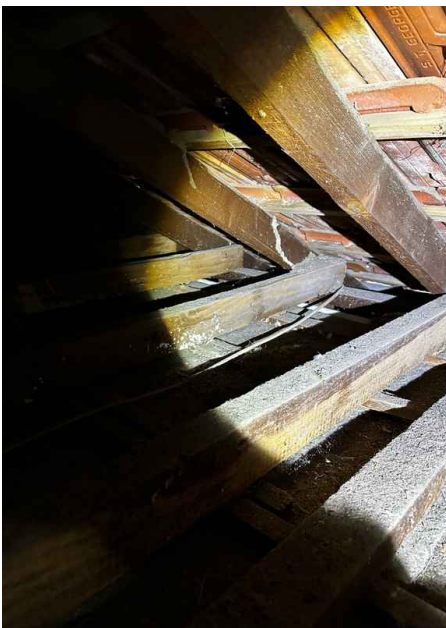
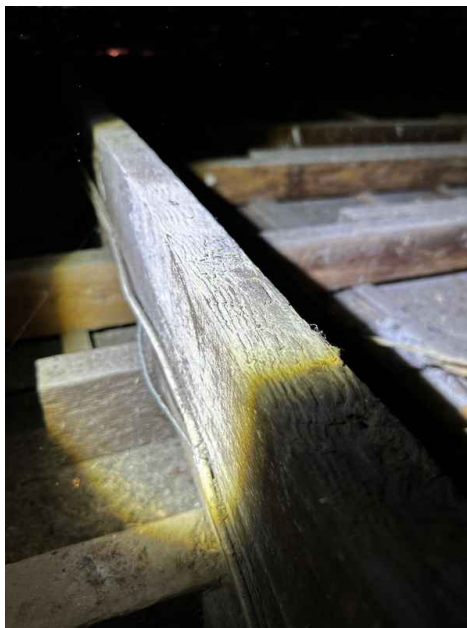
Was any evidence of timber damage visible

Yes
