## TIMBER FRAME INSPECTION

**1234 MAIN STREET  
SYDNEY**

02/05/2023

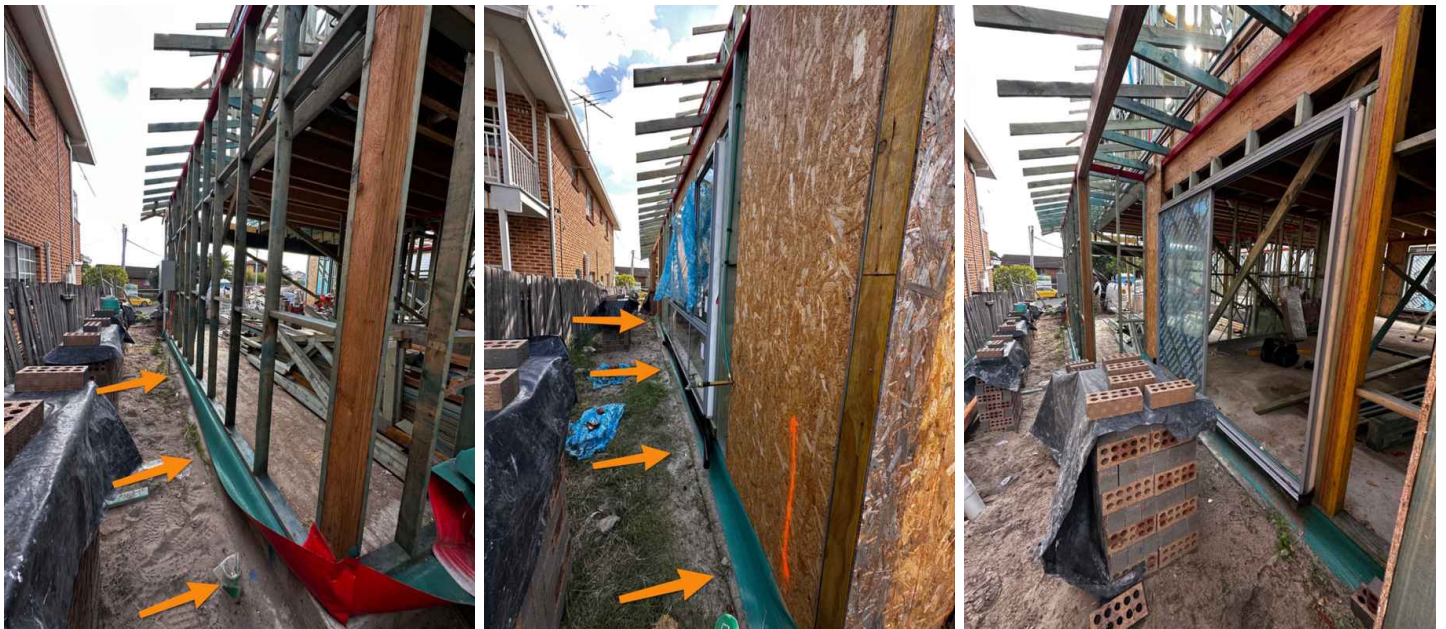
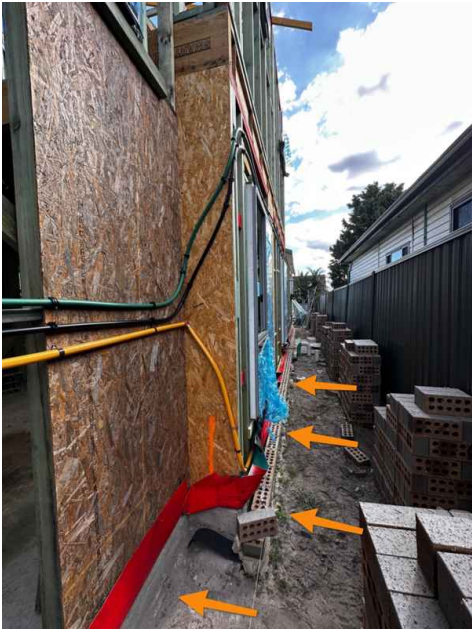
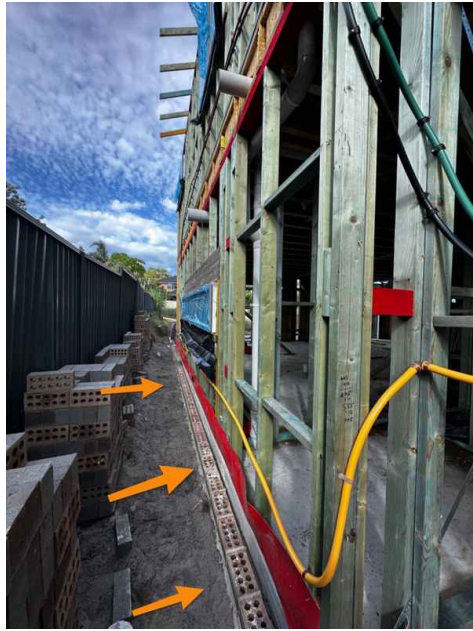
### 1.2.1 Vapour barrier

All of the existing loose fill that has been placed up against the slabs edge beams will need to be removed and the polyethylene vapour barrier properly extended up the external side faces of the edge beams to at least the height of future finished ground level or paving i.e. 75mm below the damp-proof course and bottoms of the weepholes, after which any termite barriers that are in place, if required, will also need to be properly instated.

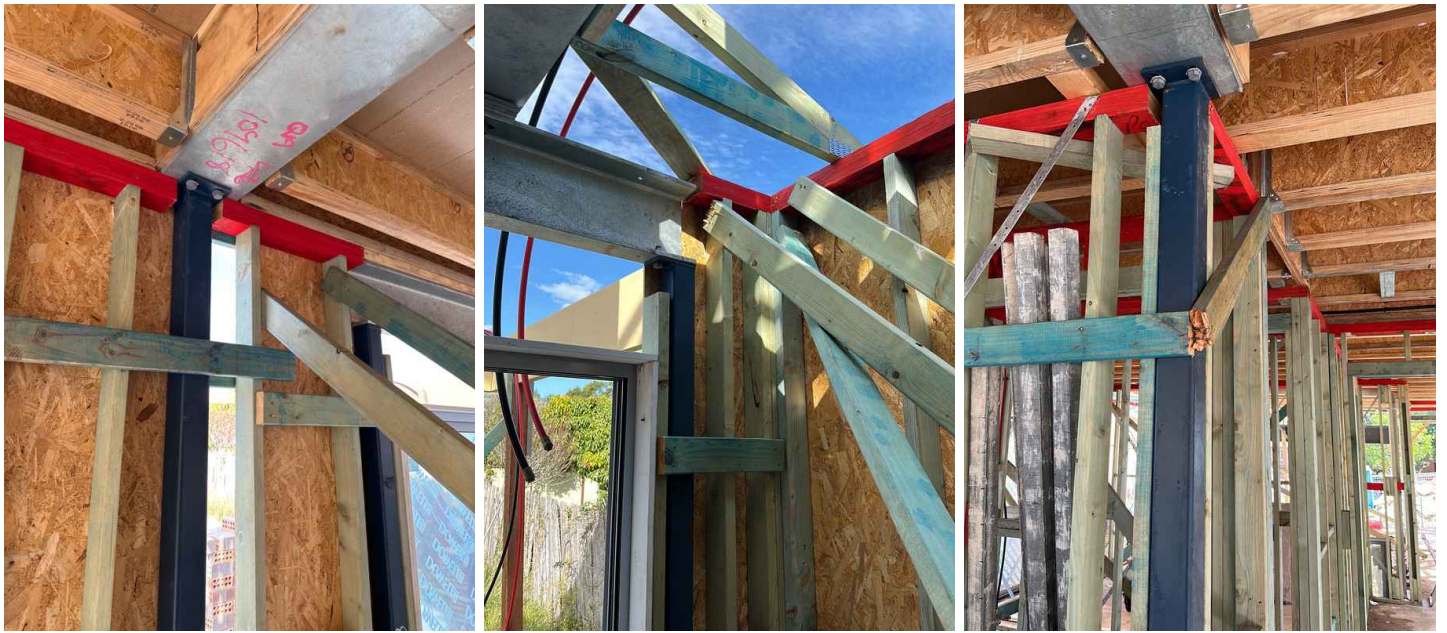
#### TOP PLATES CUT

There was no detail or section showing how cut top plates should tie into posts or steel beams. This should be reviewed after receiving documentation

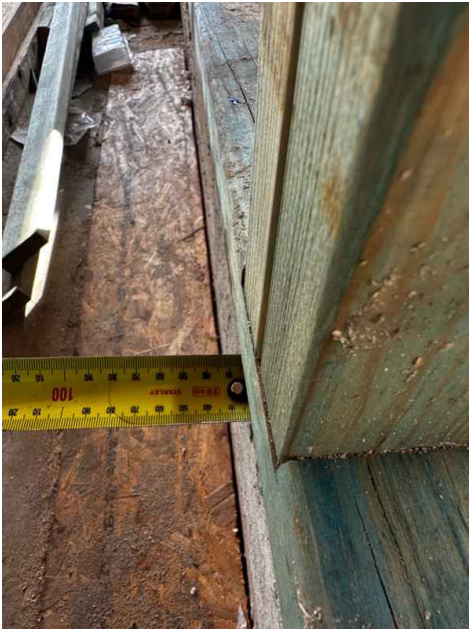
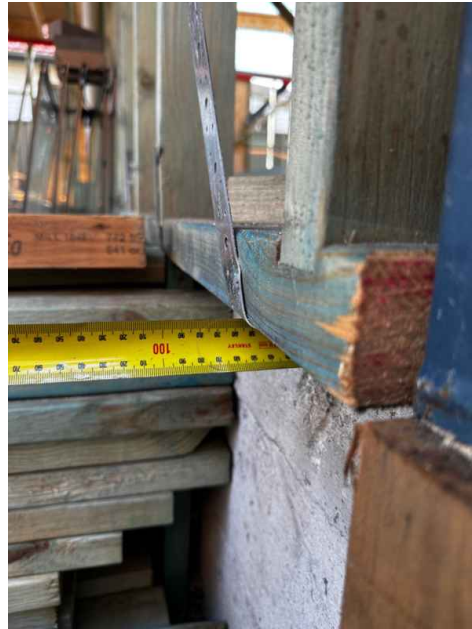
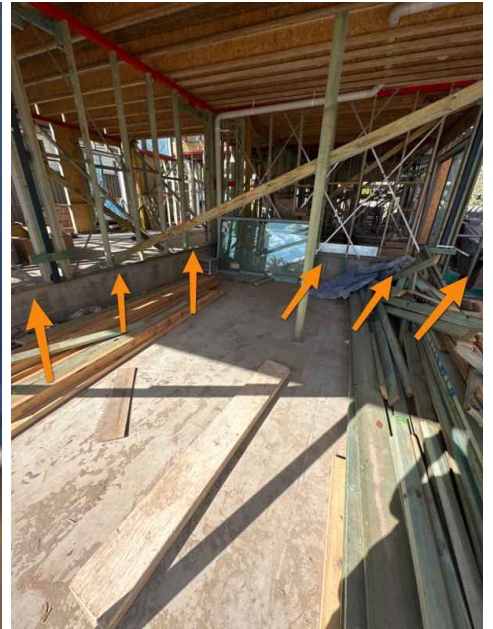
2.2.1 Bearing

#### FRAME EXCEEDS MINIMUM BEARING ON SLAB

The maximum allowed overhang of a 90mm bottom plate is 10mm. The works below are non compliant.

25mm Frame overhang

60mm Frame overhang

This overhanging bottom plate will need to be supported by an appropriately designed and certified engineered system so that it complies with As 1684.2, clause 6.3.3, and the BCA.

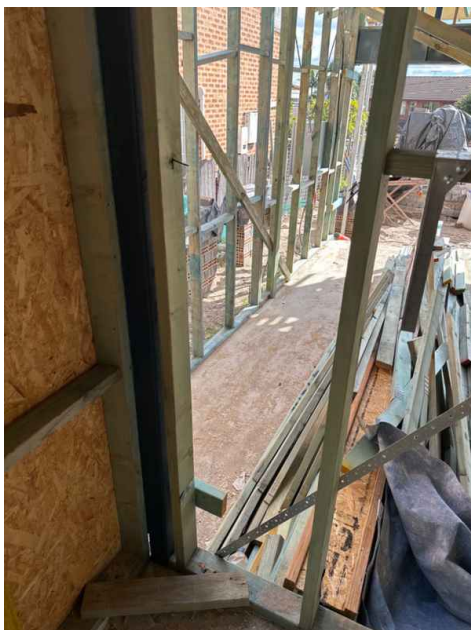
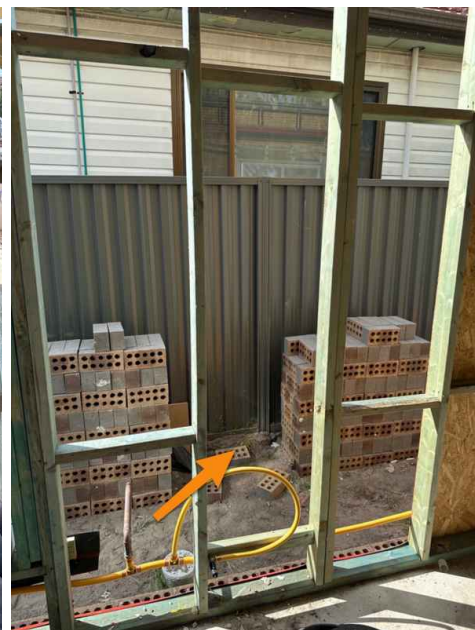
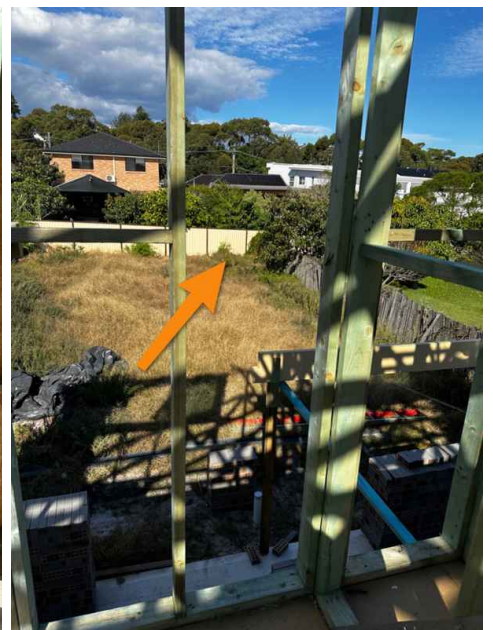
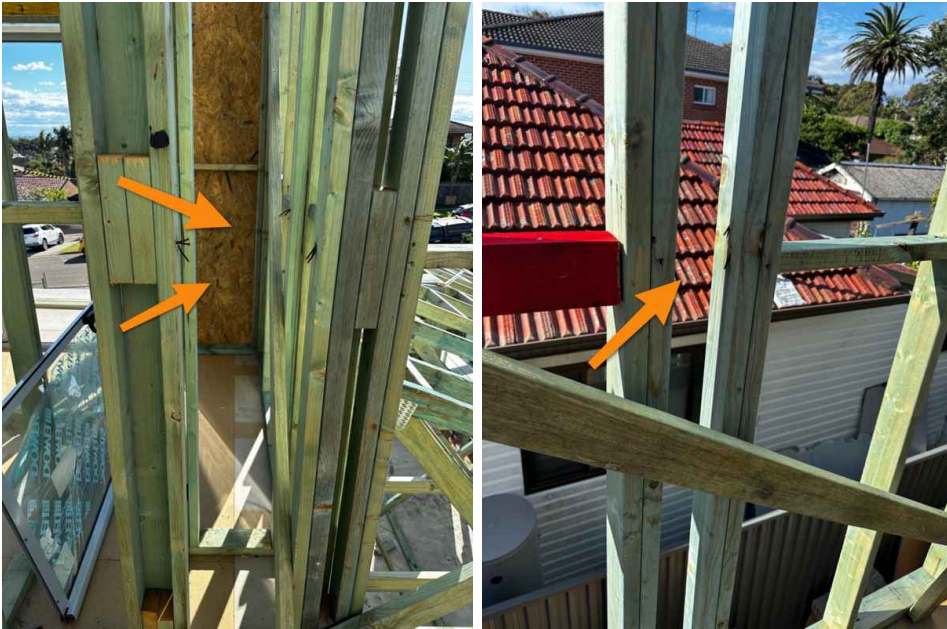
#### 2.4.1 Noggings

### **NOGGINGS ARE NON-COMPLIANT**

Noggings are non-compliant due to reasons below

Missing

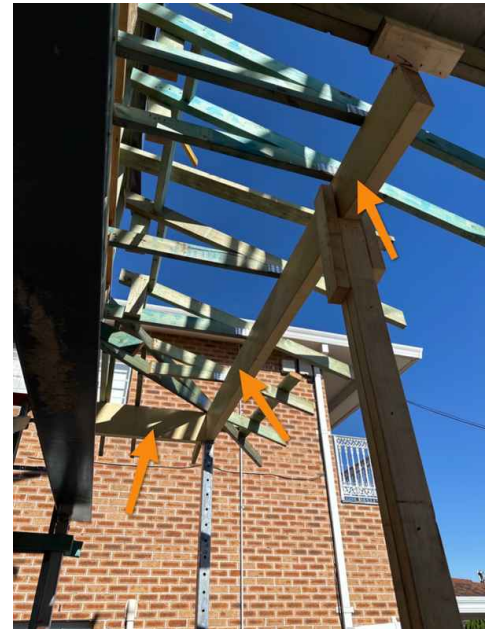
2.5.1 Items not installed as per the drawings

**PLAN SPECIFIES LVL**

The plan specifies an LVL to be installed. Instead a primed pine beam has been installed. This does not follow the engineering documentation. It is recommended that an engineer check.

Primed pine beams installed instead of the required LVL's

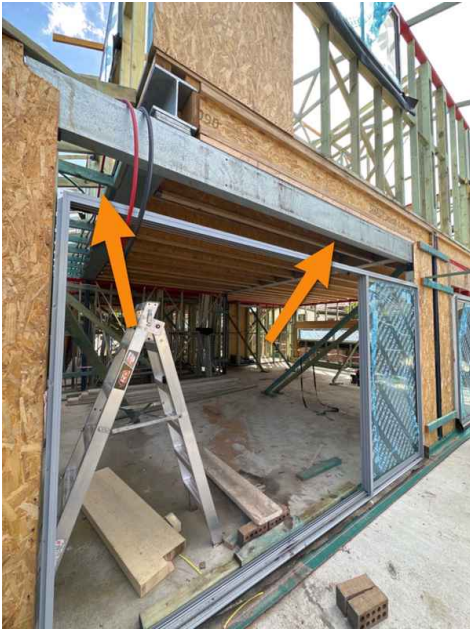
2.6.1 Incomplete

**FRAMING INCOMPLETE**

Sections of framing are incomplete

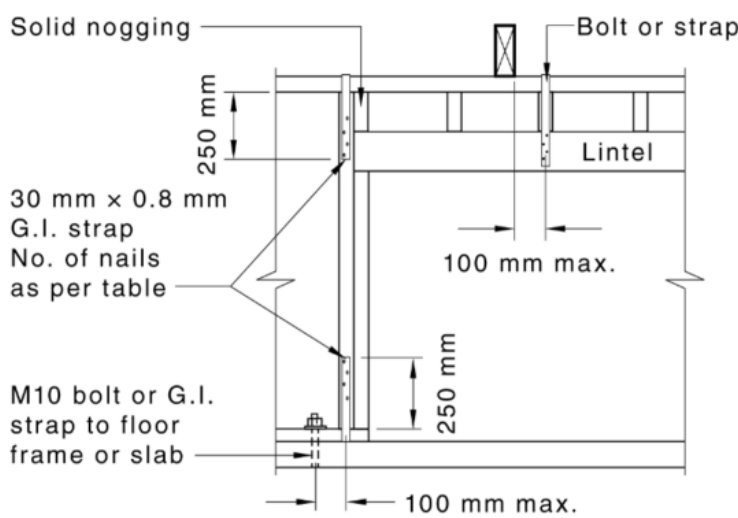
2.8.1 Bracing

**METAL BRACING NOT INSTALLED**

Metal bracing has not been installed in sections

Arrows show areas where bracing has not been installed

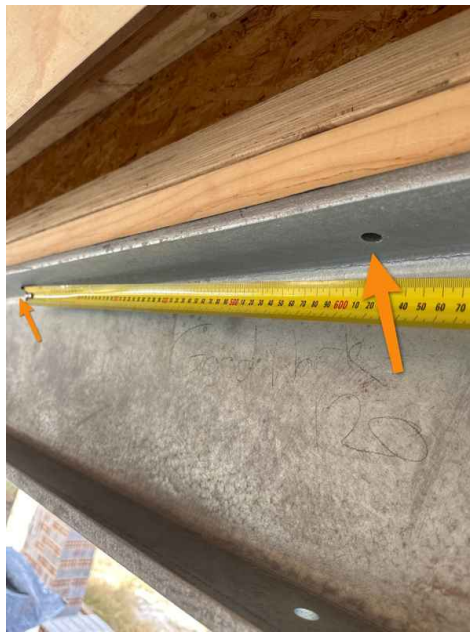
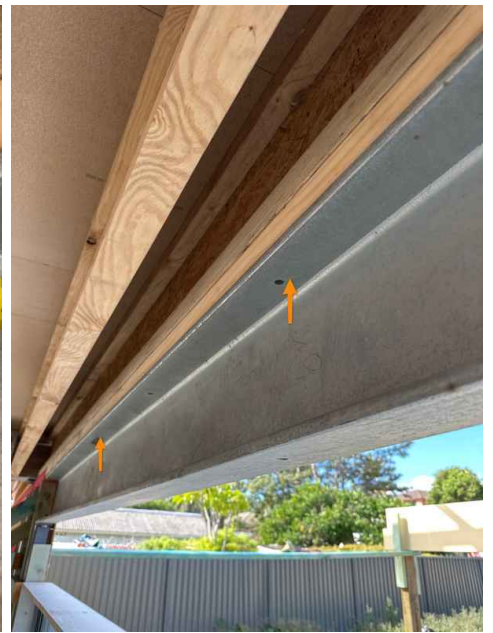
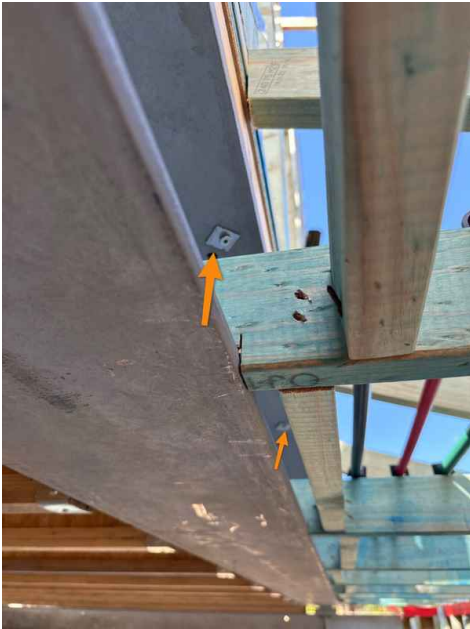
### 3.2.1 Fixings and anchors

#### INADEQUATE ANCHORS

Inadequate anchors between bottom plate and steel beam as required by the engineers plans. It is required to be Mechanically fixed at 500mm centres. Currently the bugles have been installed at 600mm centres with some not finished. This is common throughout the build. It is recommended these sections be bolted as the bugle may not reach the bottom plate.

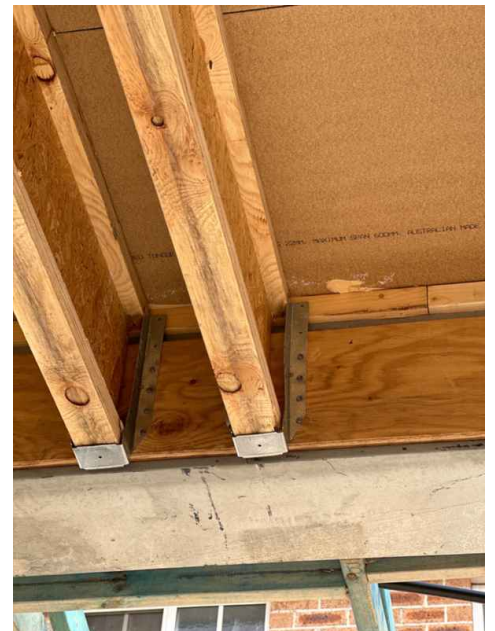
### 3.2.2 Fixings and anchors

#### **INADEQUATE NAILS IN HANGERS**

Only 4 nails were installed on each side of the hanger. As per the manufactures guide, 6 nails should be installed on either side. Please see screenshot of the manufactures guide below.

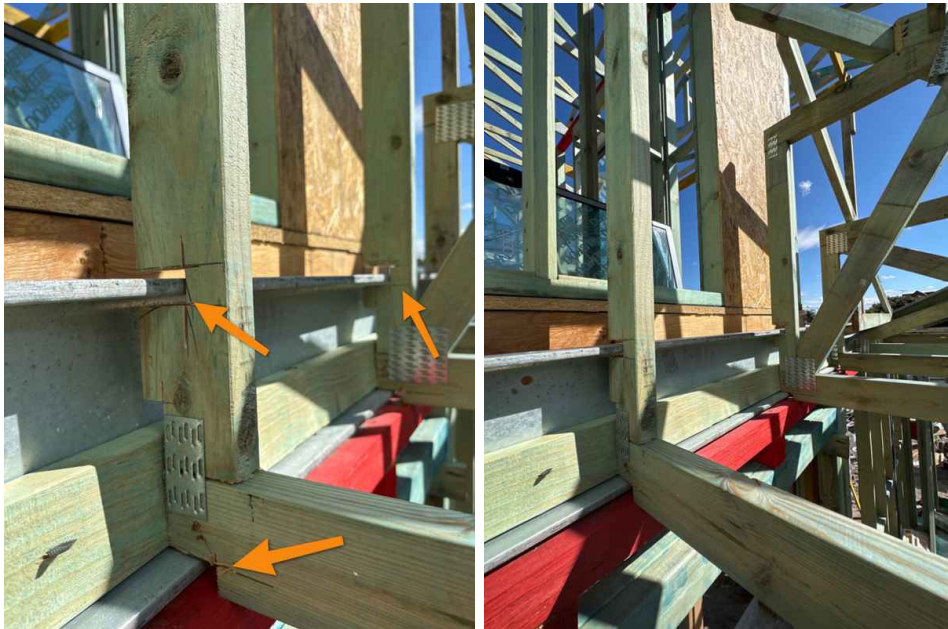
### 4.1.1 Trusses

#### TRUSSES CUT

Trusses have been notched out around a steel beam. Trusses should not be altered or notched out once on site. These trusses also appear to be installed in an incorrect position as they should not be cut around the beam. This beam is installed to provide support for the brick veneer wall. With the trusses in the way there is not enough room for bricks to be installed.

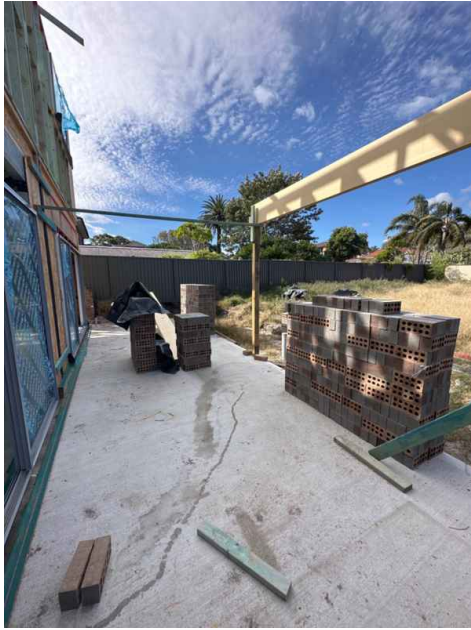
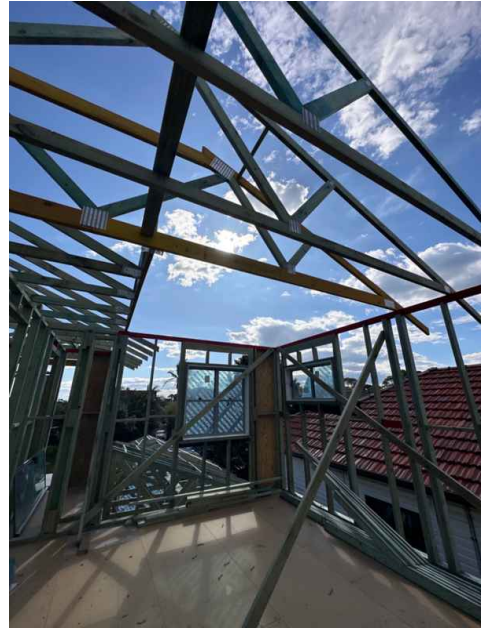
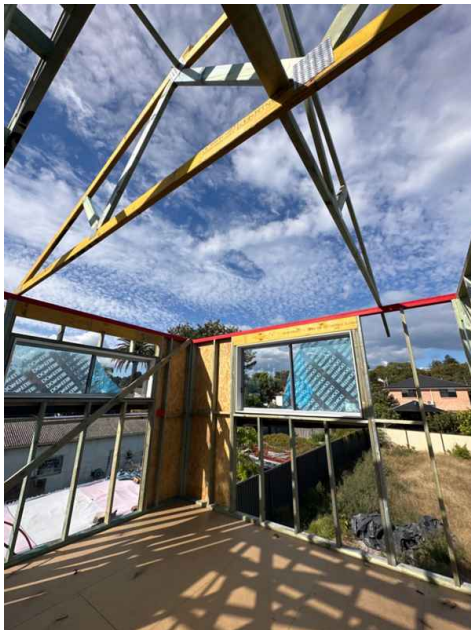
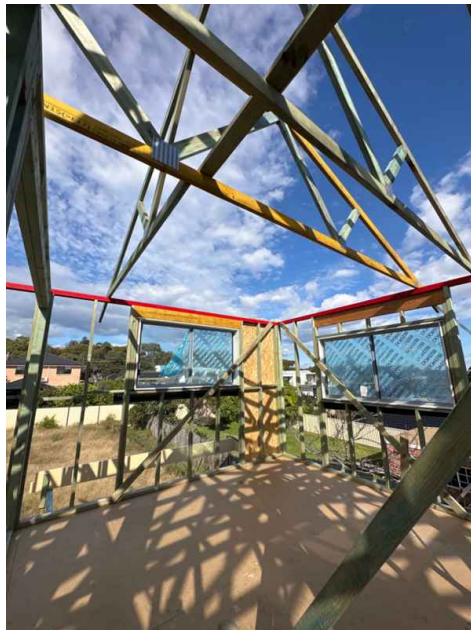
### 4.2.1 Incomplete

#### FRAMING INCOMPLETE

Some sections of framing are yet to be completed. It is recommended this be re-inspected once completed

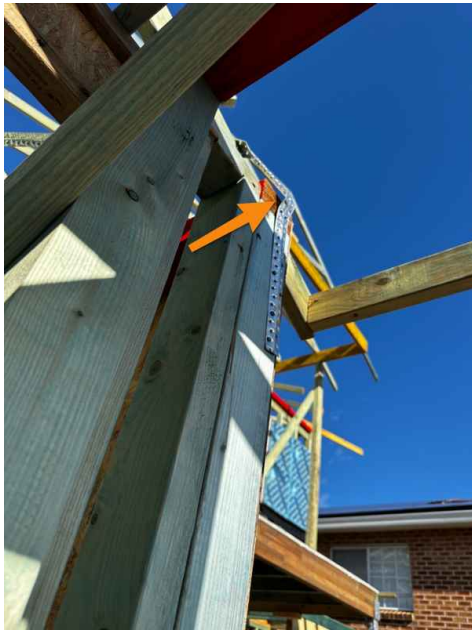
#### 4.3.1 Bracing

### ROOF BRACING TIE OFF

The roof bracing should terminate to the underside of the top plate

Loose nails

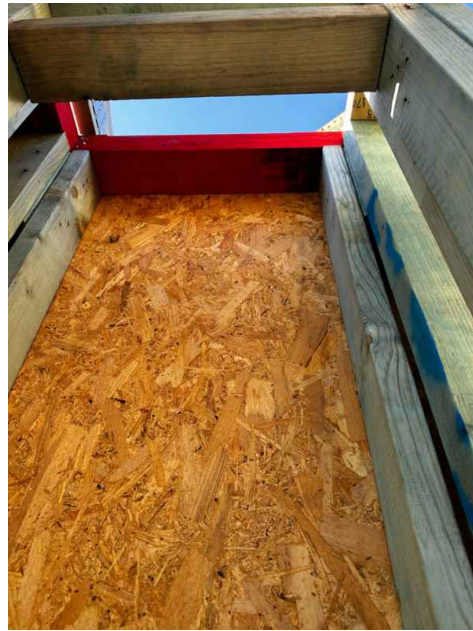
Terminates to the ply bracing

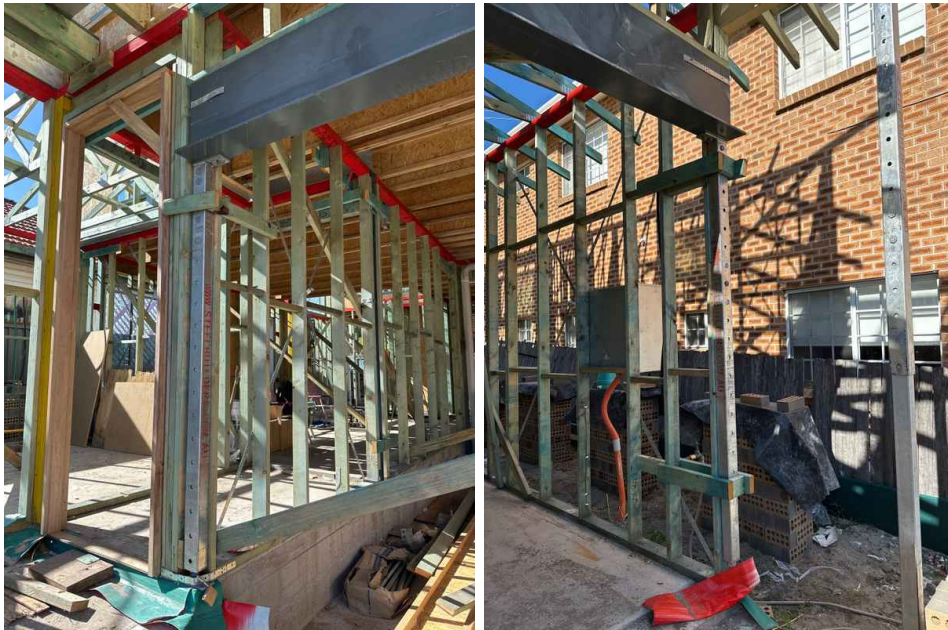
Joins, fixings and bearing

### **NO DETAIL FOR TYPICAL ADJUSTABLE STEEL POSTS**

No detail provided for the typical adjustable steel posts. It is recommended this detail be provided to make sure installation is correct.

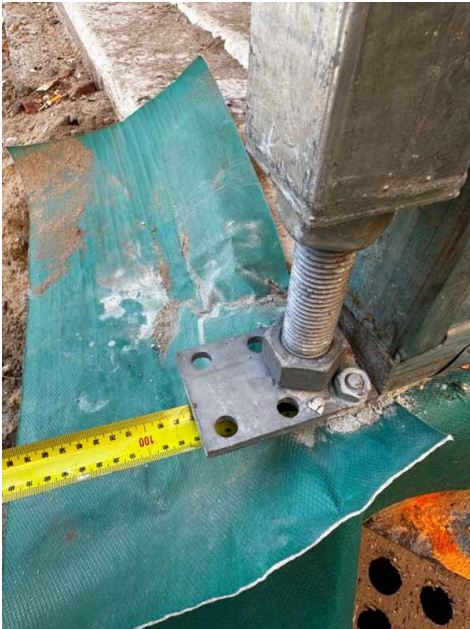
5.1.1 Joins, fixings and bearing

### **INADEQUATE BEARING**

Steel posts has inadequate bearing. The steel plates have excessive overhangs to the concrete slab. These area required to have full bearing on the slab. This should be assessed by the structural engineer to determine a solution.

70mm overhang

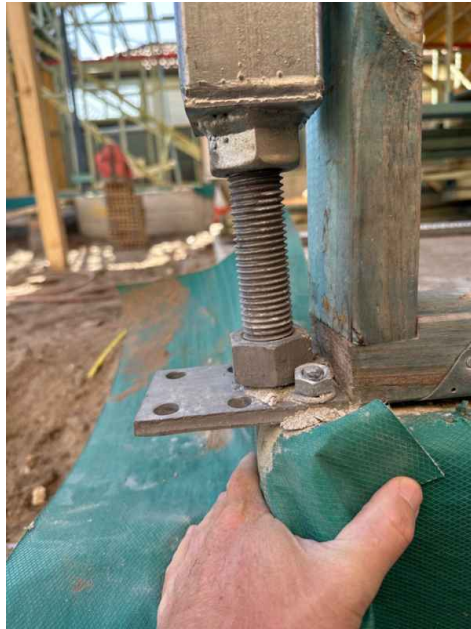
45mm overhang from concrete slab with no fixings into the concrete slab

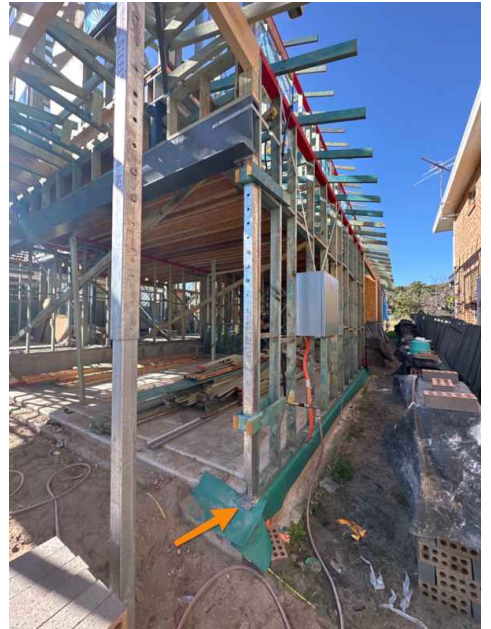
20mm overhang with only a single fixing

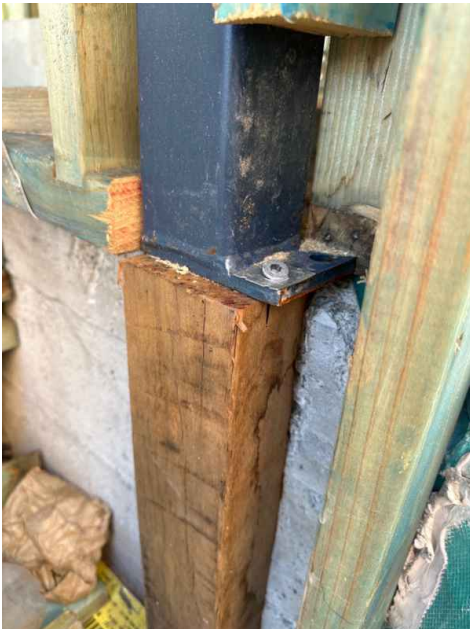
Structural load not designed to bear on timber, this has been done as it appears the slab edge was poured short

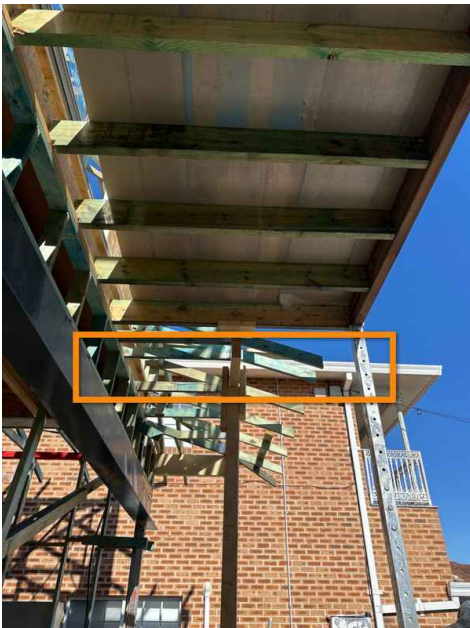
5.1.2 Joins, fixings and bearing

**NOT INSTALLED**

The plans shows a steel beam should be installed.

Plan shows a 200x200x10 T-beam should be installed around the highlighted area. No section or drawings available to show how this connects.

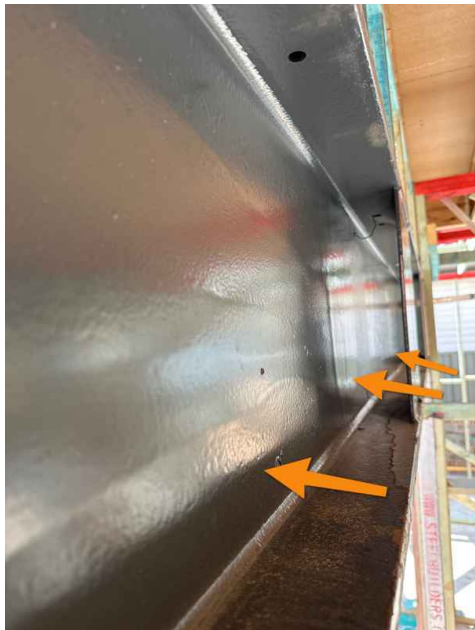
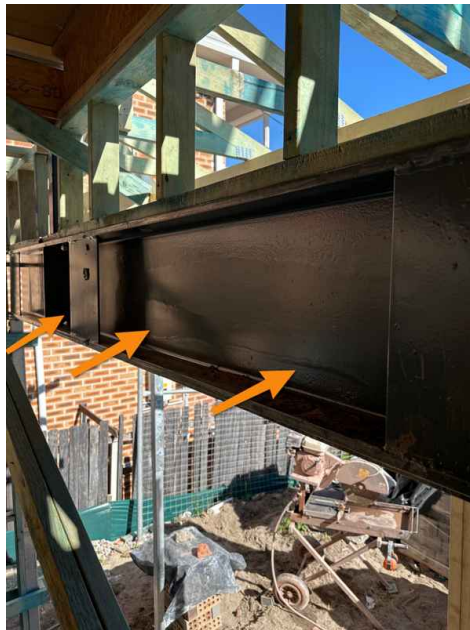
5.1.3 Joins, fixings and bearing

**NO BOLTS INSTALLED**

The engineers documents specify M24 bolts at 400 centres. These have not been installed.

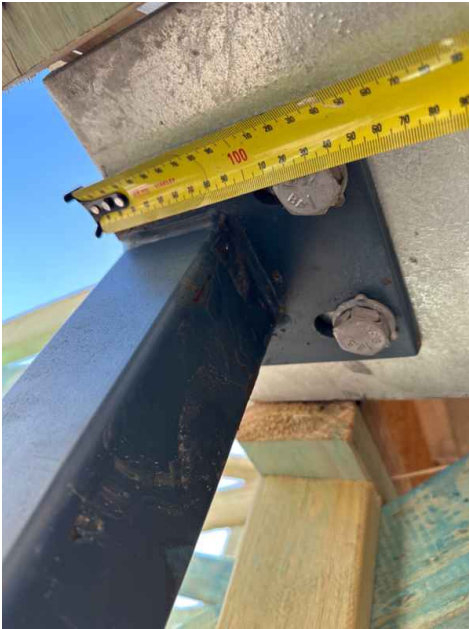
5.1.4 Joins, fixings and bearing

**INCORRECT PLATE**

The engineer plans specify a 200mm long 10mm thick plate. What has been installed is inadequate

Plate is only 150mm

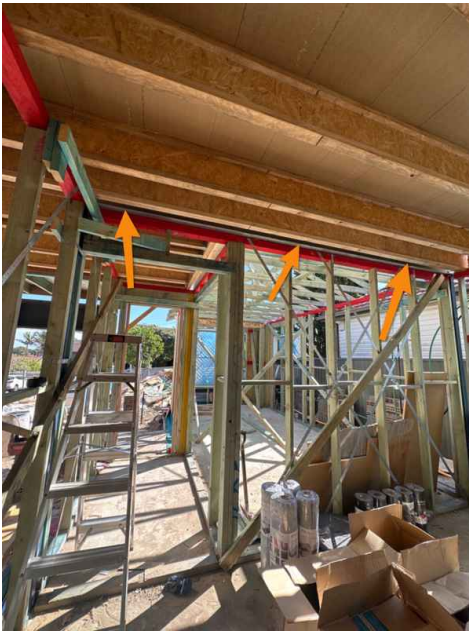
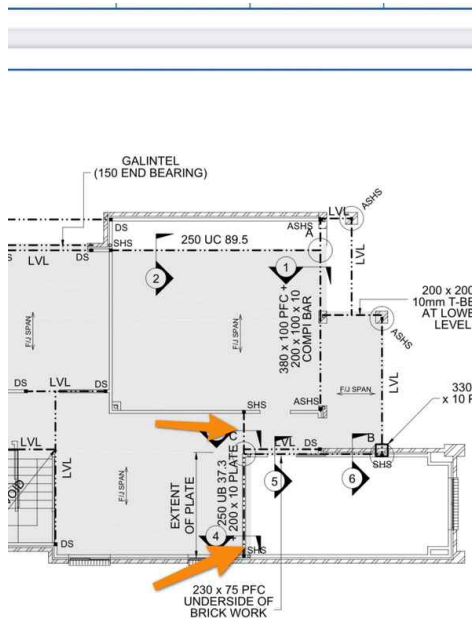
5.1.5 Joins, fixings and bearing

**INCORRECT BEAM**

The engineers plans show a 250UBx200x10 installed. What has been installed is a 250UBx150x10

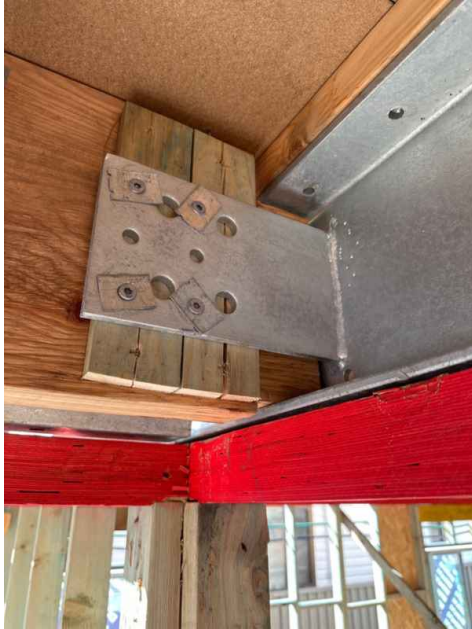
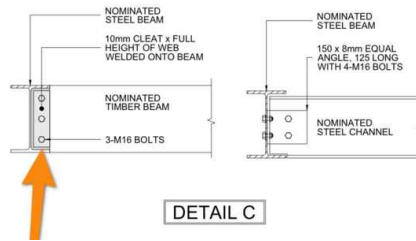
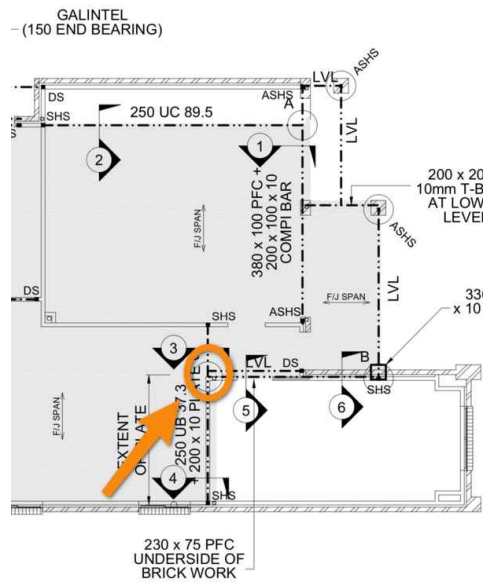
5.1.6 Joins, fixings and bearing

**INCORRECT CONNECTION**

The connection between the steel beam and the timber does not match the engineers plans. The plate should be the full height of the steel beam web and and 3xM16 bolts installed as per the drawings

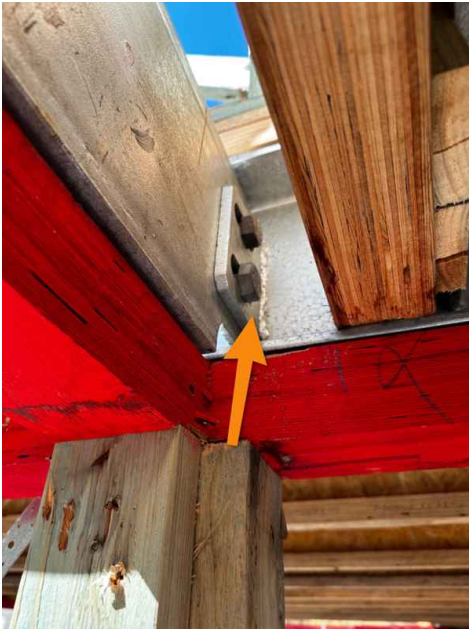
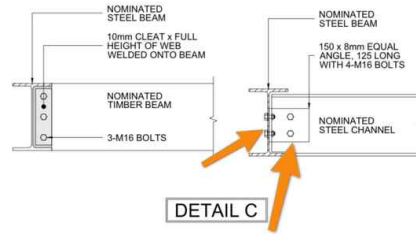
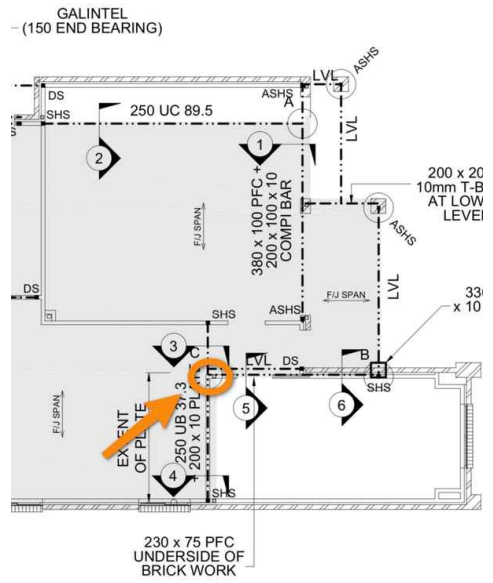
5.1.7 Joins, fixings and bearing

**INCORRECT CONNECTION 2**

The connection between 2 steel beams doesn't not follow the engineers documentation. Currently there is only a single plate 100mm long. It is required that a 125mm EQUAL ANGLE be installed as per drawings.

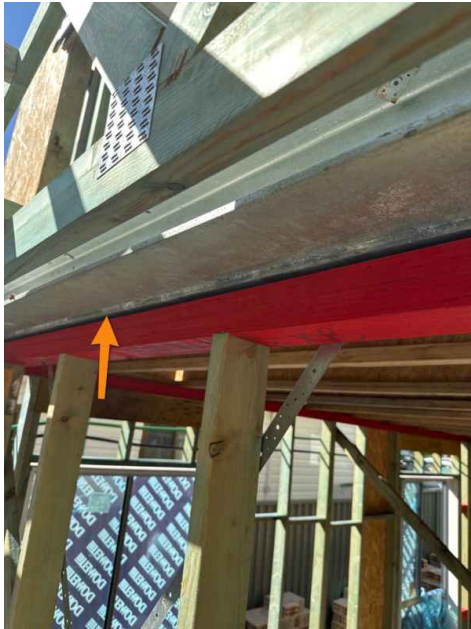
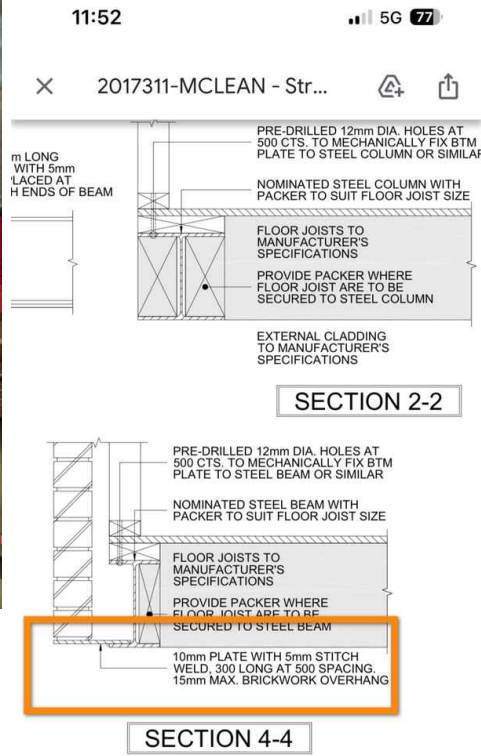
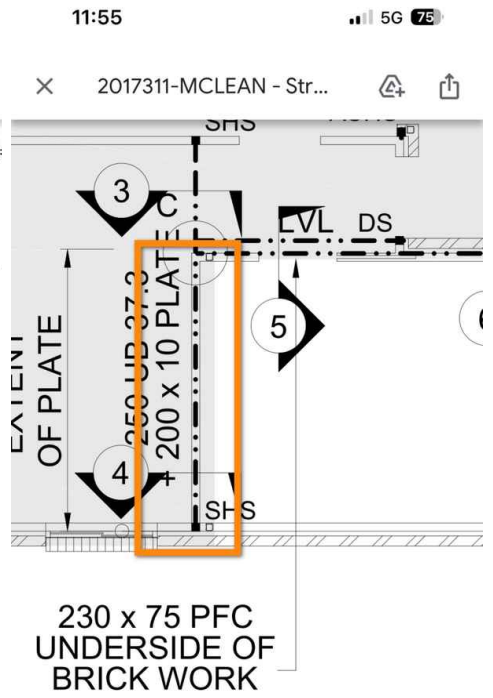
5.1.8 Joins, fixings and bearing

**WELDING**

Welding does not following the engineers plans. Plans show welds should be 300mm long at 500mm spacing

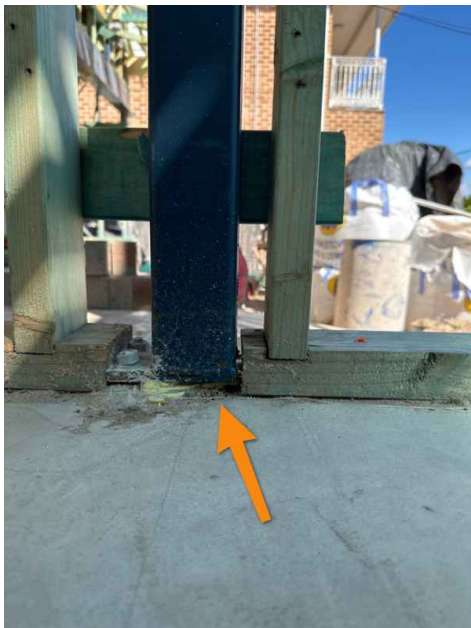
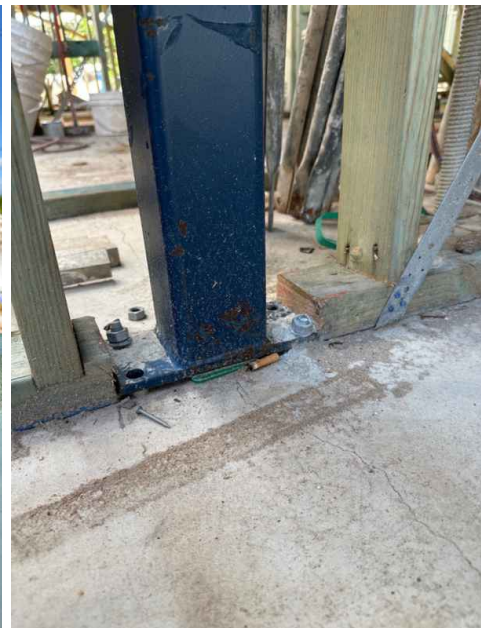
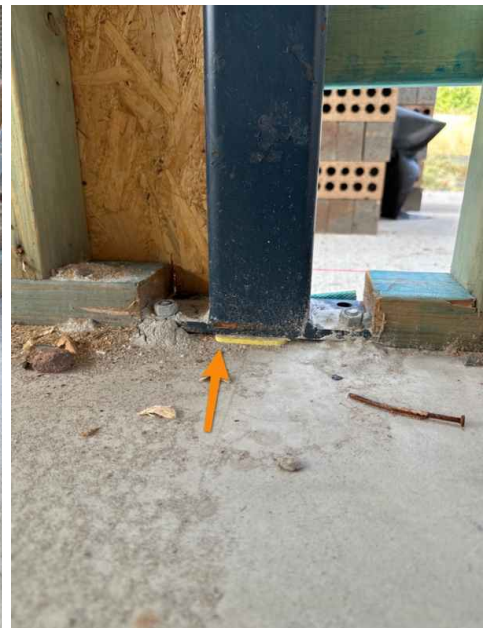
### 5.1.9 Joins, fixings and bearing

## REQUIRES STRUCTURAL GROUT

Steel post is sitting on plastic packers. It is required this be replaced with structural grout.

Structural grout and addition bolts require

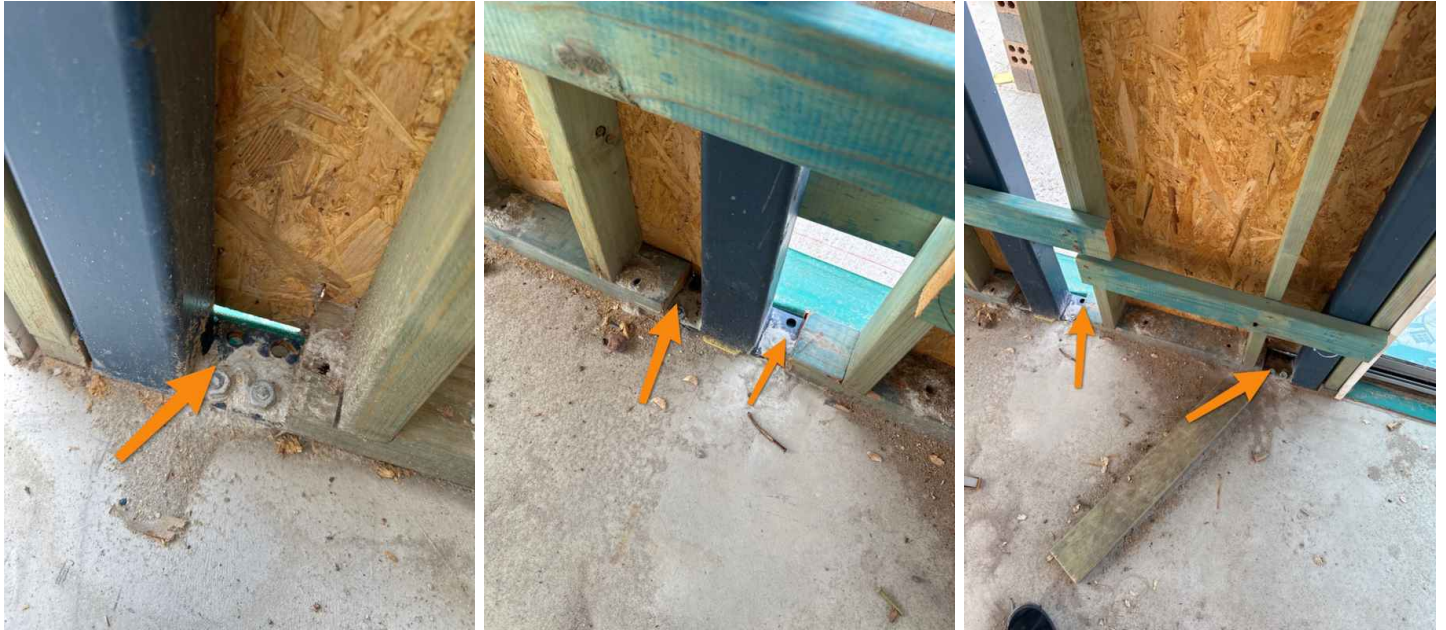
5.1.10 Joins, fixings and bearing

**BOLTS MISSING**

Bolts are missing from steel plates on almost all connections. This significantly weakens the tie down capacity of the structure.

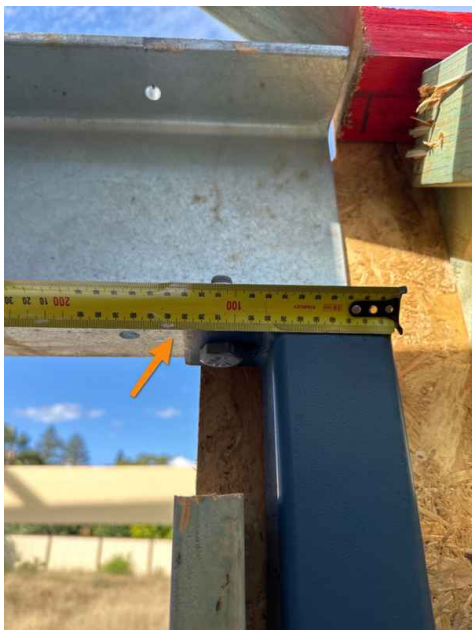
5.1.11 Joins, fixings and bearing

**BEAM INADEQUATE BEARING**

Steel beams has inadequate bearing according to the engineers plans. The engineer needs to assess these areas and provide updated documentation and solutions before proceeding.

Post plate has been cut short and now only allows a single bolt

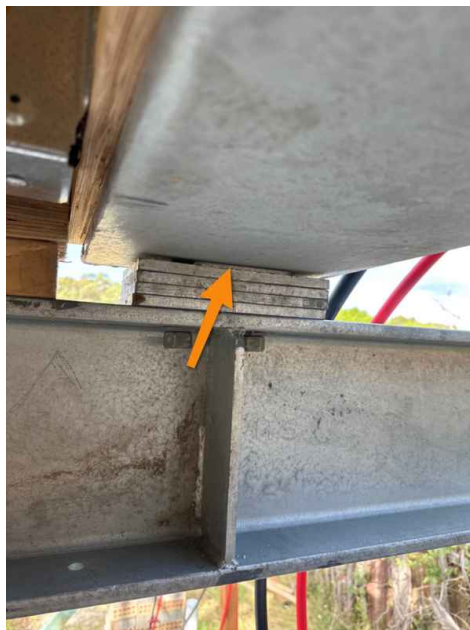
Beam should have 200mm of bearing. Currently the last packer is only 100mm wide. This connection is not as it specified by the engineers drawings
