BUILDING & PEST INSPECTION

1234 Main Street
Sydney, NSW 2227

Buyer Name
01/10/2024 9:00AM

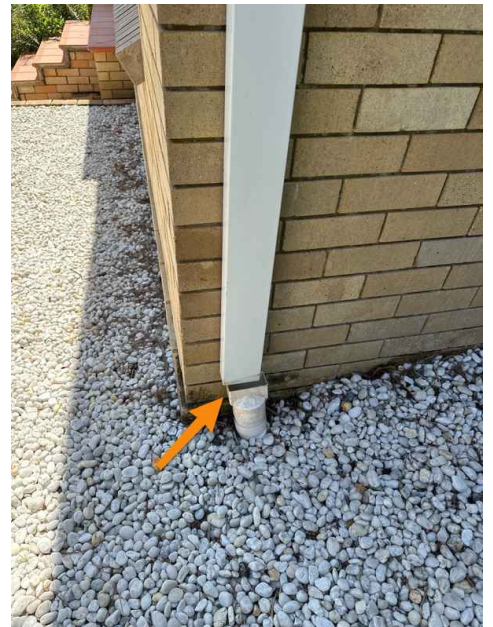
Minor Defect/Repair Recommendations

Contact a qualified roofing professional.

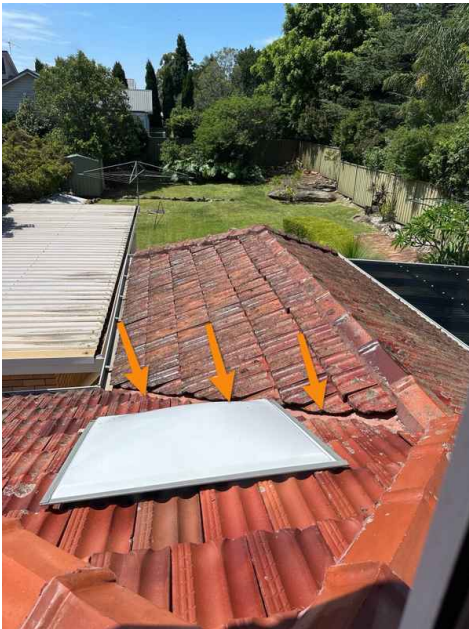
3.4.1 Flashings

CORRODED - MINOR

Roof valley flashing showed signs of corrosion, but are still in working condition. Flashing should be monitored to prevent severe corrosion leading to moisture intrusion.

Contact a qualified roofing professional.

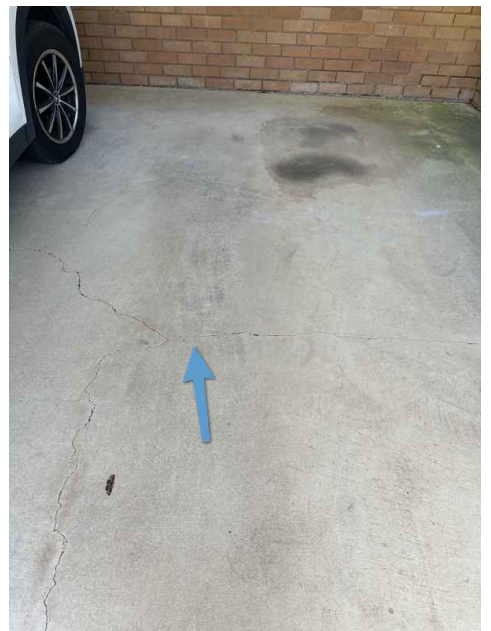
4.2.1 Floor

CRACKS - MINOR

Typical cracking to concrete in garage.

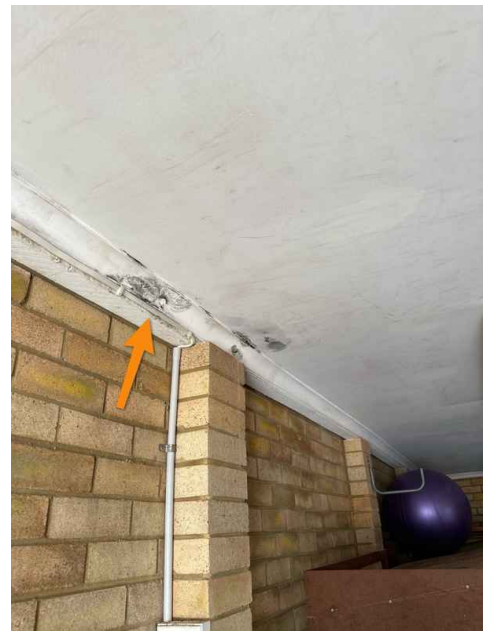
There are possible signs of fungi growth on ceiling. It is unknown if this is a safety hazard. Recommend a qualified mold inspector evaluate.

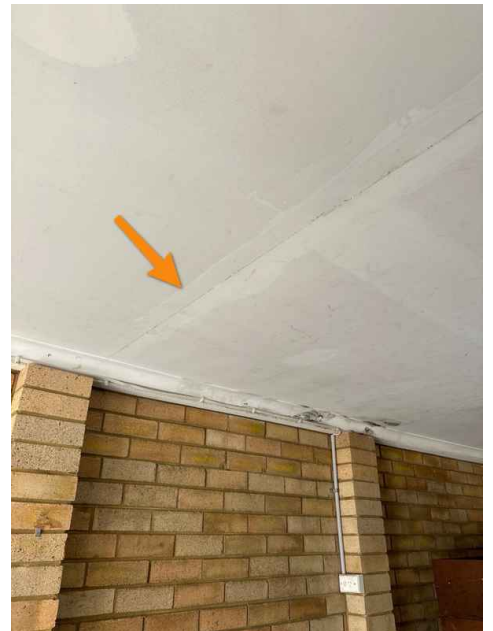
5.3.2 Ceiling

SHEET JOIN CRACKS

Sheet join cracks noted.

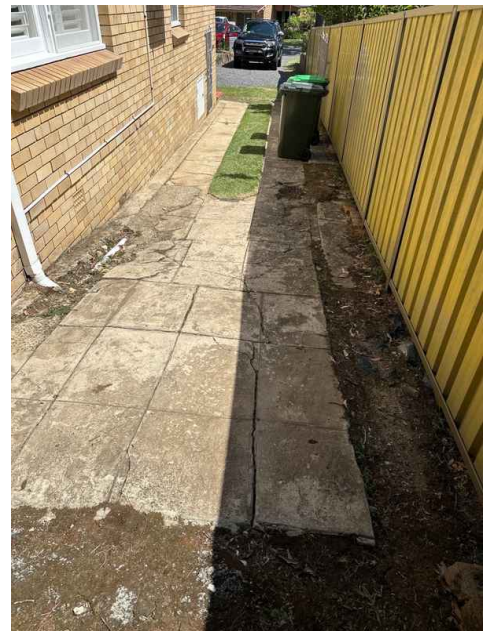
**WALKWAY CRACKING
- MAJOR**

Major cracks observed. Recommend concrete contractor evaluate and correct to prevent trip hazard & preserve appearance.

Contact a qualified concrete contractor.

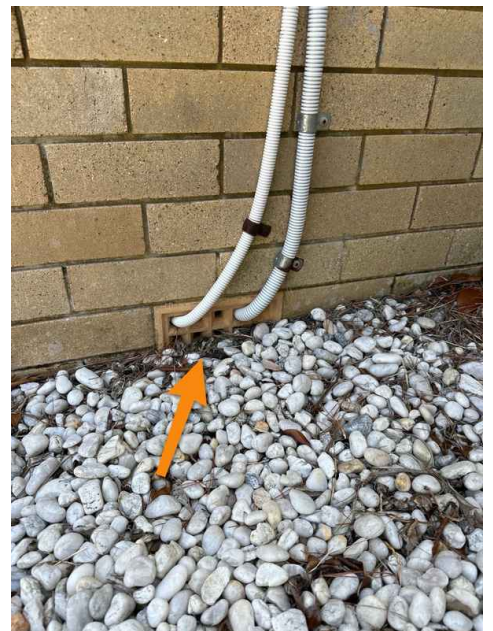
6.2.1 External

Vents have been covered/partially covered. It is recommended that these vents be unobstructed to allow ventilation to the subfloor

Contact a qualified professional.

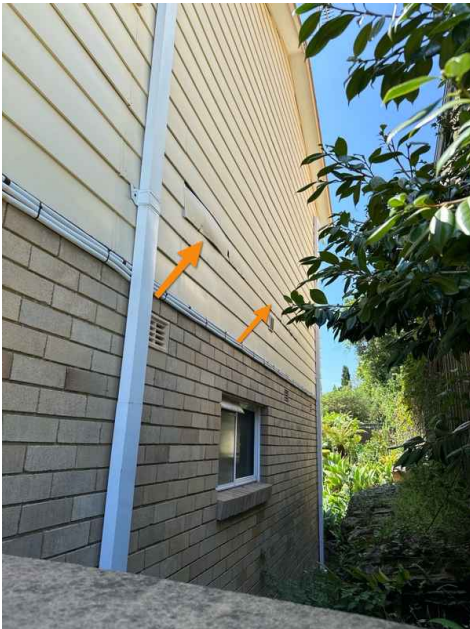
6.2.2 External

**LOOSE AND
DAMAGED BOARDS**

One or more siding boards were loose and damaged, which could result in moisture intrusion. Recommend a qualified siding contractor secure and fasten.

Contact a qualified professional.

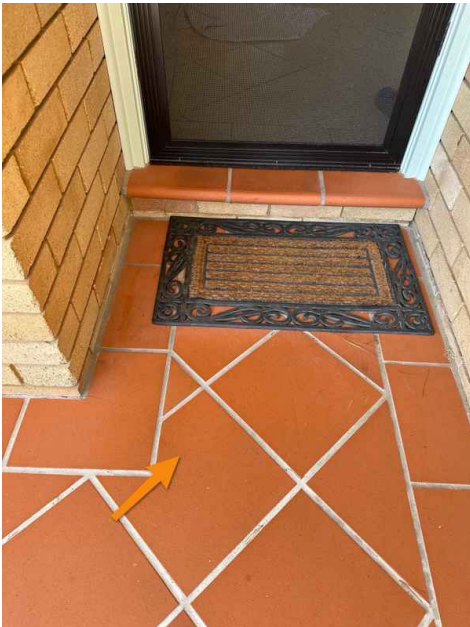
6.11.1 Verandah

CRACKED TILES

Cracked tiles noted.

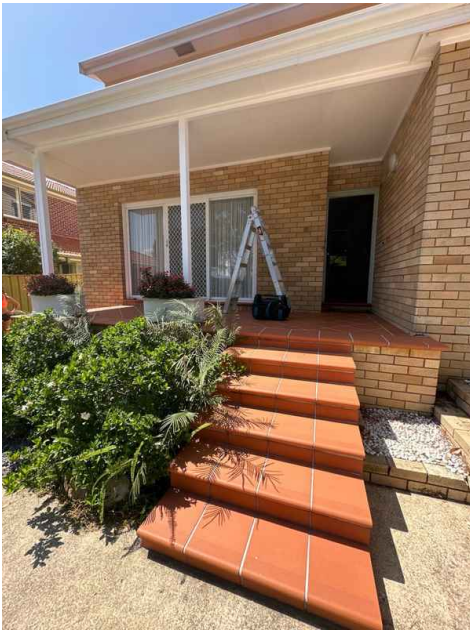
6.11.2 Verandah

NO BALUSTRADE RAIL

No balustrade rail. This is a safety issue and should be fixed immediately. It is recommended a qualified carpenter is contacted for repairs.

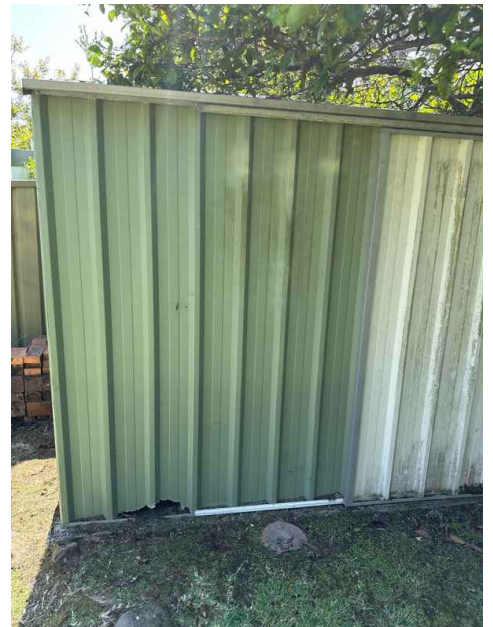
POOR CONDITION

The shed is considered in poor condition and repairs/replacement should be considered.

Contact a qualified carpenter.

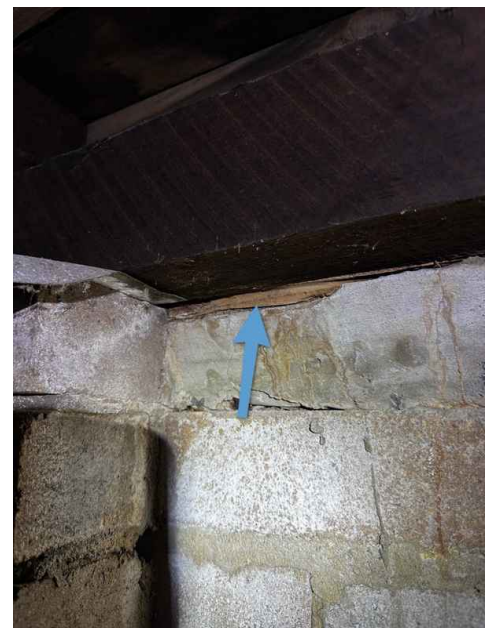
Historical Timber pest attack noted to a non structural piece of timber. No rectification required. It is recommended that a termite management system be implemented to protect the proeprty.

Contact a qualified professional.

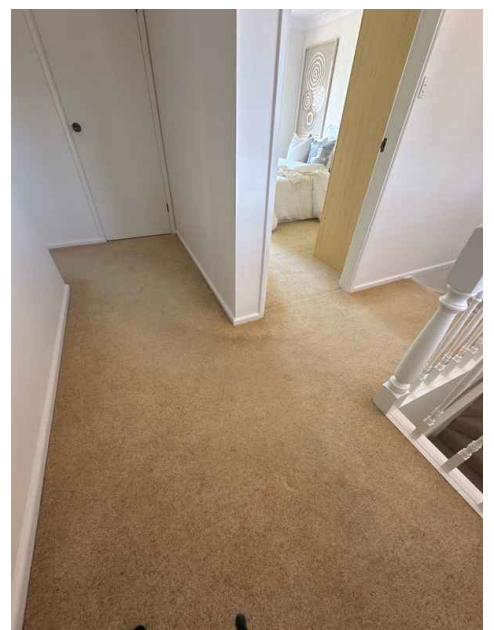
MODERATE WEAR THROUGHOUT

Floors in the home exhibited moderate surface wear along major paths of travel upstairs. Recommend a qualified flooring contractor evaluate for possible re-finish.

Contact a qualified flooring contractor

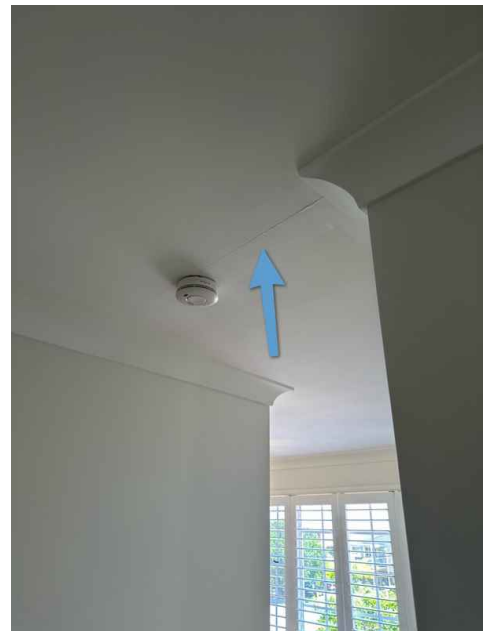
8.5.1 Ceilings

MINOR SETTLEMENT CRACKS

Settlement Cracks Noted. These are typical and generally, patch and paint will suffice, however, we recommend monitor these cracks and if become wider or longer, you will need to contact a structural engineer to assess.

Contact a qualified professional.

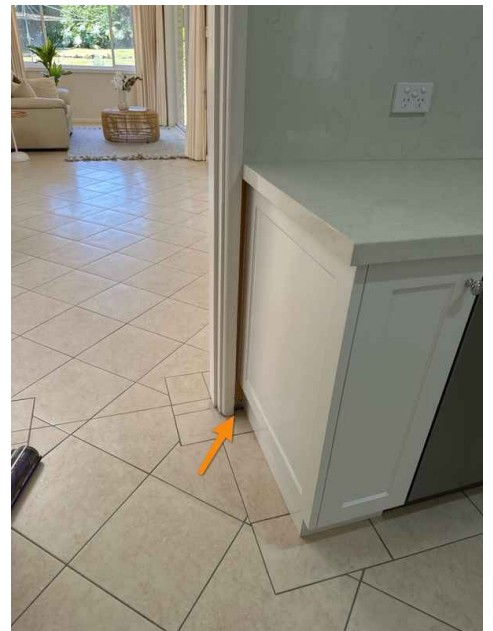
11.4.1 Walls

SKIRTING LOOSE OR MISSING

Skirting is loose/missing install/fix as needed

Contact a qualified professional.

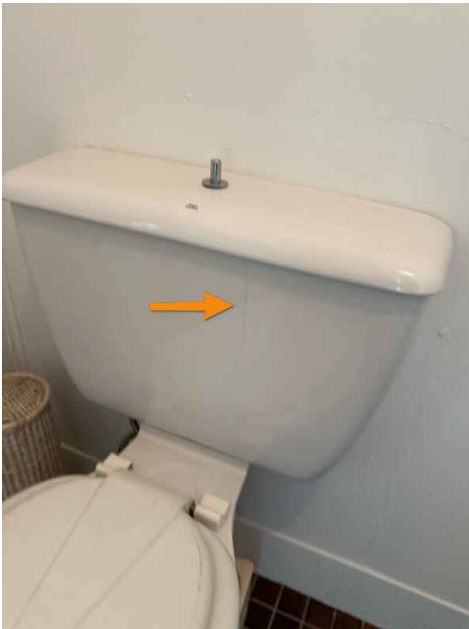
DAMAGE

Damage to toilet noted.

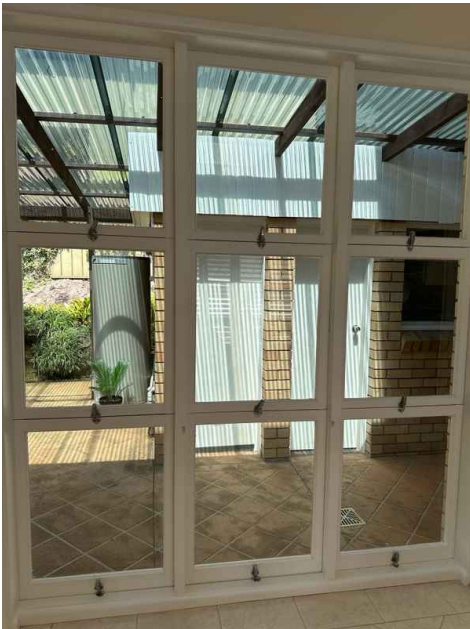
14.2.1 Windows

BINDING

Some windows are binding and will require offending edges to be sanded down.

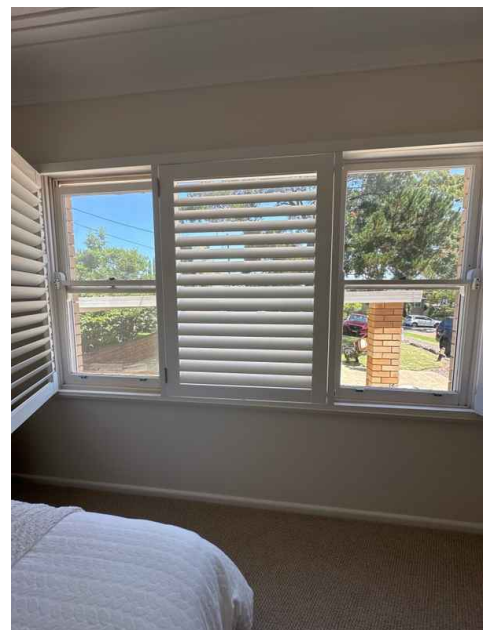
15.2.1 Windows

One or more windows are painted shut. Recommend windows be restored to functional use.

Contact a qualified window repair/installation contractor.

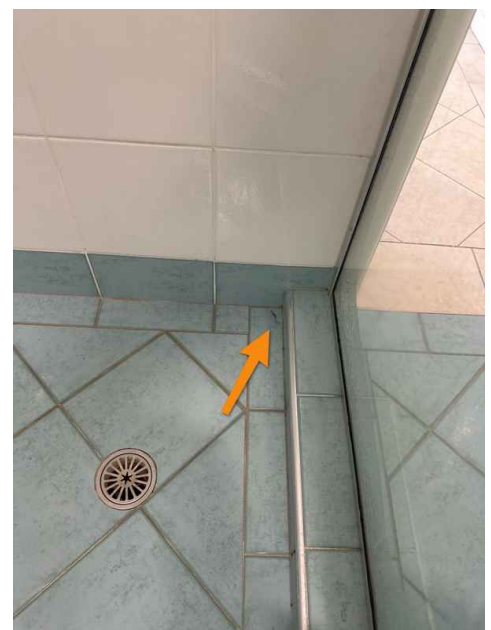
CRACKED TILES

Cracked tile/s noted. This can cause extensive floor and floor frame damage if water is leaking through the cavity. A qualified tiler should be engaged for advice and recommendations.

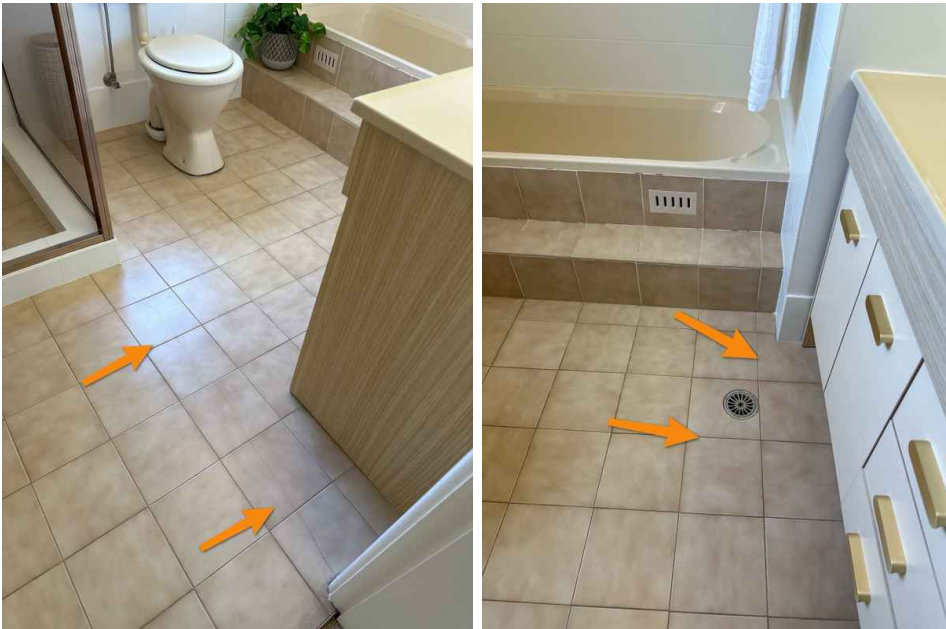
CRACKED FLOOR TILES

Cracked floor tiles. This should be repaired at the earliest as this has the potential to lead to many related issues such as dampness, water ingress to other areas. Contact a licensed tiler for repairs and recommendation

Contact a qualified tile contractor

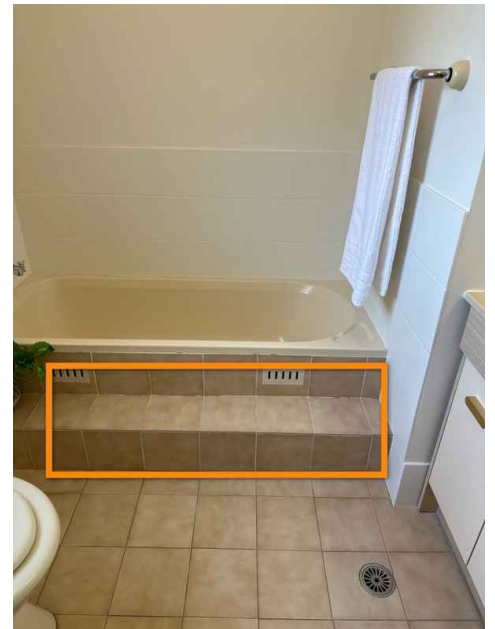
21.4.2 Floor

**GROUT
DETERIORATION**

Deteriorated grout noted. This should be repaired as this will lead to water ingress under the tiles causing uplifting and possible water penetration.

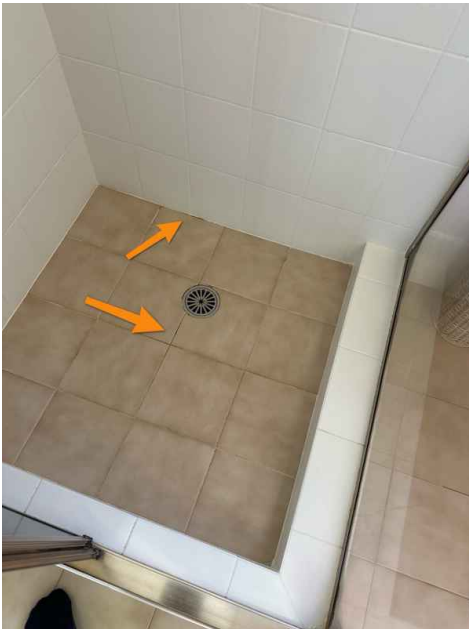
21.9.1 Shower & Bath

**TILE GROUT
DETERIORATION**

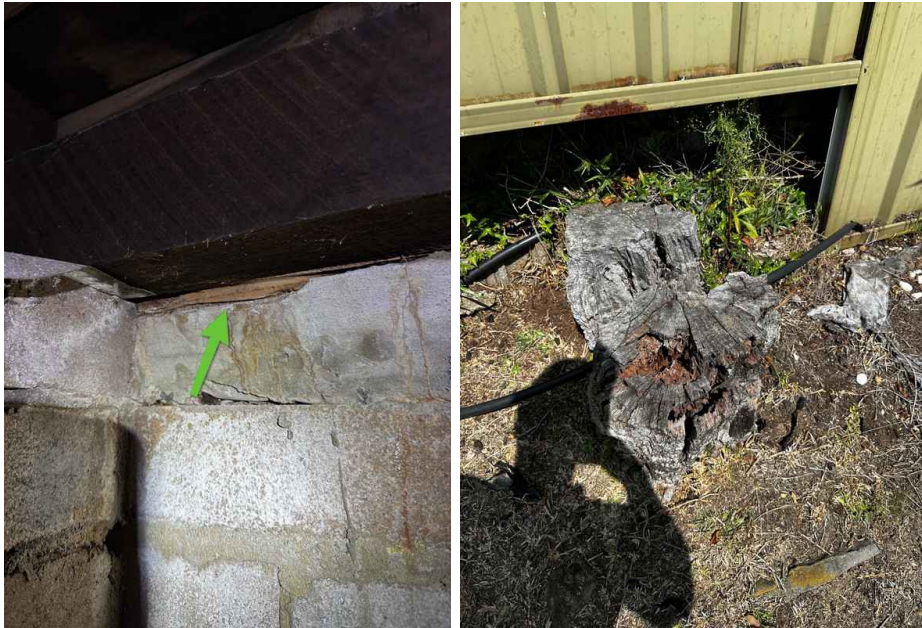
Subfloor, Tree/Tree stump

Termite damage/workings are not confined to these areas and further damage may also be located in concealed areas.
