Inspection Report

Homesafe Inspections Pty Ltd

Pest And Building Inspection

The Scope of the Inspection: This report Complies with Australian Standards AS 4349.1-2007. Inspection of Buildings Part 1: Pre- Purchase Inspections-Residential Buildings- Appendix "C" and with AS 4349.3-2010 (Visual Timber Pest Inspection Report)

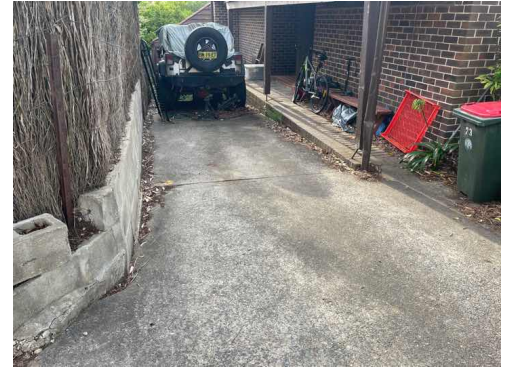
Driveway Condition

Common cracks & settlement were observed on the driveway. Maintenance is recommended. Note: Whilst these cracks appeared to be minor at the time of inspection, we strongly recommend you monitor these cracks and if worsening occurs contact a concreter for further advice.

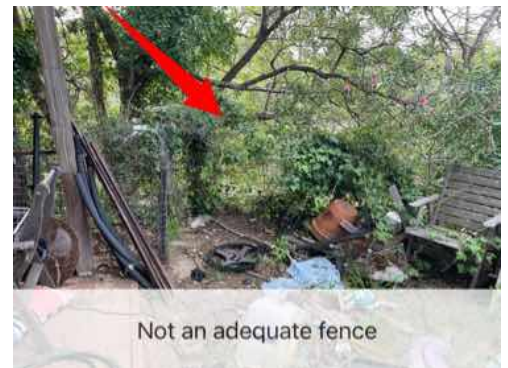
Overall Condition

Not an adequate fence. Site grounds drop off after fence. A more suitable stronger fence is recommended. Contact a qualified fencer or carpenter for recommendations and repairs.

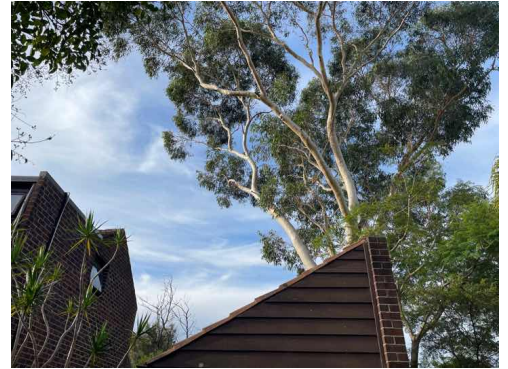
Trees**Tree Findings**

Trees are overhanging roof areas. Recommendations: These should be cut back away from the roof line and gutters.

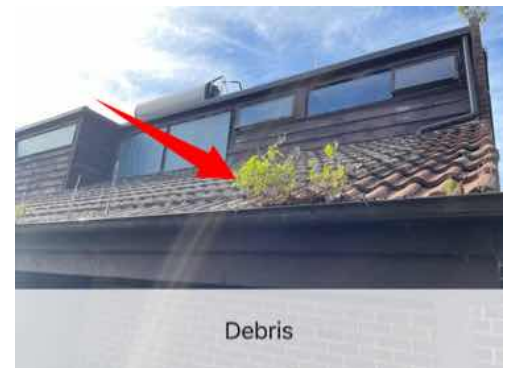
Gutter Findings

Debris in guttering areas- this requires cleaning out to prevent blocking of down pipes and leaking into eaves and fascia. Recommendations: Have gutters cleaned and assessed by a plumber for adequate fall. Also regularly clean to prevent ponding. Ponding water will contribute to rust.

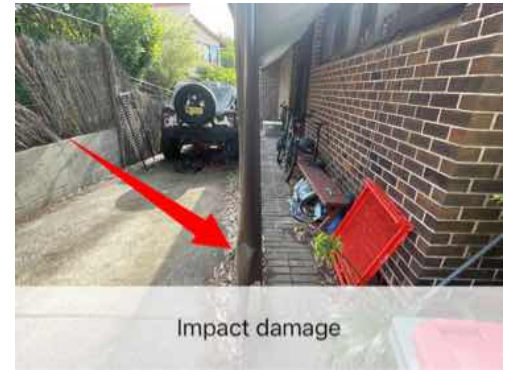
Down Pipe Findings

Impact damage noted to down pipe. Contact a roof plumber for replacement as required.

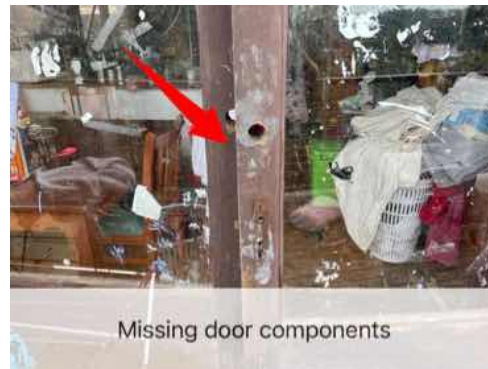
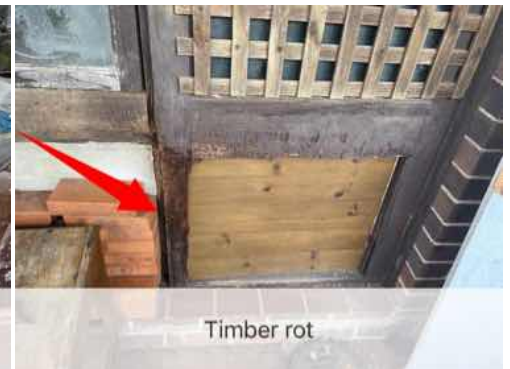
Door Findings

Timber fungal decay in door/door frame areas - Recommendations: A qualified carpenter should be engaged to assess and repairs.
External door components missing. It is recommended a qualified carpenter is contacted for repairs.

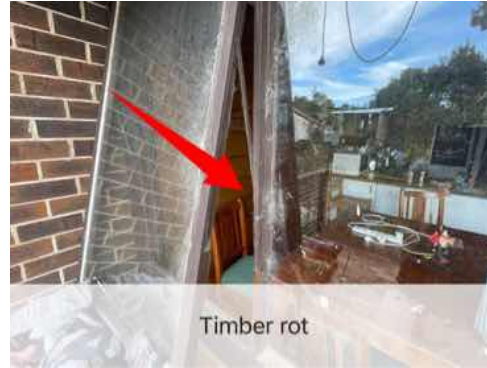
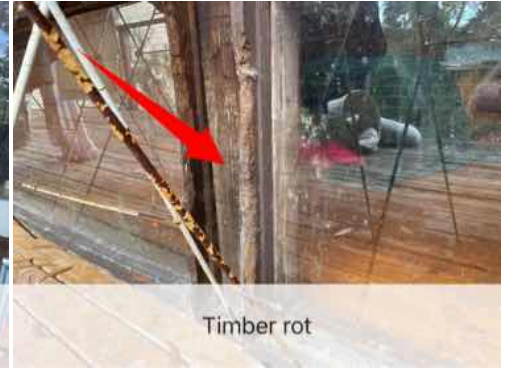
Overall Condition

Minor Timber fungal decay is evident in sections of the window framework - Some areas should be replaced.
Recommendations: A qualified carpenter should be engaged for advice and recommendations.

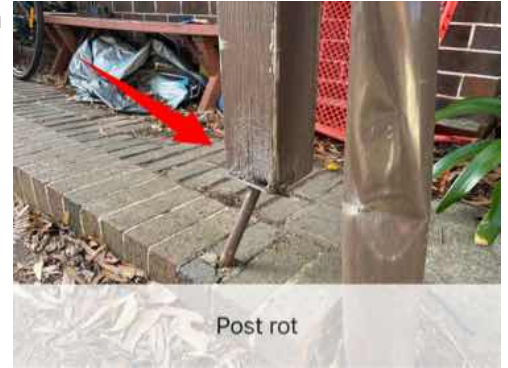
Column or Post Condition

Post base timber fungal decay - The posts had timber fungal decay (rot) on the base and were unstable. Recommendations: This is a safety concern and repairs required by a carpenter. It is preferable to keep posts out of contact with ground soil due to decay and also being conducive to timber pest infestation. A Safety Hazard

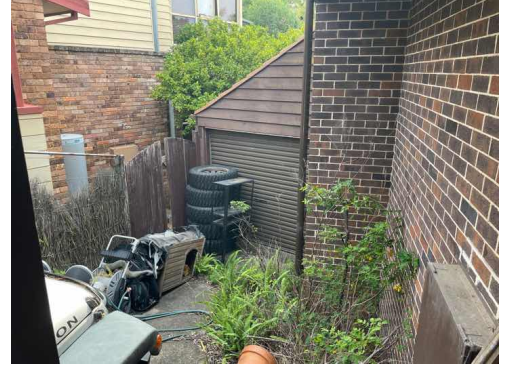
Areas Restricted

The garage was locked and no internal inspection was carried out. Defects may exist in the inaccessible areas. It is strongly recommended that full access be granted to enable a thorough inspection as there may be timber pest activity, damage or defects.

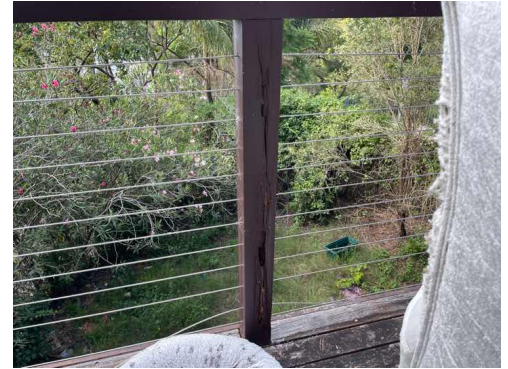
Overall Condition

Of areas visible, potential safety hazards were evident that will require further assessing and/or repair by licensed and qualified trades persons, Please read below for details.

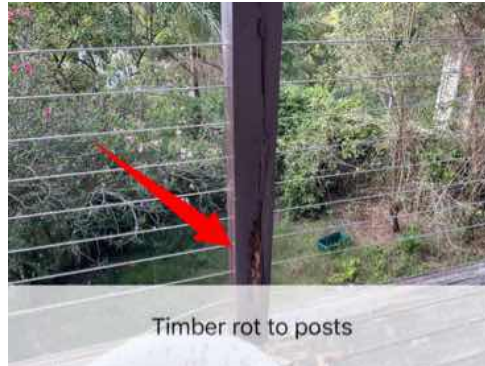
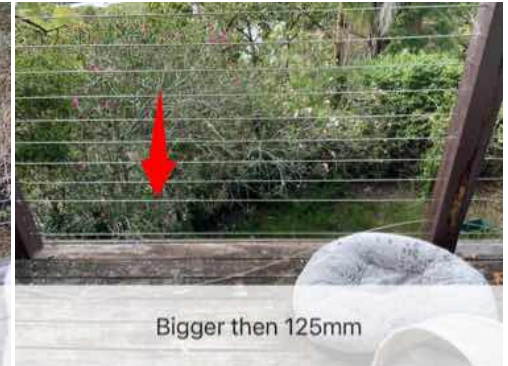
Balustrade Condition

Excess baluster gaps - Gaps between balusters / rails should not exceed 125 mm where the area is 1000 mm from finished floor level. The 125 mm gap regulation is due to the average size of a baby's head being 125 mm diameter or greater. In some circumstances this regulation was non-existent dependent on the age of the dwelling and technically there is no requirement to rectify.

Timber decay evident on rails / posts - Recommendations: A qualified carpenter should be engaged for advice and recommendations.

Recommendations: We strongly advise you rectify to comply for safety concerns to young children.

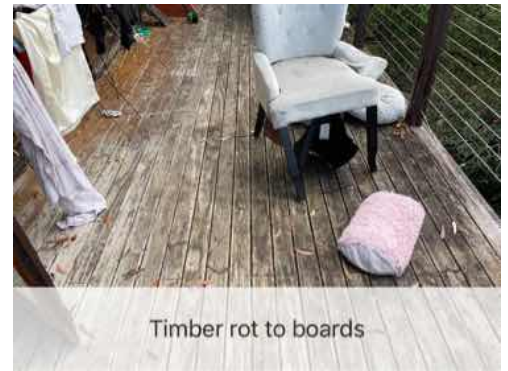
Flooring

Timber fungal decay in floor boards. This is a safety hazard and repair is required - Recommendations: A qualified carpenter should be engaged to replace all affected timbers.

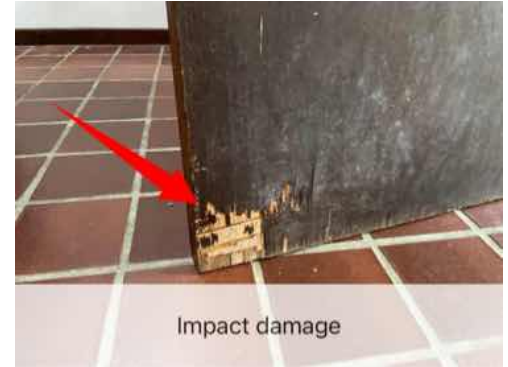
Front Entry Doors

Impact damage observed. Repairs / Replacement recommended

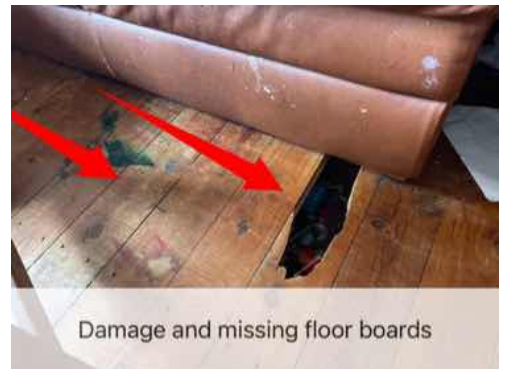
Flooring

Floor boards damaged and missing. It is recommended a qualified carpenter is contacted for repairs immediately

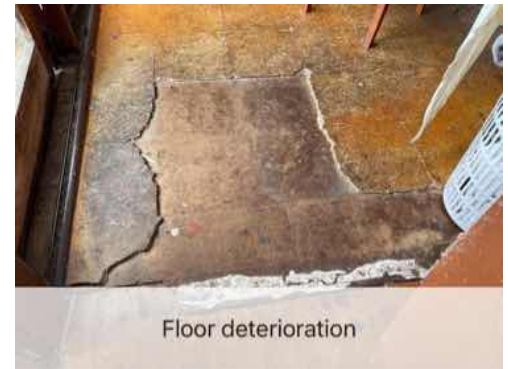
Floor deterioration. It is recommended a qualified carpenter is contacted for repairs.

Floor deterioration

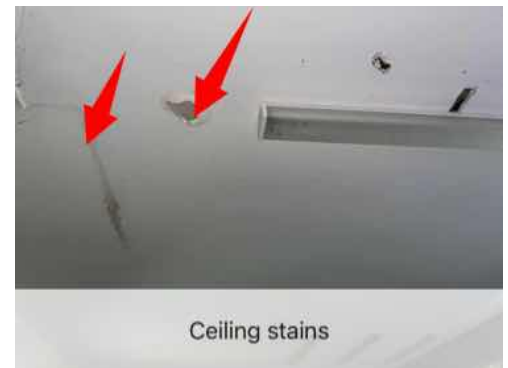
Ceiling stains - No moisture readings obtained. Recommendations: These may have been repaired, however, you will need to monitor after a prolonged period of rainfall - If leaking persists, a qualified plumber should be engaged for advice and recommendations. All water damaged plaster replaced by a qualified plasterer.

Ceiling stains

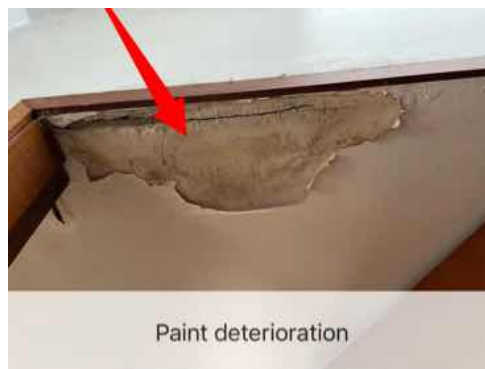
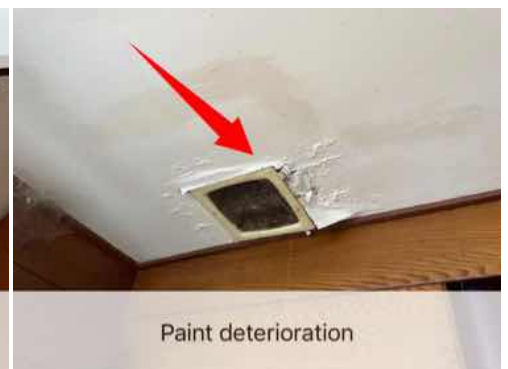
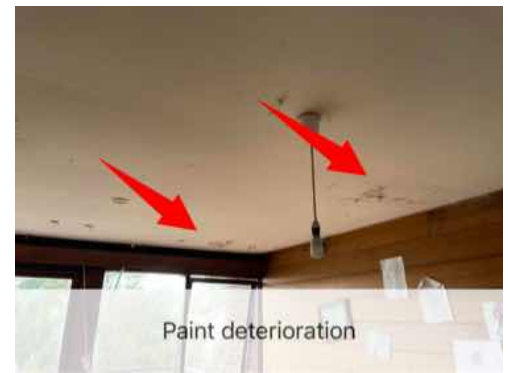
Ceiling paint flake/deterioration is evident throughout house.
Recommendations: General maintenance / painting as required.

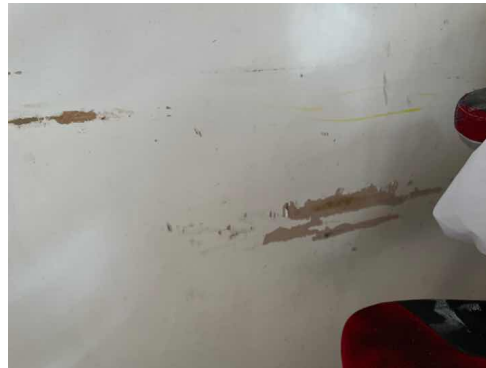
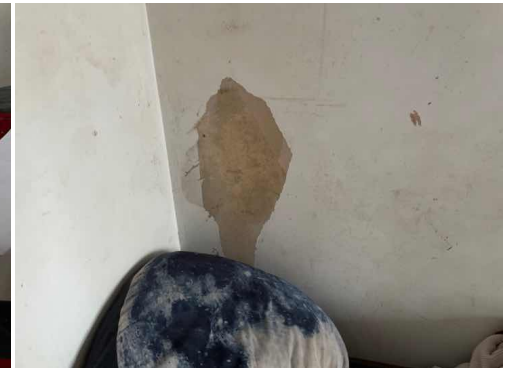
Walls

General ageing and/or denting/ impact damage and the like is evident on wall linings throughout house - Recommendations: A qualified painter should be engaged to assess and repair as required.

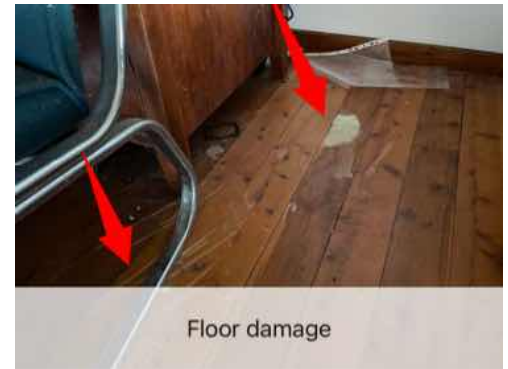
Flooring

Floor damage. It is recommended a qualified carpenter is contacted for repairs.

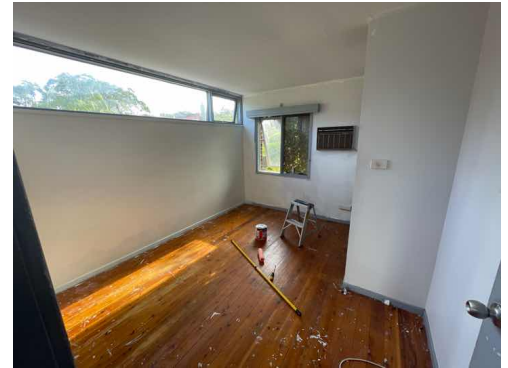
**Bedroom 3****Overall Condition**

Unfinished trade work - it is recommended qualified trades are contacted for repairs and finishes.

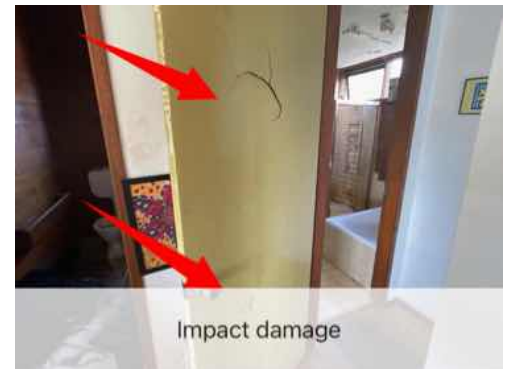
Door

Impact damage to door observed. Repairs / Replacement recommended

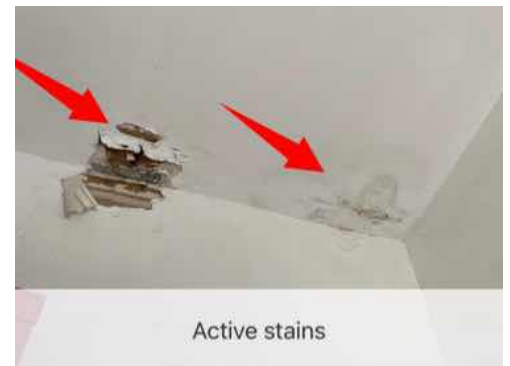
Ceiling stains - Moisture readings obtained. In the absence of rain It's difficult to ascertain with certainty the location of the leak.
Recommendations: A qualified roofer should be engaged for advice and recommendations. All water damaged plaster should be replaced by a qualified plasterer.

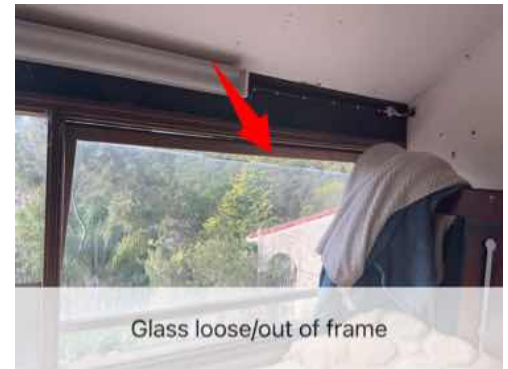
Windows

Glass has come loose and has come out of frame. It is recommended to contact a qualified glazier for repairs immediately.

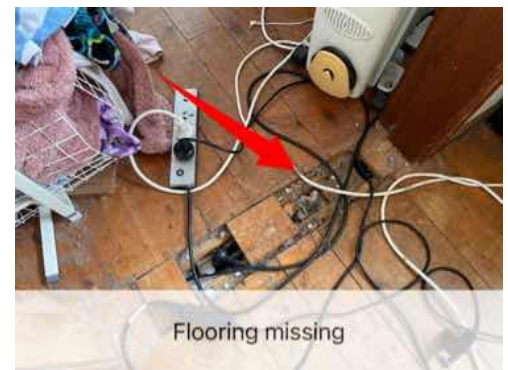
Flooring missing. Contact a qualified carpenter for repairs.

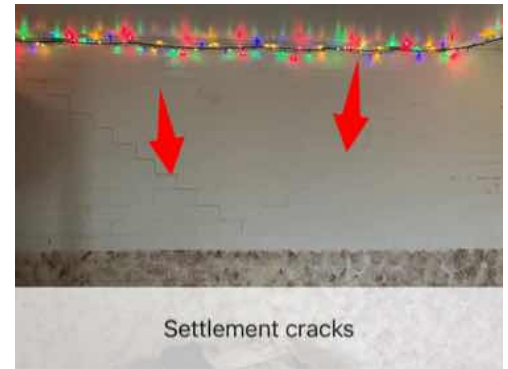
Settlement Cracks Noted. These are typical and generally patch and paint will suffice, however we recommend monitor these cracks and if become wider or longer, you will need to contact a structural engineers to assess.

Settlement cracks

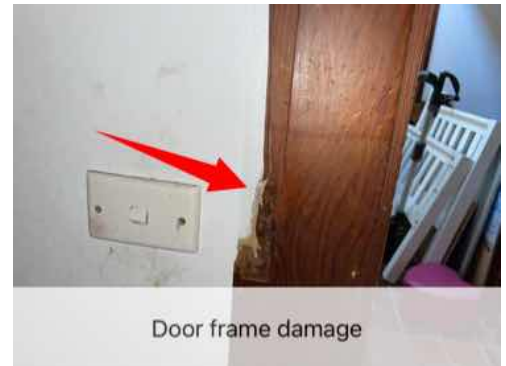
Door frame damage. Contact a qualified carpenter for repairs.

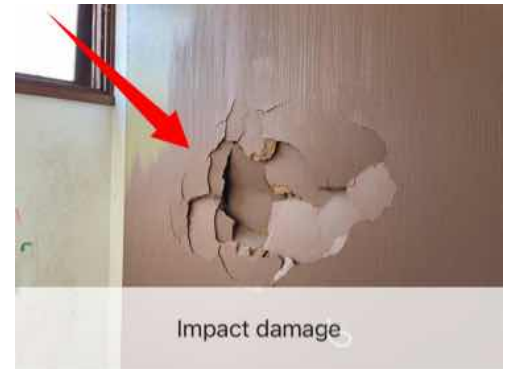
Door

Impact damage observed. Repairs / Replacement recommended

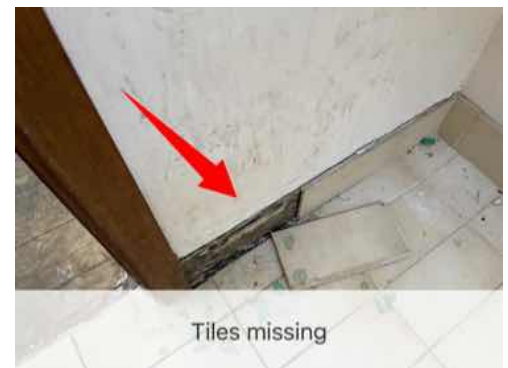
**Flooring**

Missing tile/s noted. Contact a licenced tiler and a waterproofer for repairs. Further damage may occur to the effected and adjoining walls and floor if this isn't rectified

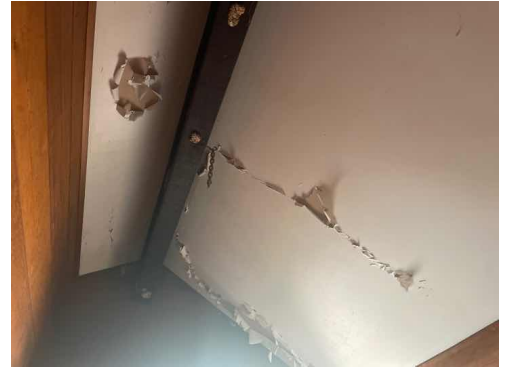
Ceiling paint flake/deterioration is evident. Recommendations: General maintenance / painting as required.

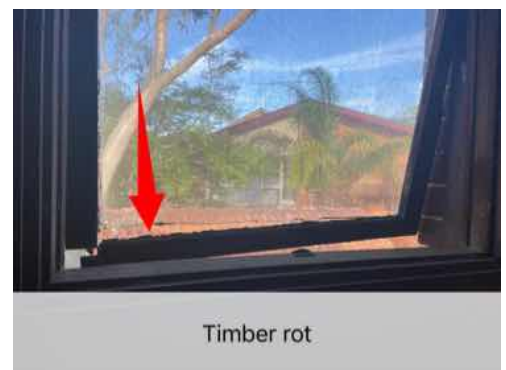
Window

Timber fungal decay on window frames. Recommendations: A qualified carpenter should be engaged for advice and recommendations.

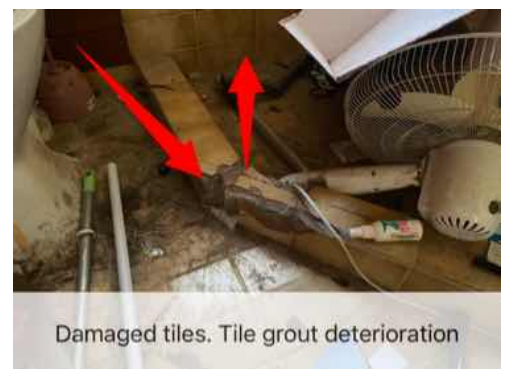
Flooring

Cracked tile/s noted. This can cause extensive floor and floor frame damage and is conducive to termite infestation if water is leaking through the cavity. A qualified tiler should be engaged for advice and recommendations.

Deteriorated grout noted. This should be repaired as this will lead to water ingress under the tiles causing uplifting and possible water penetration.

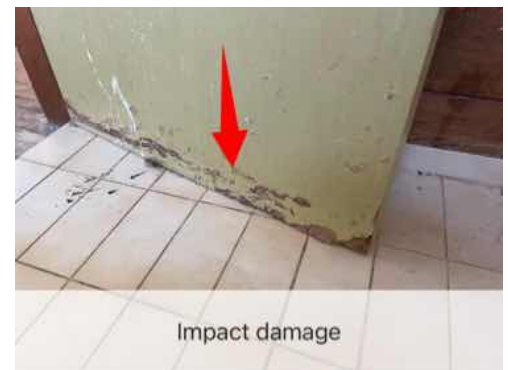
Door

Impact damage observed. Repairs / Replacement recommended

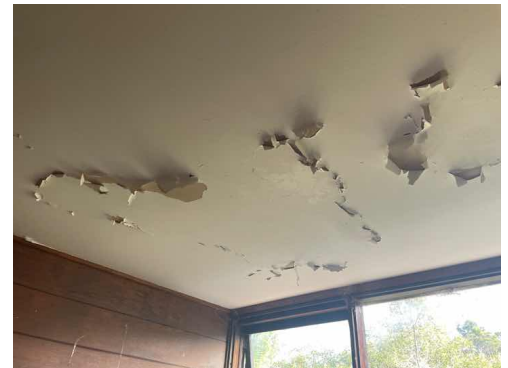
Ceiling paint flake/deterioration is evident. Recommendations: General maintenance / painting as required.

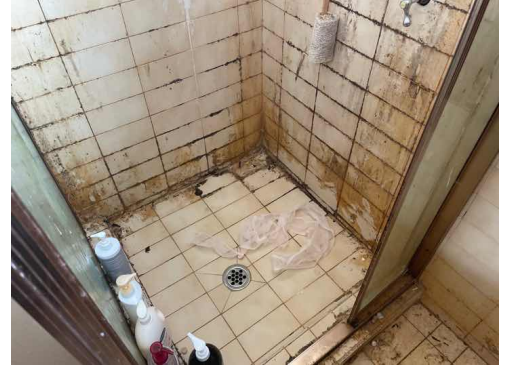
Shower And Bath

Tile grout deterioration. Re-grout / seal the shower tiles and screen junctions. A qualified plumber should be engaged for advice and recommendations.

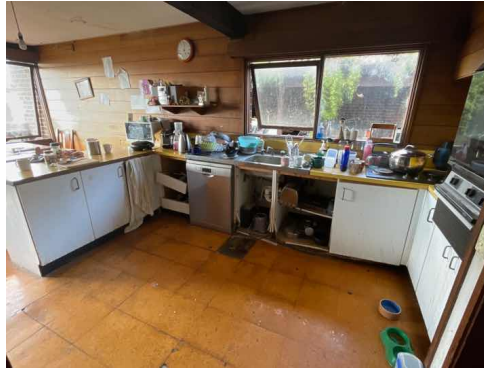
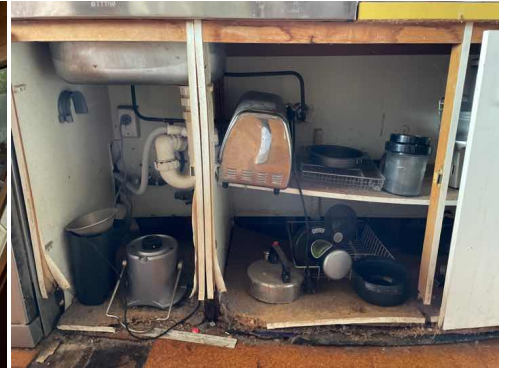
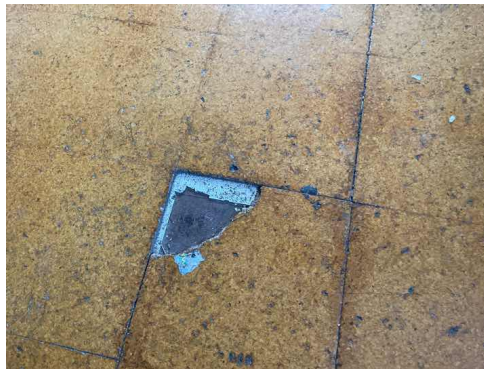
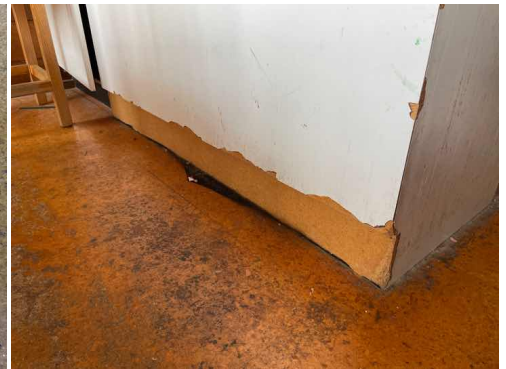
General age/damage has occurred to kitchen and components.

Recommendations: A qualified cabinet maker and plumber should be engaged for advice and recommendations regarding renovations

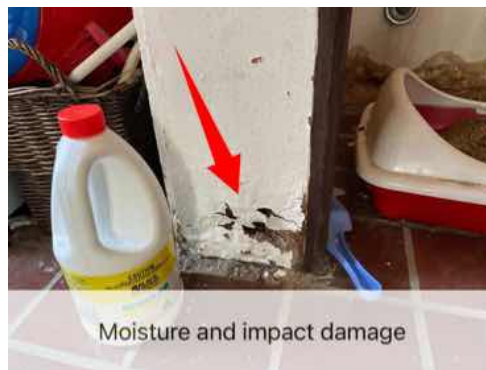
The walls are damaged from moisture and impact. Contact a licensed plasterer for repairs. Exposed electrical. This is a safety issue. Contact a licence electrician immediately for repairs.

Moisture and impact damage

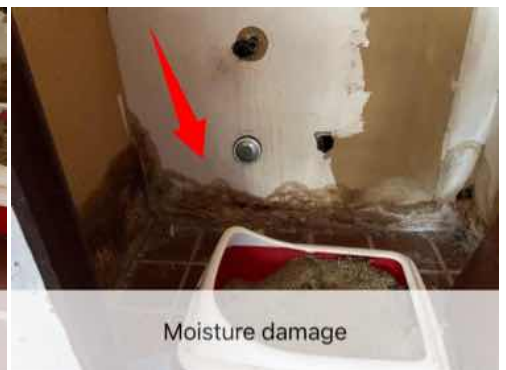
Moisture damage

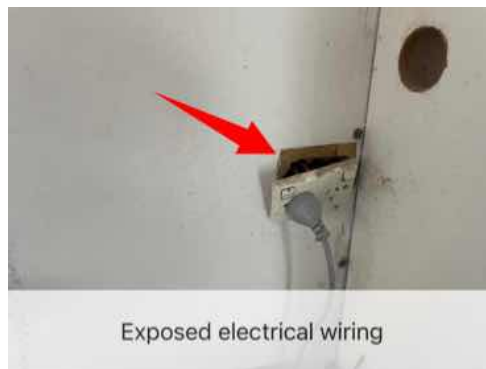
Exposed electrical wiring

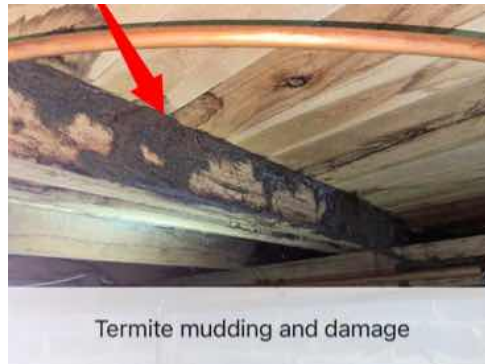
Timber pest attack noted to joist, bearers and floor timber's noted. See a licensed pest technician and a licensed carpenter for further evaluation and advice. Note that if this is a building inspection only we strongly recommend that you obtain a timber pest inspection prior to a decision to purchase. Where a combined report is ordered, please refer to the attached visual timber pest inspection report

Termite mudding and damage

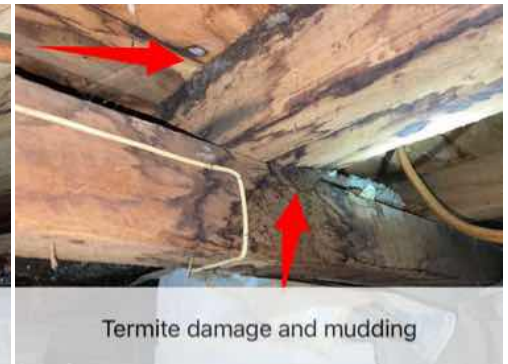
Termite damage and mudding

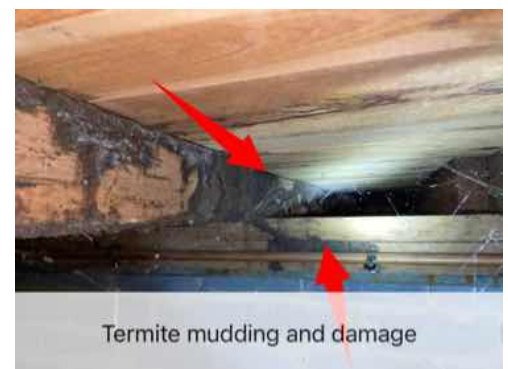
Termite mudding and damage
