## TIMBER FRAME INSPECTION

**1234 MAIN STREET  
SYDNEY**

02/05/2023

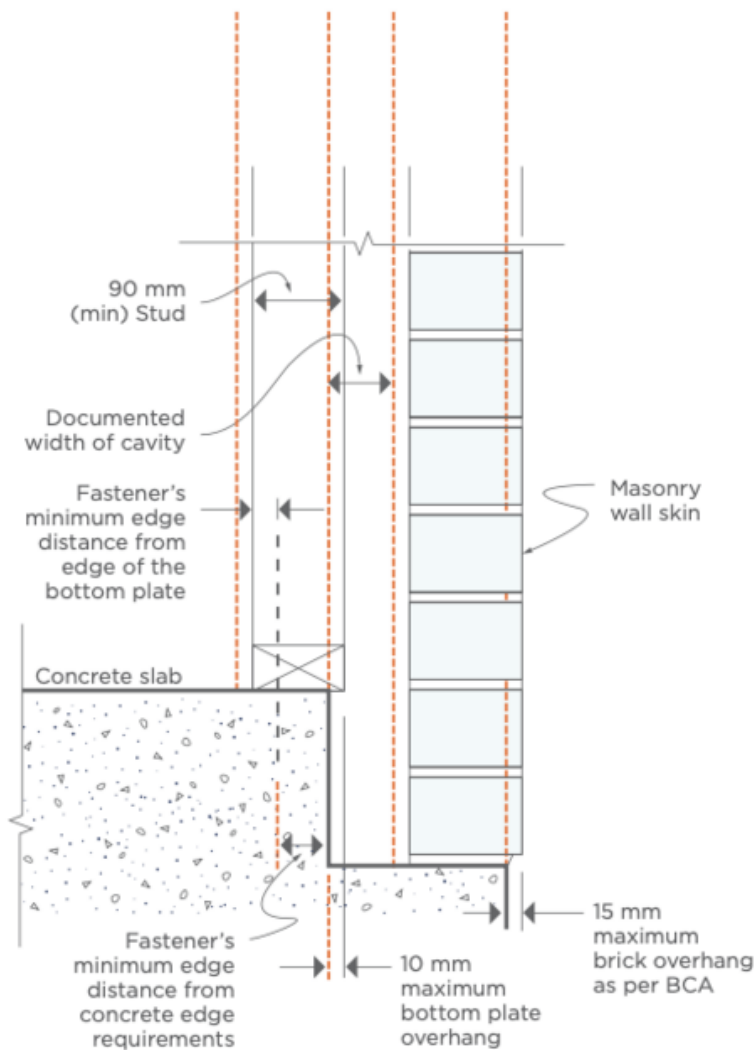
**DIAGRAM 4.08** BOTTOM PLATES THAT OVERHANG CONCRETE SLABS

Bottom plates that are less than 90 mm wide and overhang concrete slabs are defective.

Bottom plates that are 90 mm wide or greater and overhang concrete slabs by more than 10 mm are defective.

25mm Frame overhang

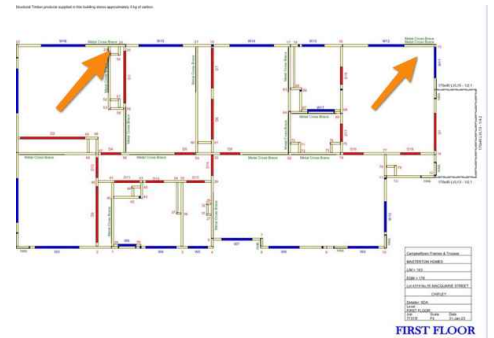
**METAL BRACING NOT INSTALLED**

Metal bracing has not been installed in sections

Arrows show areas where bracing has not been installed

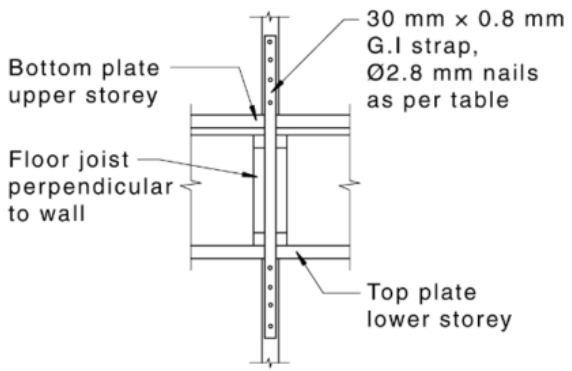
Tie down connections have not been installed to timbers where the load is transferred to the below timbers. Continuity of tie down shall be provided from the roof sheeting to the foundations. This is a requirement set out in AS1684.2:2022. Below tables show examples of tie downs.

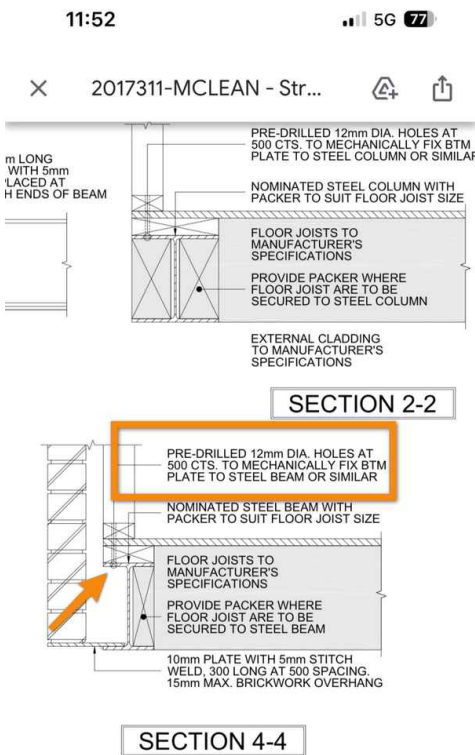
#### INADEQUATE ANCHORS

Inadequate anchors between bottom plate and steel beam as required by the engineers plans. It is required to be Mechanically fixed at 500mm centres. Currently the bugles have been installed at 600mm centres with some not finished. This is common throughout the build. It is recommended these sections be bolted as the bugle may not reach the bottom plate.

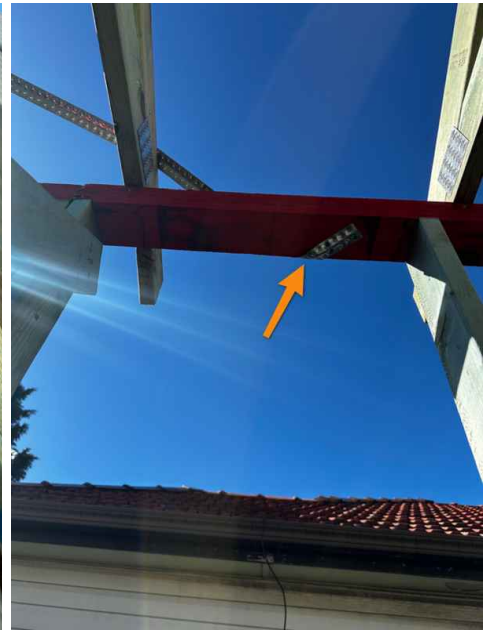
Example of how it should be done

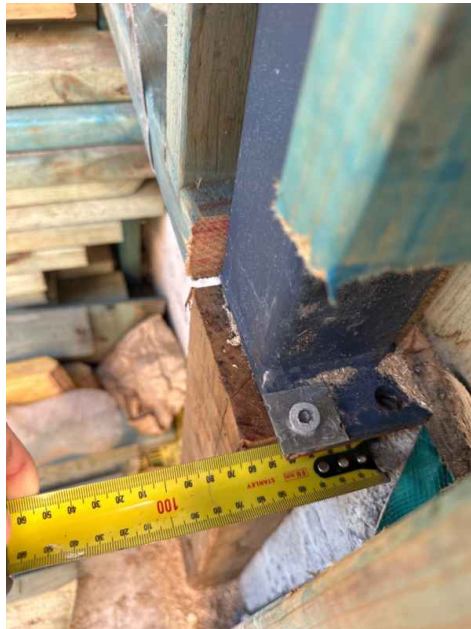
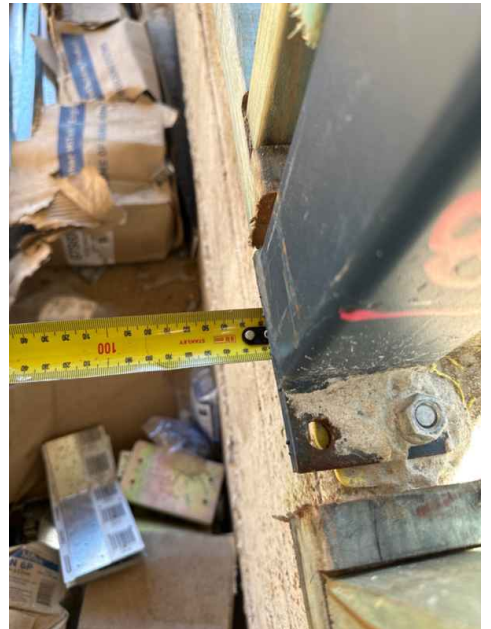
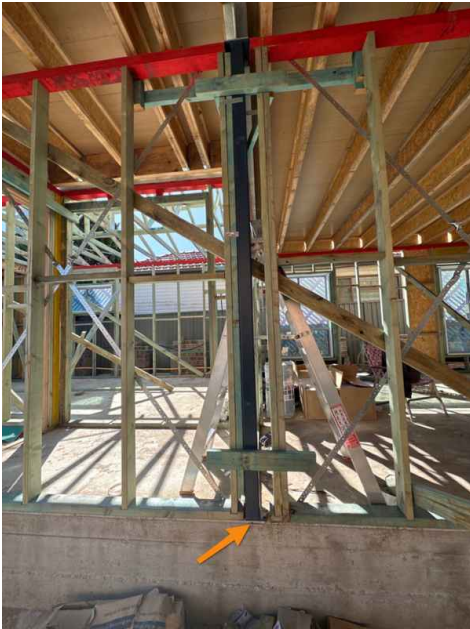
Steel posts has inadequate bearing. The steel plates have excessive overhangs to the concrete slab. These area required to have full bearing on the slab. This should be assessed by the structural engineer to determine a solution.

Structural load not designed to bear on timber, this has been done as it appears the slab edge was poured short

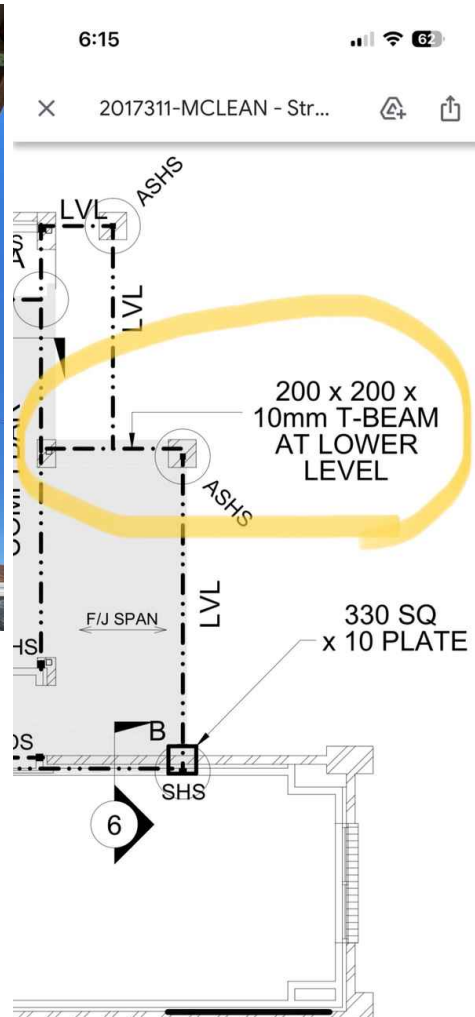
Plan shows a 200x200x10 T-beam should be installed around the highlighted area. No section or drawings available to show how this connects.

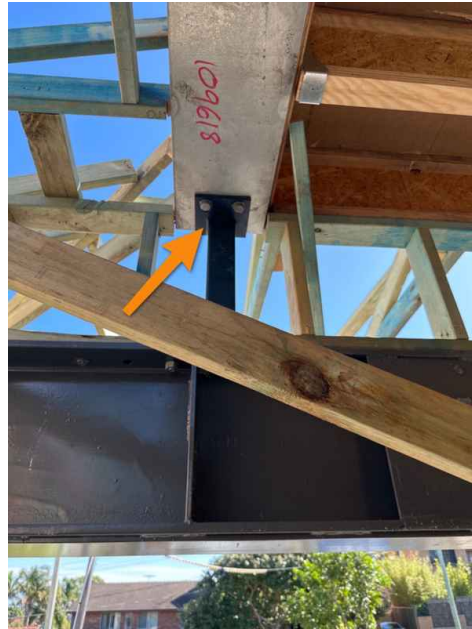
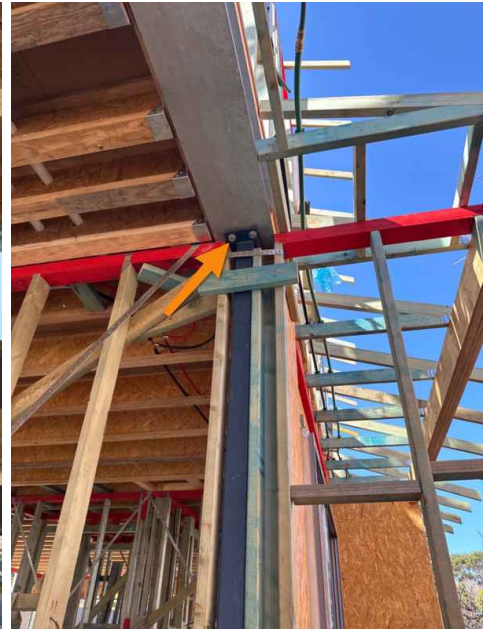
The engineer plans specify a 200mm long 10mm thick plate. What has been installed is inadequate

Plate is only 150mm

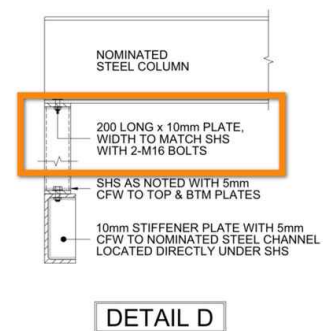
Beam should have 200mm of bearing. Currently the last packer is only 100mm wide. This connection is not as it specified by the engineers drawings
