Inspection Report

Homesafe Inspections Pty Ltd

Pest And Building Inspection

The Scope of the Inspection: This report Complies with Australian Standards AS 4349.1-2007. Inspection of Buildings Part 1: Pre- Purchase Inspections-Residential Buildings- Appendix "C" and with AS 4349.3-2010 (Visual Timber Pest Inspection Report)

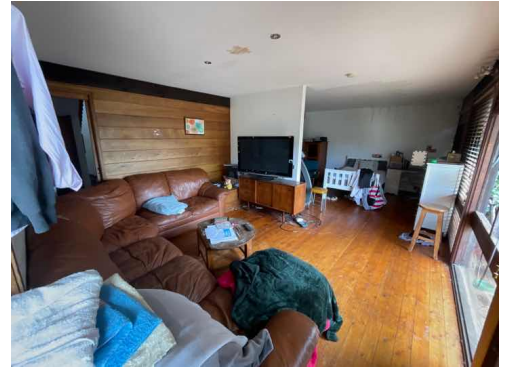
On inspection, defects were present that will require further assessing and recommendations by a qualified trades persons, please read below for details.

Floor boards damaged and missing. It is recommended a qualified carpenter is contacted for repairs immediately

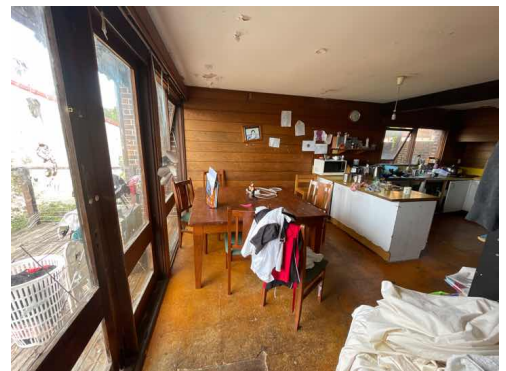
On inspection, defects were present that will require further assessing and recommendations by a qualified trades persons, please read below for details.

Floor deterioration. It is recommended a qualified carpenter is contacted for repairs.

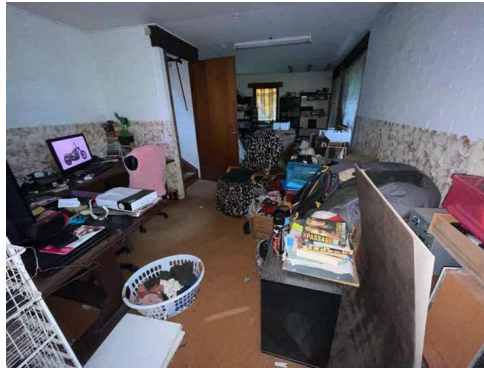
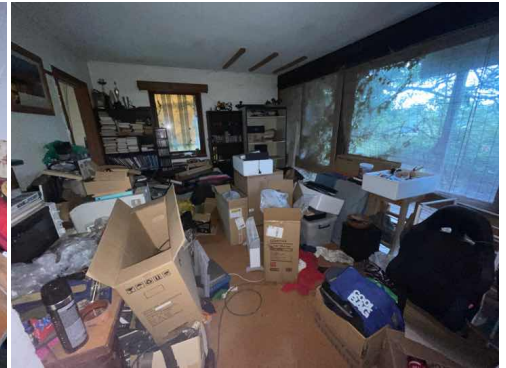
Ceiling stains - No moisture readings obtained. Recommendations: These may have been repaired, however, you will need to monitor after a prolonged period of rainfall - If leaking persists, a qualified plumber should be engaged for advice and recommendations. All water damaged plaster replaced by a qualified plasterer.

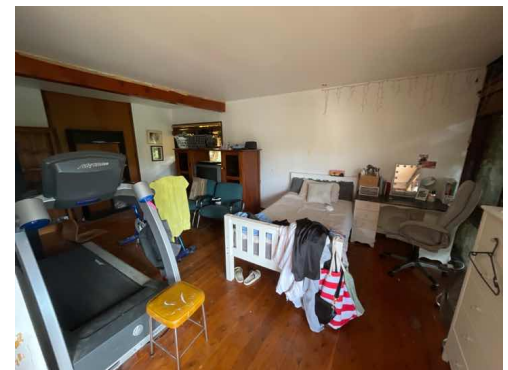
Floor damage. It is recommended a qualified carpenter is contacted for repairs.

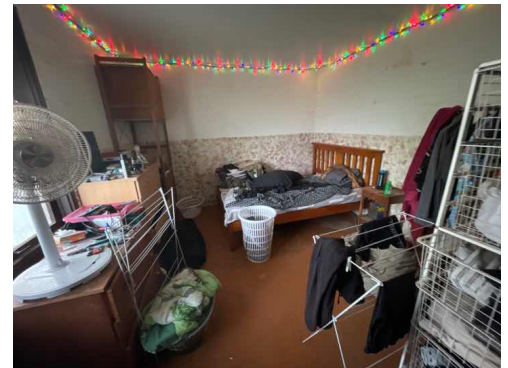
Settlement Cracks Noted. These are typical and generally patch and paint will suffice, however we recommend monitor these cracks and if become wider or longer, you will need to contact a structural engineers to assess.

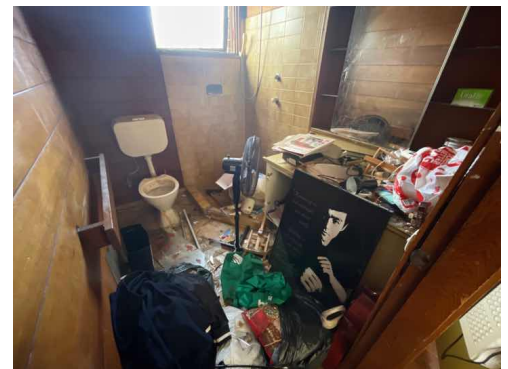
Ceiling paint flake/deterioration is evident. Recommendations: General maintenance / painting as required.

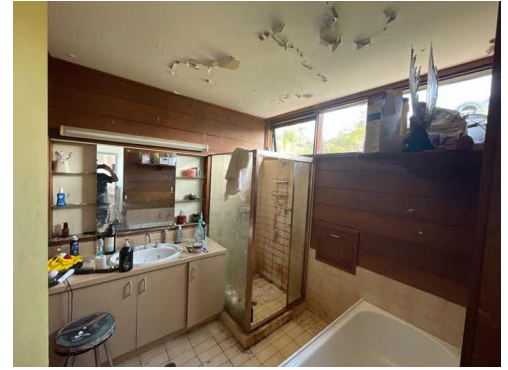
Impact damage observed. Repairs / Replacement recommended

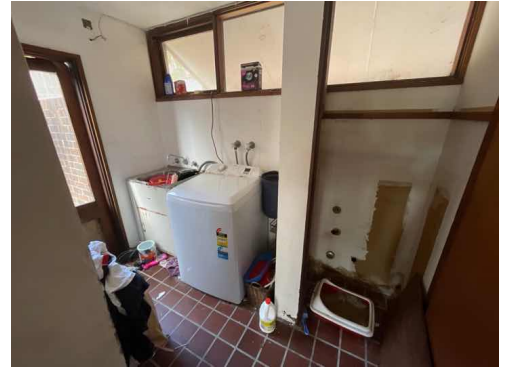
KITCHEN & LAUNDRY	Laundry Findings	Walls	The walls are damaged from moisture and impact Contact a licensed plasterer for repairs.
SUBFLOOR	Sub-Floor Observation.	Dampness	Dampness in sub floor soil. Damp sub floor soil should be avoided as it can cause fungal decay, mould and possibly footings problems. Recommendations: A qualified drainage plumber should be engaged for advice and recommendations.
SUBFLOOR	Sub-Floor Observation.	Subfloor Cleanliness	There was debris and other material in the subfloor, we recommend cleaning these to aid with ventilation and reduce the likely hood of rodents and pests.
CONCLUSION	Condition Of Inspected Structure	The Incidence of Minor Defects	The incidence of minor defects in this residential building as compared with similar buildings is considered HIGH

The walls are damaged from moisture and impact. Contact a licensed plasterer for repairs. Exposed electrical. This is a safety issue. Contact a licence electrician immediately for repairs.

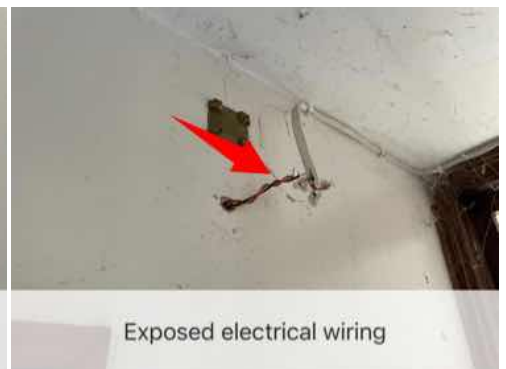
Exposed electrical wiring

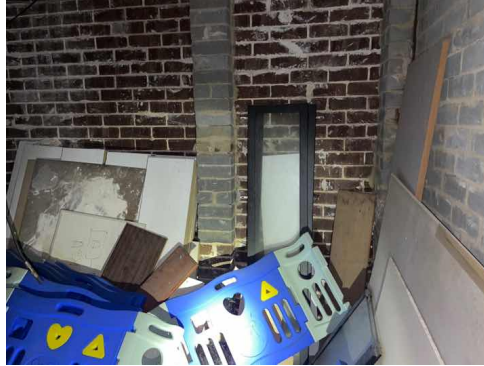
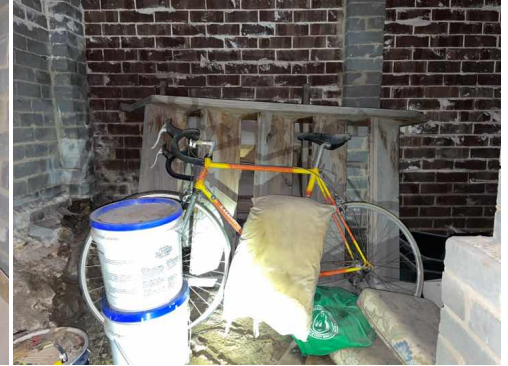
Joists

Timber pest attack noted to joist, bearers and floor timber's noted. See a licensed pest technician and a licensed carpenter for further evaluation and advice. Note that if this is a building inspection only we strongly recommend that you obtain a timber pest inspection prior to a decision to purchase. Where a combined report is ordered, please refer to the attached visual timber pest inspection report
