HOMESAFE INSPECTIONS  
info@homesafeinspections.com.au  
<http://www.homesafeinspections.com.au>

## PCI OR DEFECTS REPORT

1234 MAIN STREET,  
SYDNEY NSW 2227

BUYER NAME  
08/06/2023

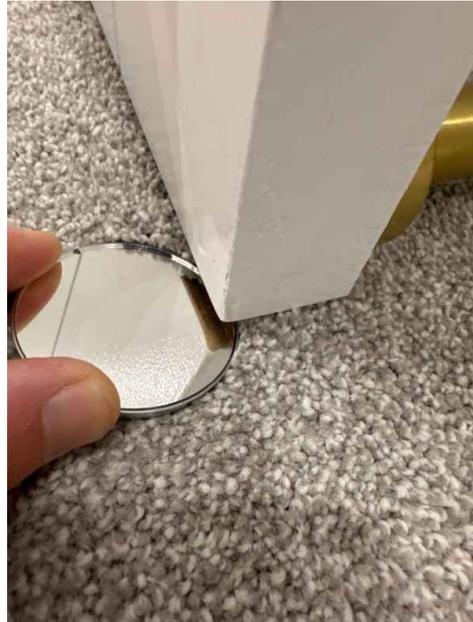
Downstairs bedroom

Bottoms and tops of doors have not been painted/sealed. This is defective please see the below reference to The Guide to Standards and Tolerances

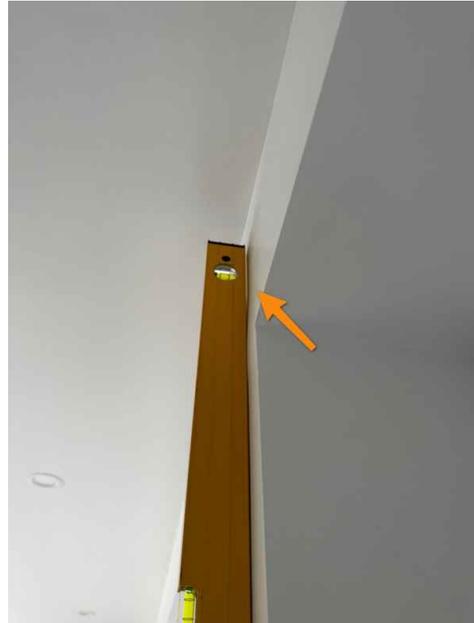
Bow in plasterboard between wall and bulkhead in the kitchen is 4mm

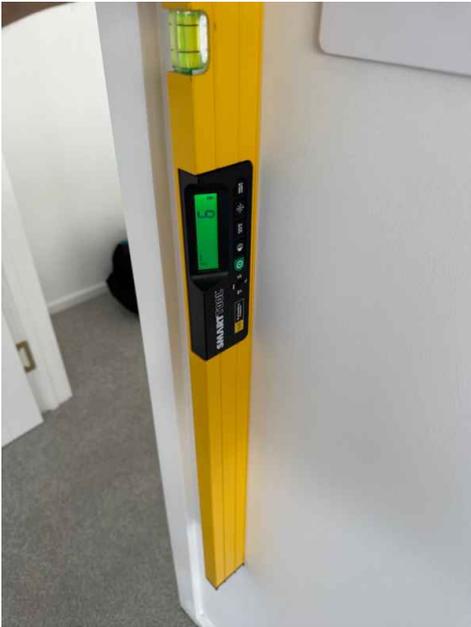
Master bedroom entry wall is out 6mm over 1200mm

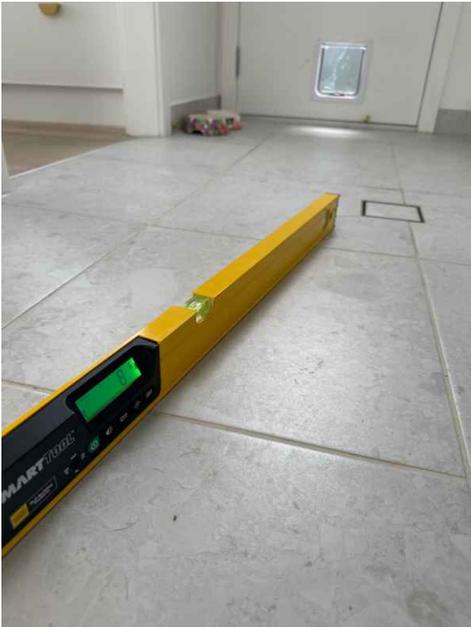
Fall should be minimum 12mm. Only 8mm has been achieved

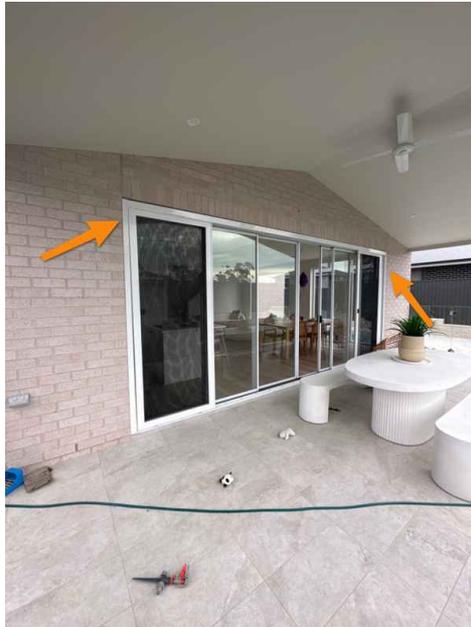
Articulation joints blocked by door system being installed tight to the brickwork

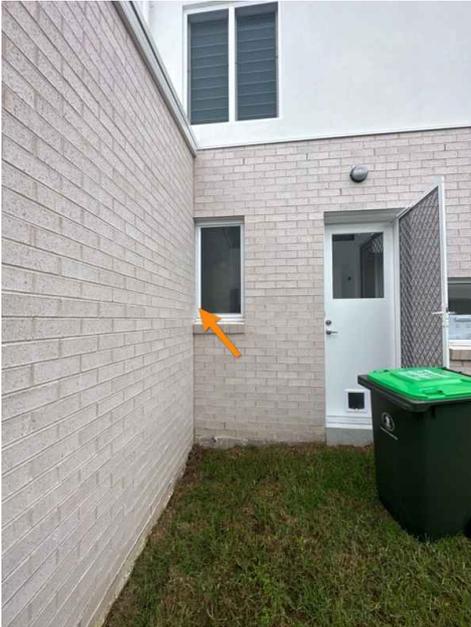
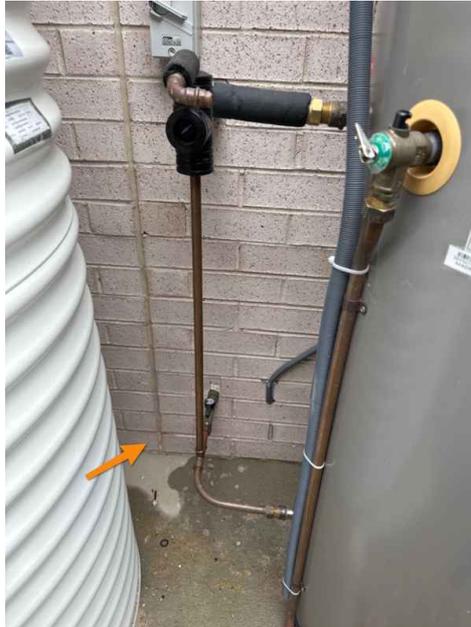
Blocked by window

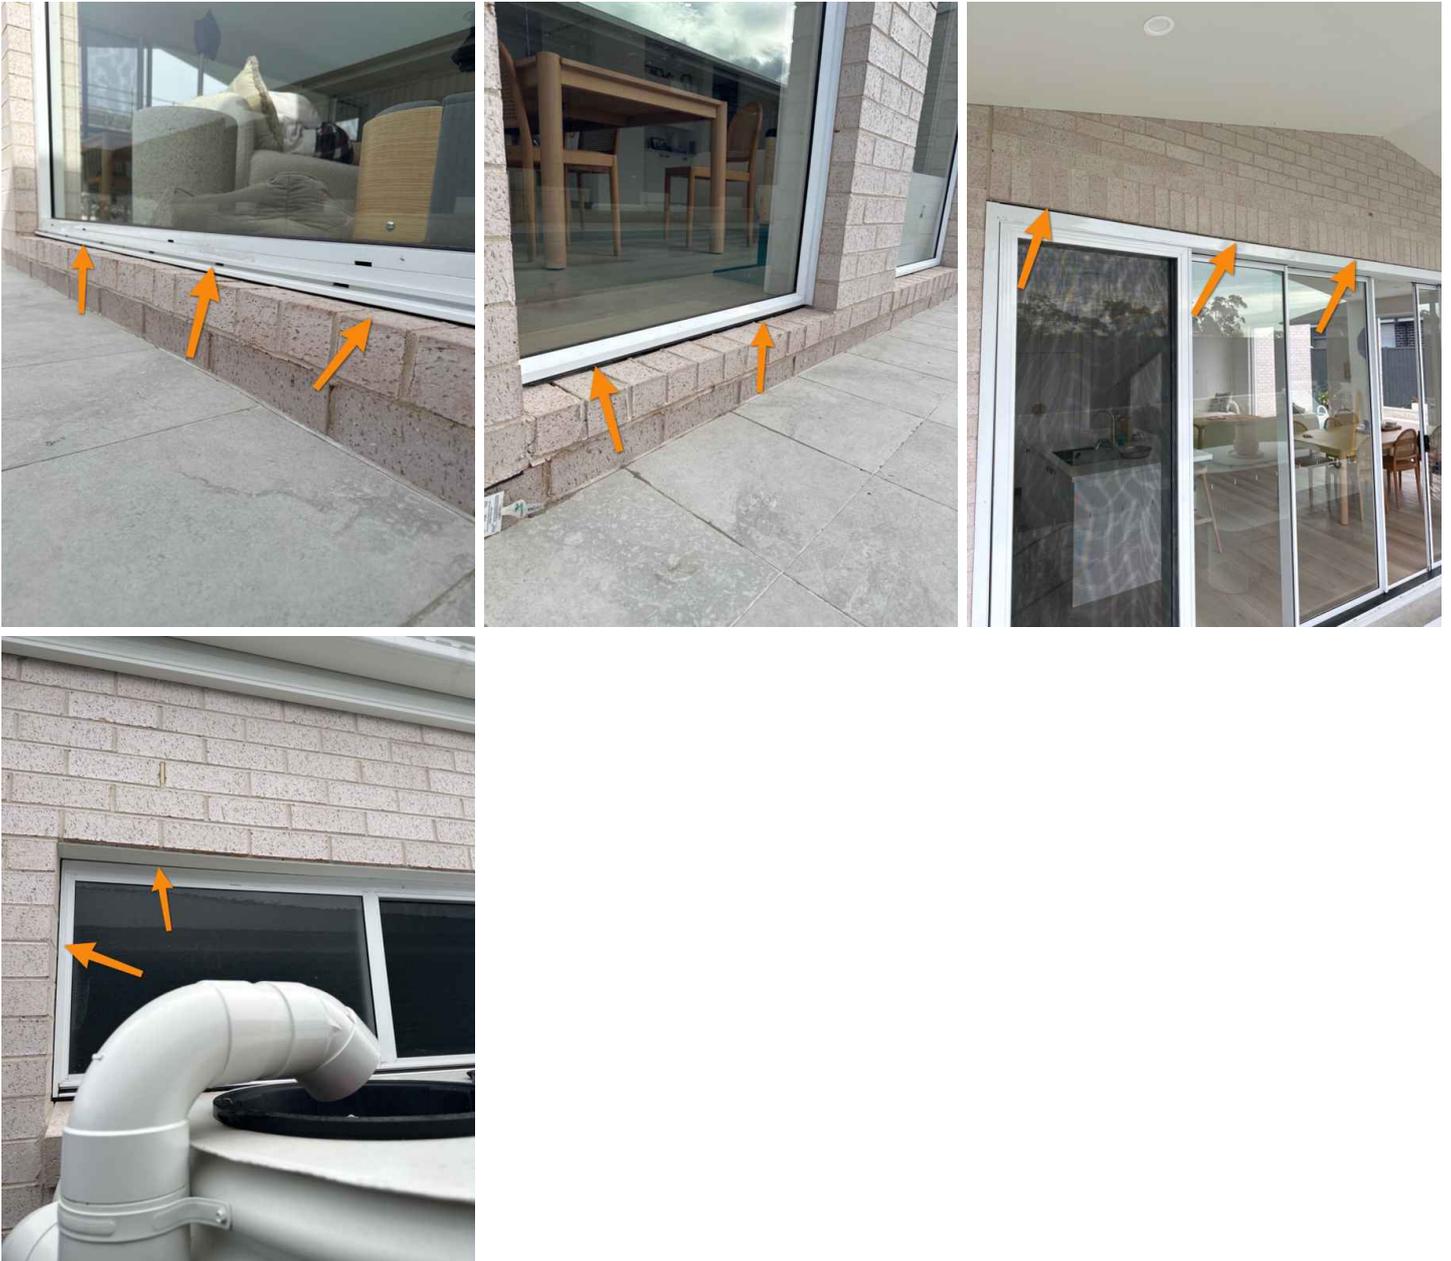
### 3.5.3 External windows

#### **LINTEL SAG**

The lintel outside the kitchen has sagged. This means the steel lintel installed is not adequate to support the weight of the brick veneer wall. It is recommended the lintel be checked against the engineer plans to determine if the correct one was installed.
