HOMESAFE INSPECTIONS
info@homesafeinspections.com.au
<http://www.homesafeinspections.com.au>

COMBINED BUILDING AND PEST INSPECTION

1234 MAIN STREET
SYDNEY NSW 2227

03/07/2023

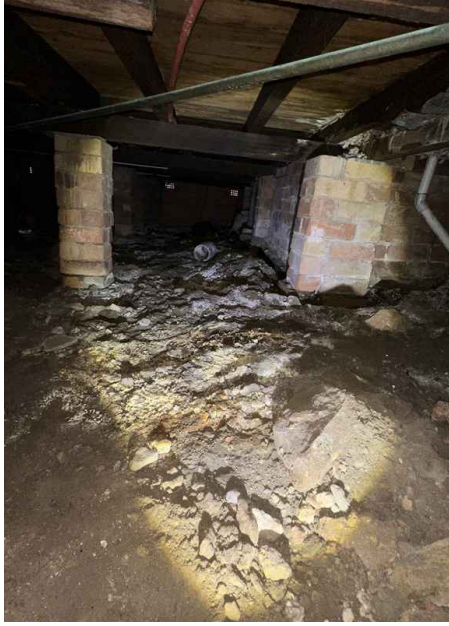
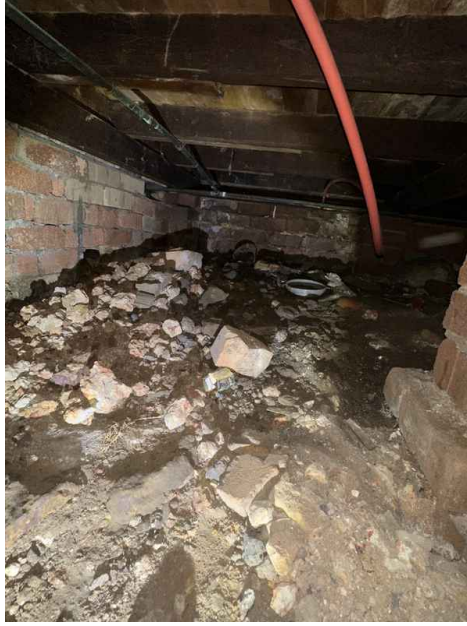
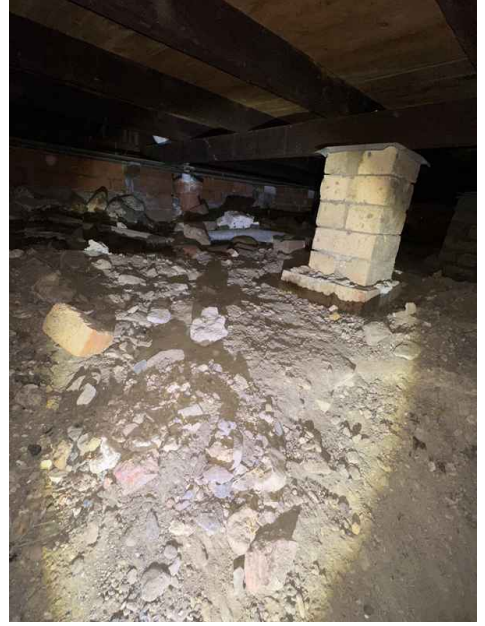
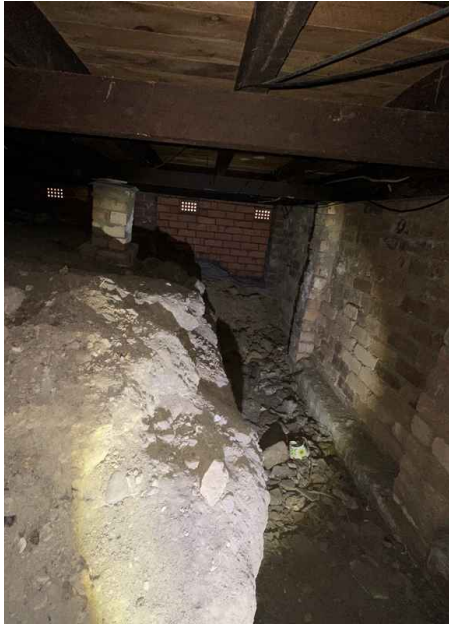
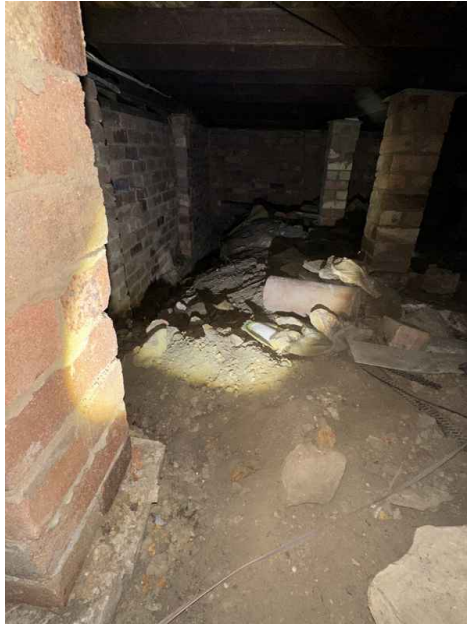
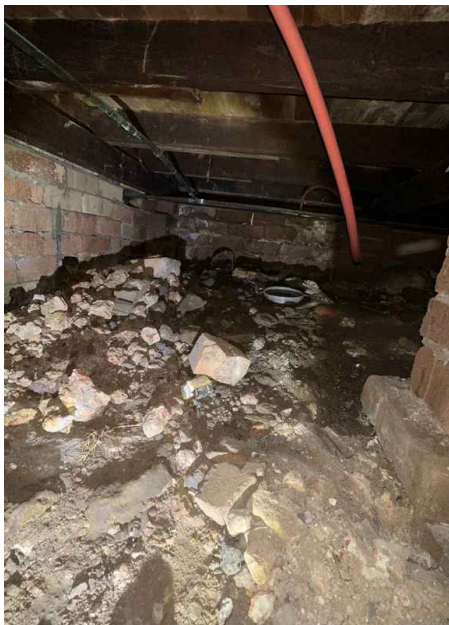
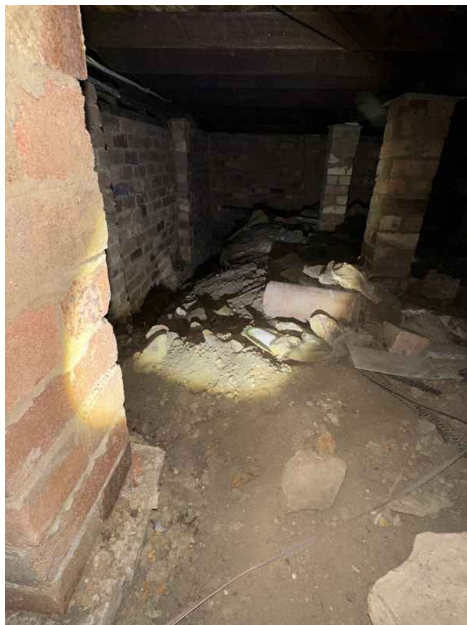
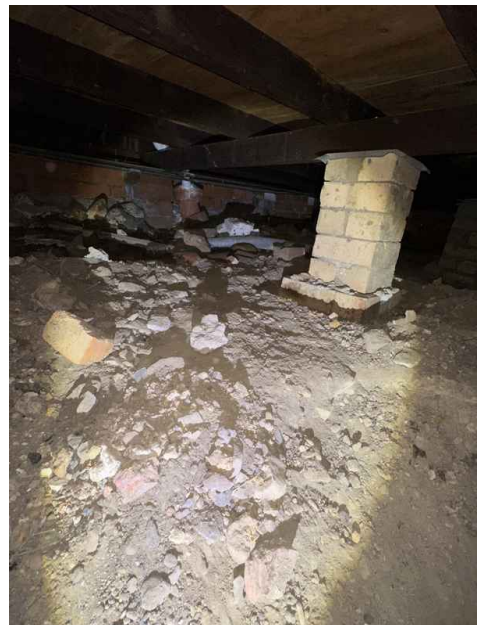
Subfloor: General View

General view of the subfloor at the time of inspection

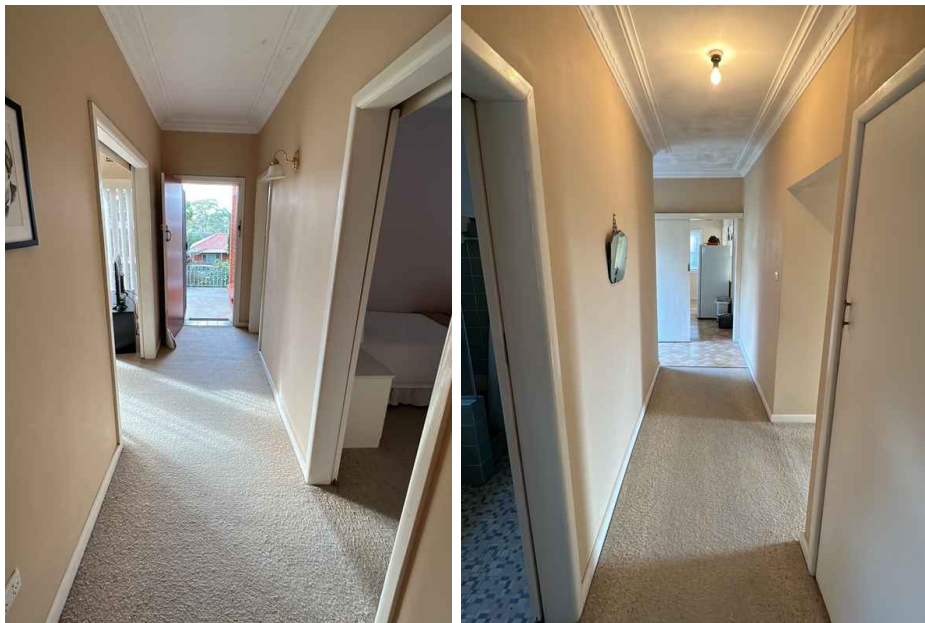
General View

General view of Entry & Hallways at the time of inspection

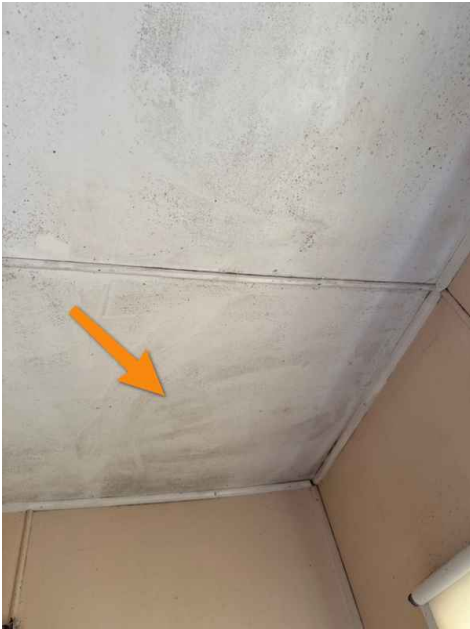
There are possible signs of fungi growth on ceiling. It is unknown if this is a safety hazard. Recommend a qualified mold inspector evaluate.

Contact a qualified mold inspection professional.

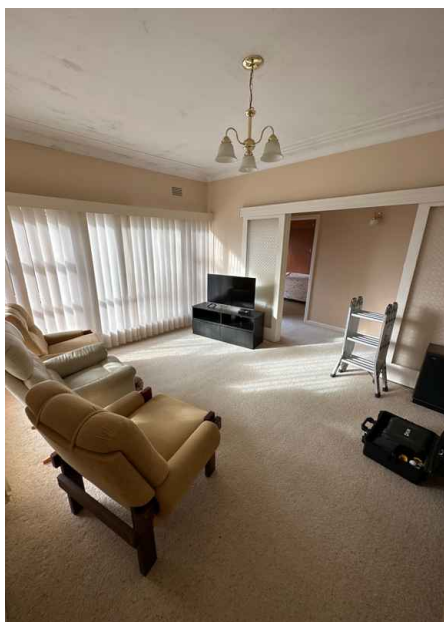
General View

General view at the time of inspection

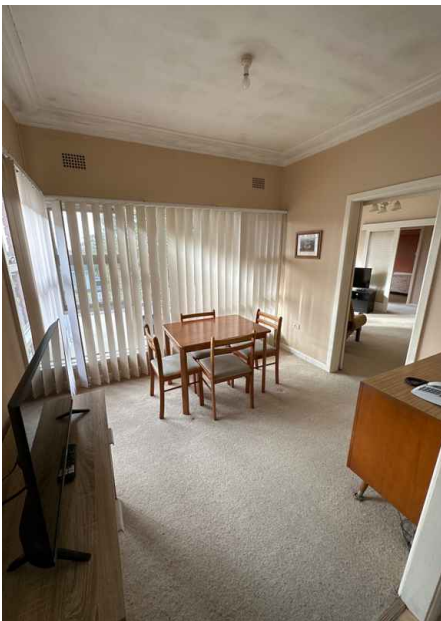
General View

General view at the time of inspection

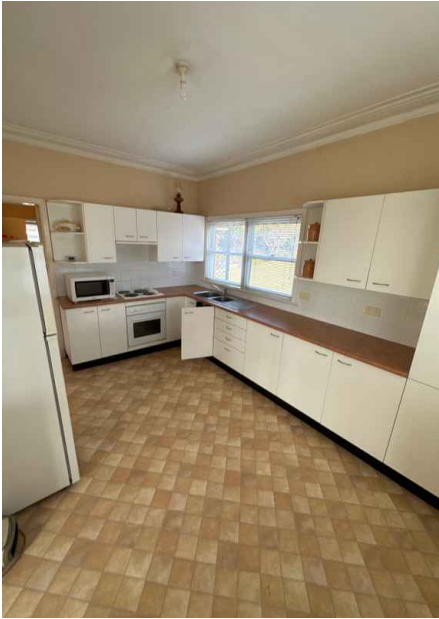
General View

General view at the time of inspection

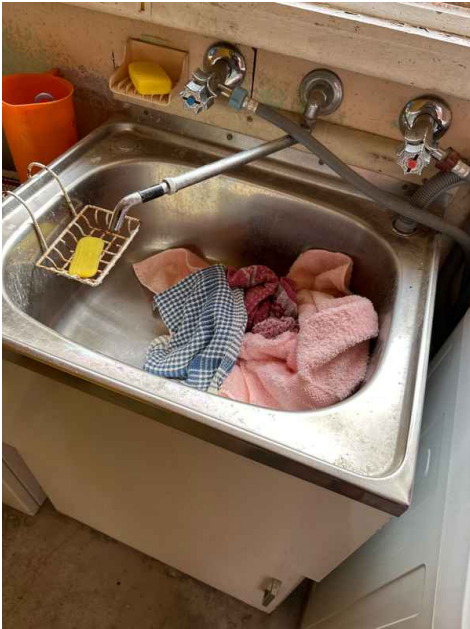
OWNERS BELONGINGS

Owners belongings in tub. Unable to test

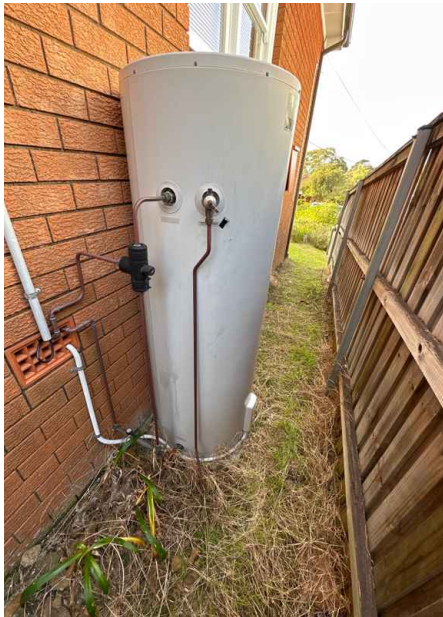
Hot Water Unit: General view of hotwater system
