BUILDING & PEST INSPECTION

1234 Main Street
Sydney, NSW 2227

Buyer Name
01/10/2024 9:00AM

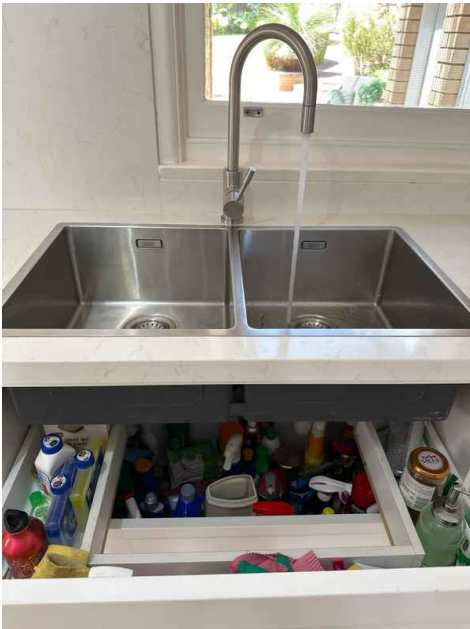
Sink, Cabinetry & Benchtops

OWNER POSSESSIONS

There are owner's possessions, items in cupboards/under sink & personal belongings present which is preventing a thorough inspection of some areas of the Kitchen from being undertaken.

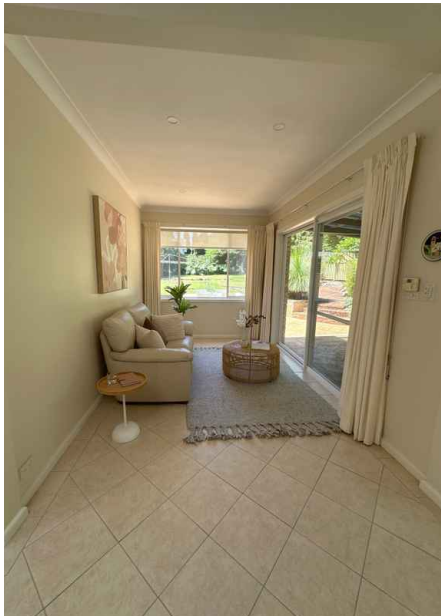
General view at the time of inspection

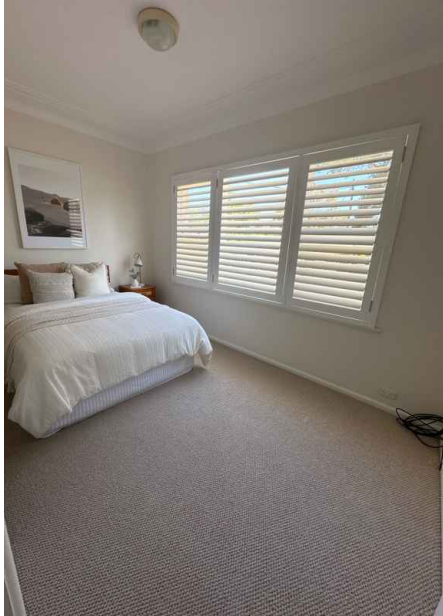
General view at the time of inspection

One or more windows are painted shut. Recommend windows be restored to functional use.

Contact a qualified window repair/installation contractor.

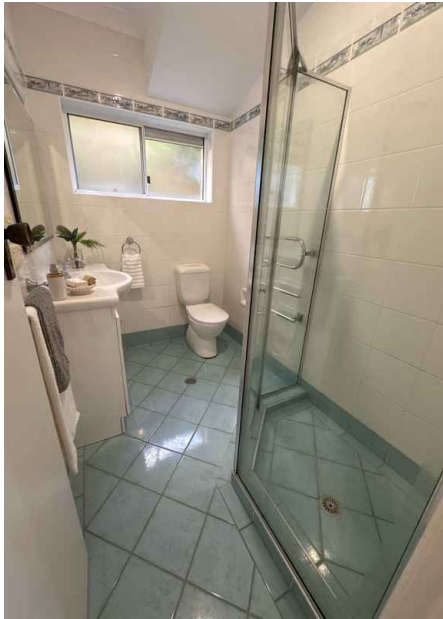
General view at the time of inspection

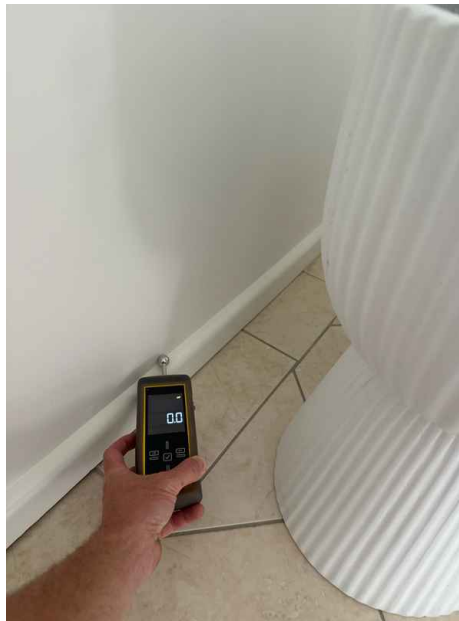
Shower & Bath: Was there high moisture readings to the walls adjacent to the shower recess

No

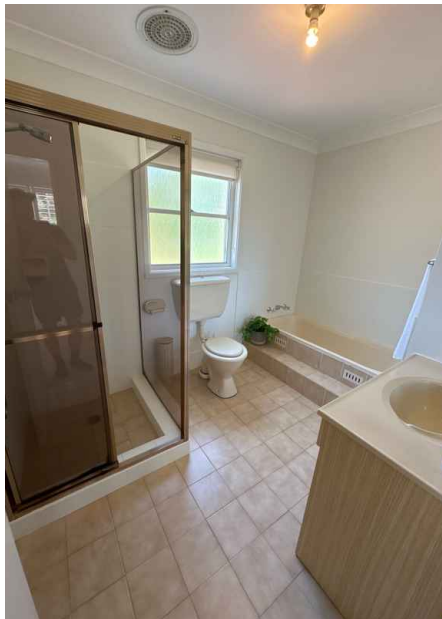
General view at the time of inspection

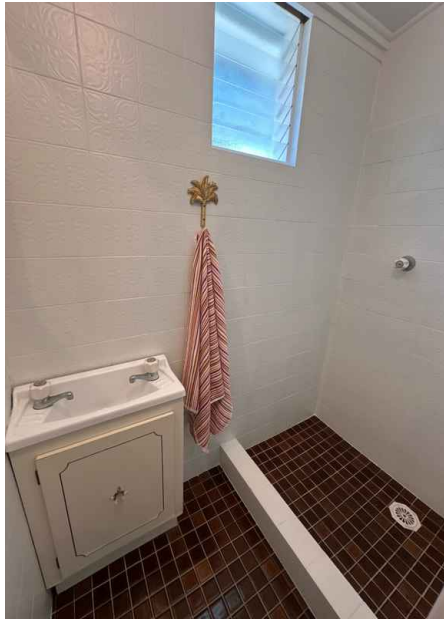
General view at the time of inspection
